## **Policy Group – 31 January 2018**

### **Northbrook Road pedestrian bridge, Swanage – proposal for replacement**

<b>TRANSPORTATION SERVICES</b>		Inspector: A A PARFETT	
	<b>HIGHWAY STRUCTURE INSPECTION REPORT</b>		Date: 12/09/2017	
Bridge Name: KING GEORGES FOOTBRIDGE NORTHBROOK CEMETARY SWANAGE		Bridge Ref: 000	Road Ref: NOT APPLICABLE	
Inspection Type: PRINCIPAL	Next Inspection: GENERAL (12/09/2019)	Map Ref: SZ	O.S.E: 402592	O.S.N: 078930

**KING GEORGES FOOTBRIDGE – NORTHBROOK CEMETARY SWANAGE  
INSPECTION SUMMARY & RECOMMENDATIONS**

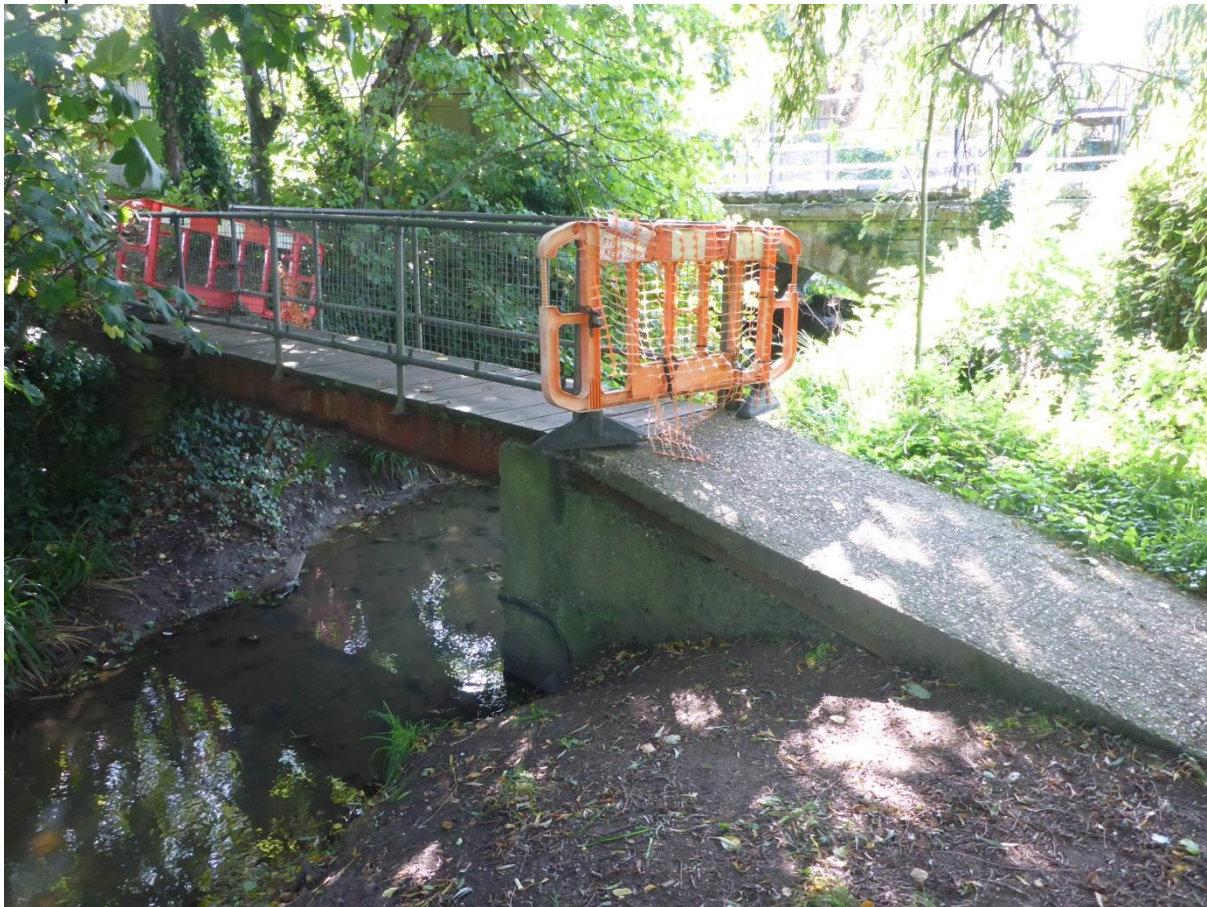
**1. Upstream Elevation**

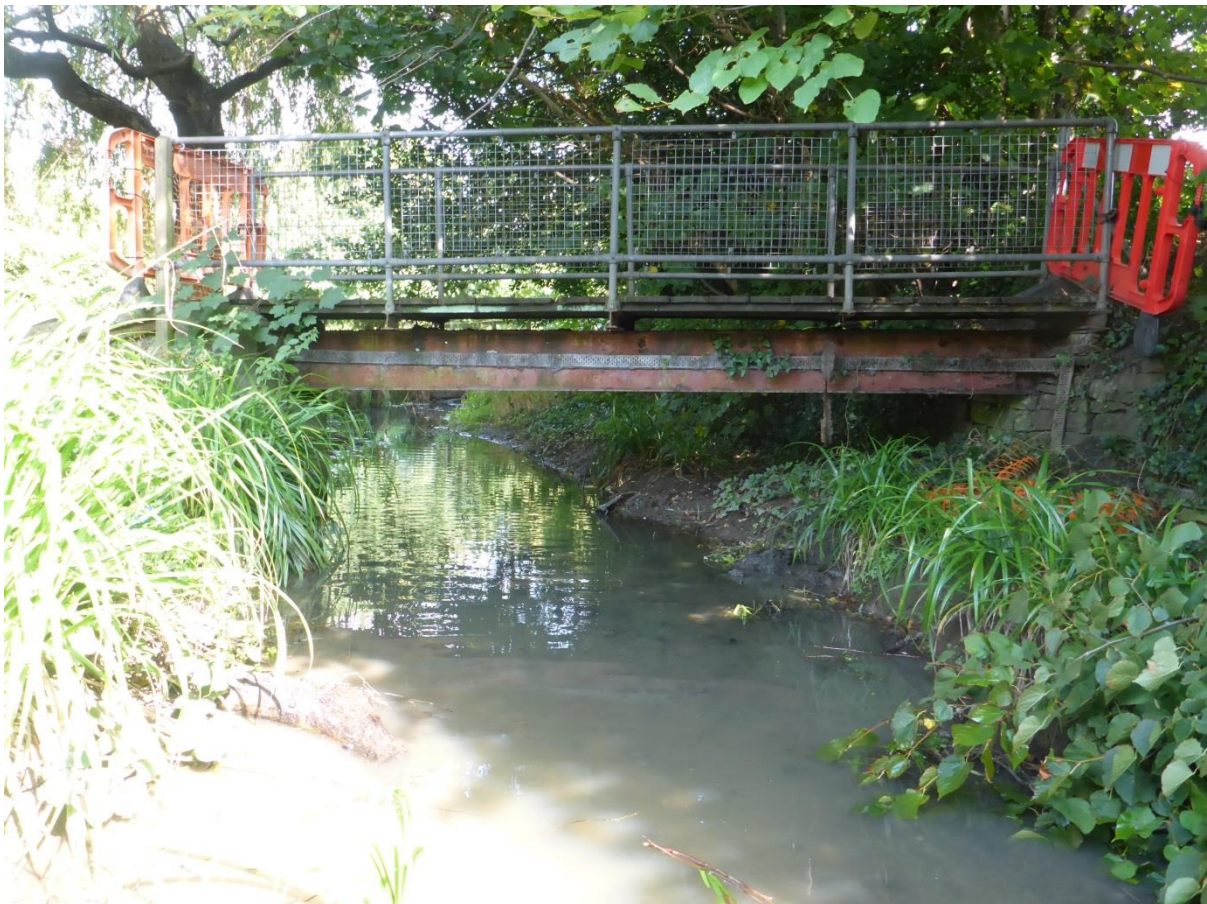
**2. Downstream Elevation**

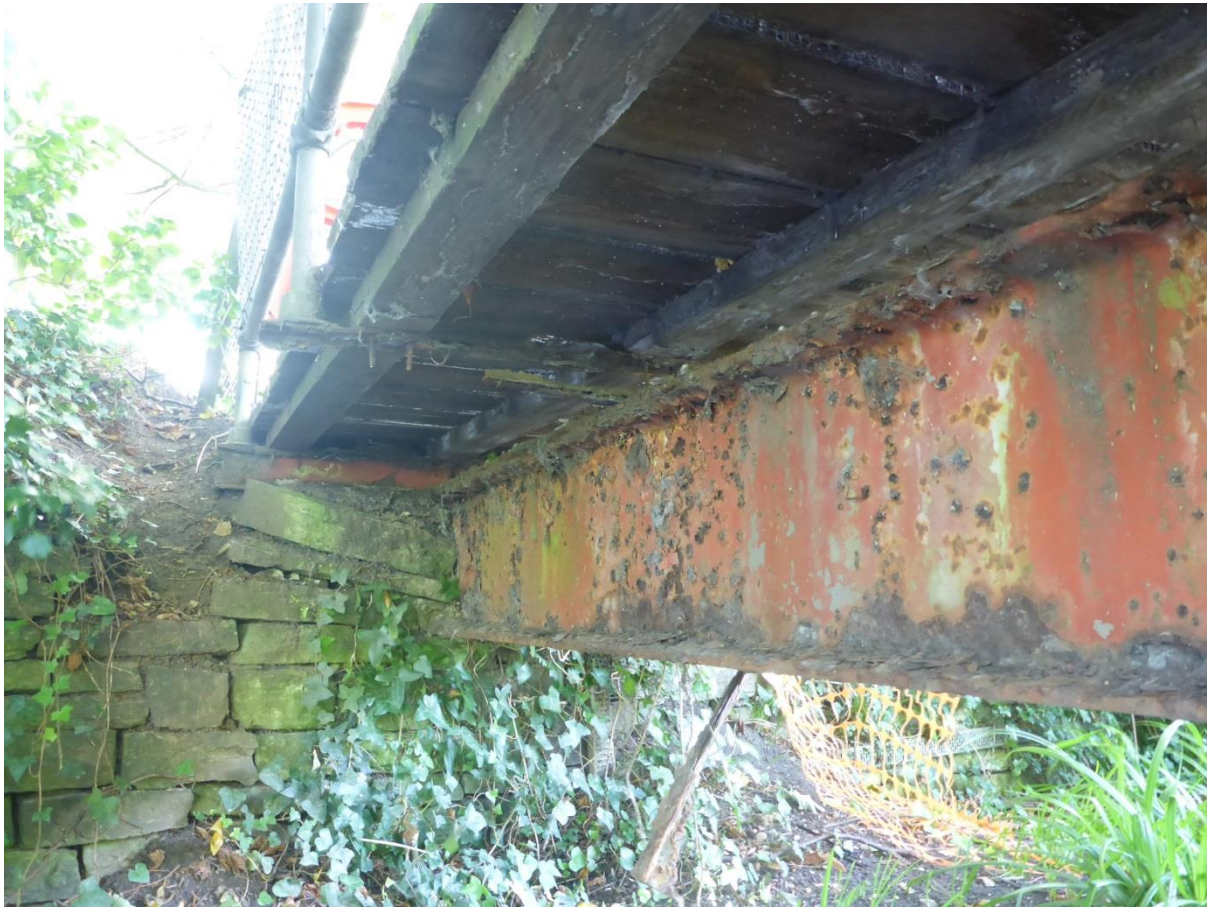
3. East Abutment

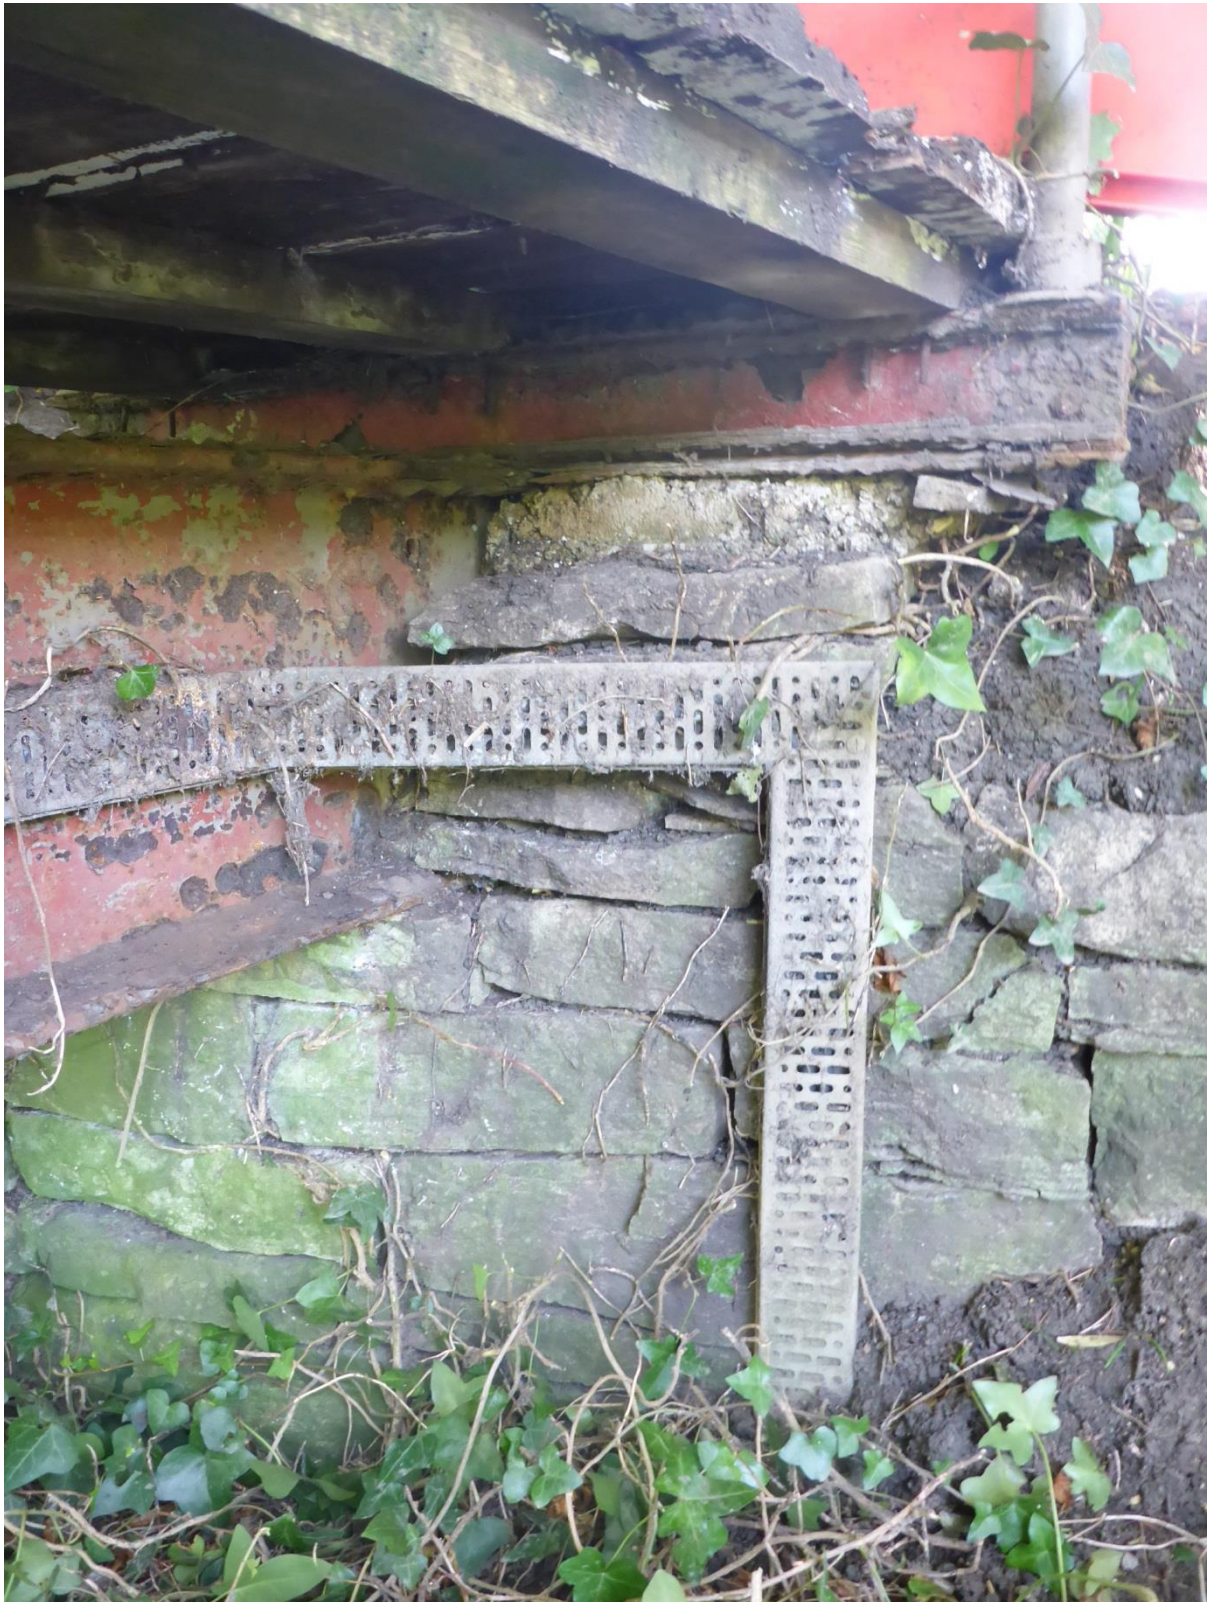
4. East Abutment

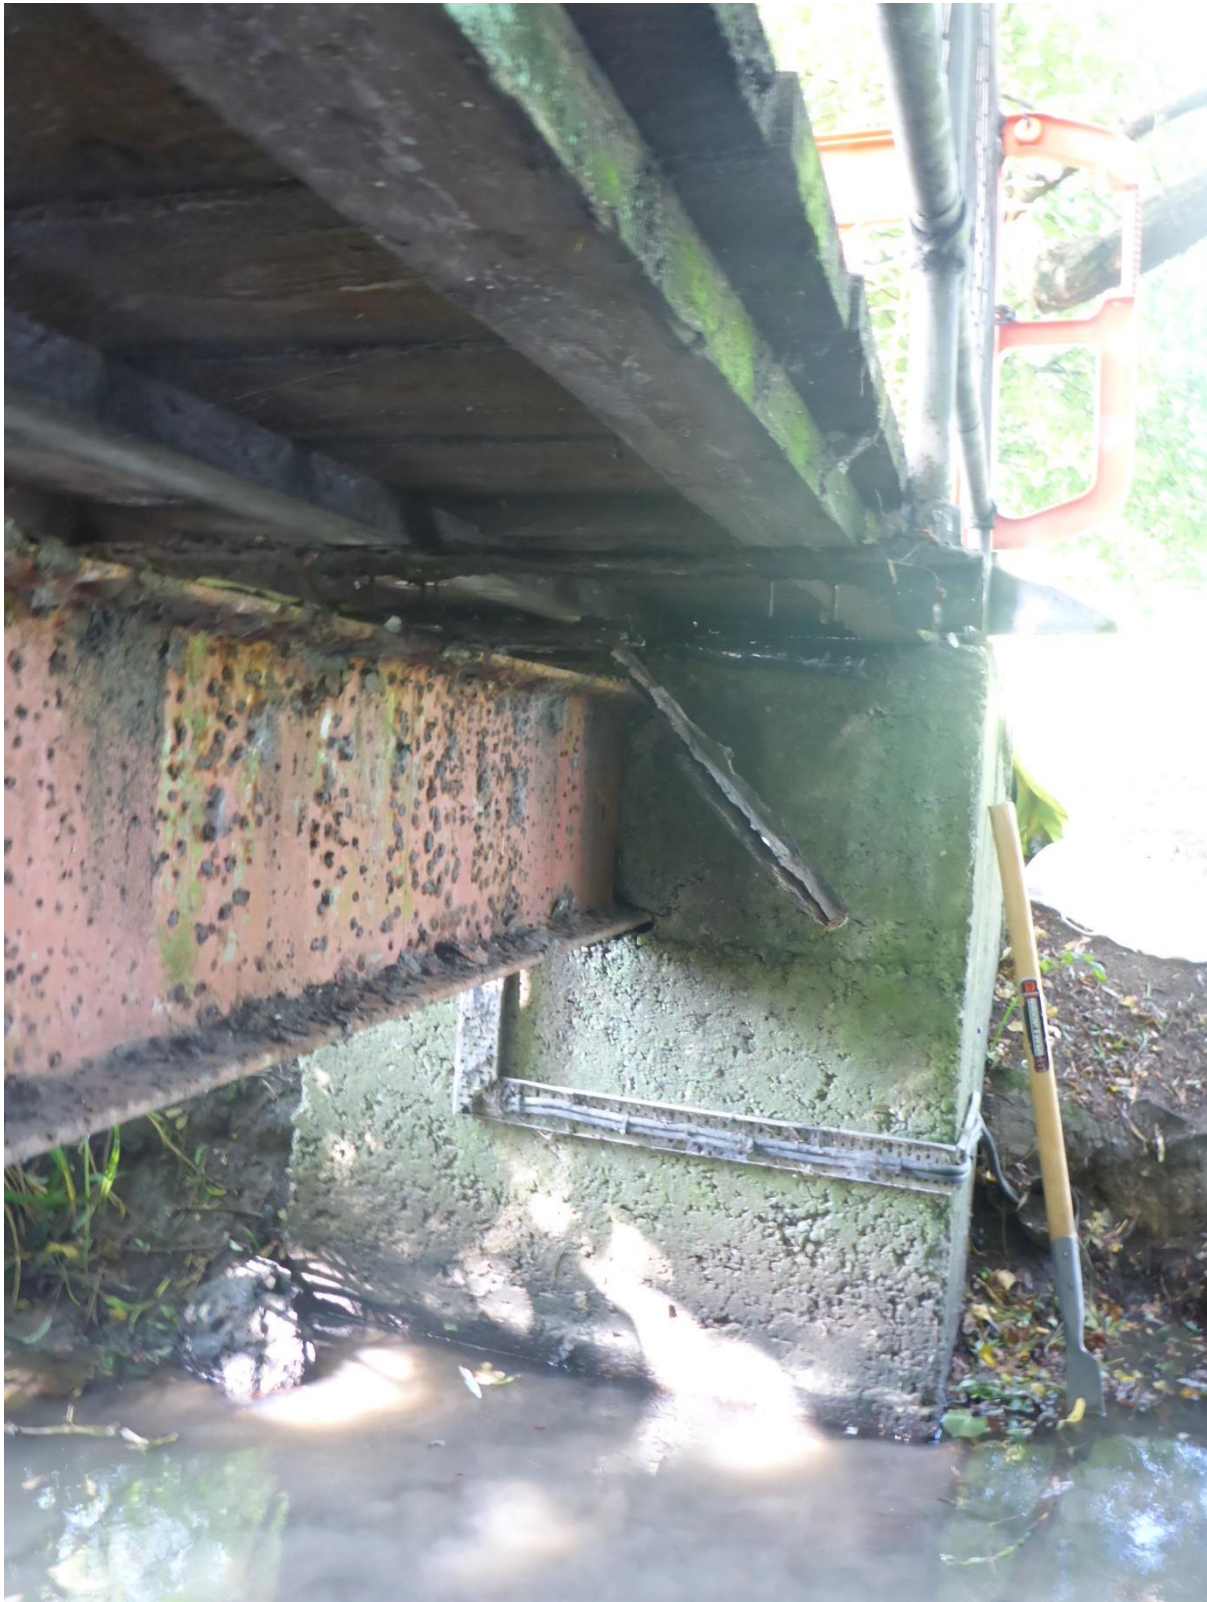
06	West Abutment	2	B	R	H	Mass Insitu Concrete Abutment incorporating a mass concrete approach ramp behind. The I section main beam is encapsulated in to the concrete. All concrete surfaces have an exposed aggregate open textured finish indicating poor compaction and or the concrete was too dry when poured. A sloping 75 x 75mm steel I beam is exposed in the elevation faces of the concrete ramp. The beams are connected to a transverse I beam also encapsulated in the concrete behind the watercourse abutment face. It is probable the concrete is a more recent construction with the original abutment and steel framed approach ramp buried beneath.	
Safety Elements	07	Handrail/Parapets	5	E	R	U	42.4mm Dia. Key Clamp galvanised tubular post and rail handrails with square mesh infill panels. Handrails are in good condition, but post baseplates are secured to the severely corroded/missing transverse beams. Some of the rail/post joints have pulled apart due to flexing of the unsupported bridge deck. In addition the handrail height is below the minimum 1.0m high design standard and preferred 1.15m height for footbridges.

The existing concrete abutments are fit for purpose and could be reused to support a refurbished I beam with a like for like bridge deck. Equally they could be modified to support a new design bridge which would reduce costs and cause minimal environmental disturbance.

5. West Abutment

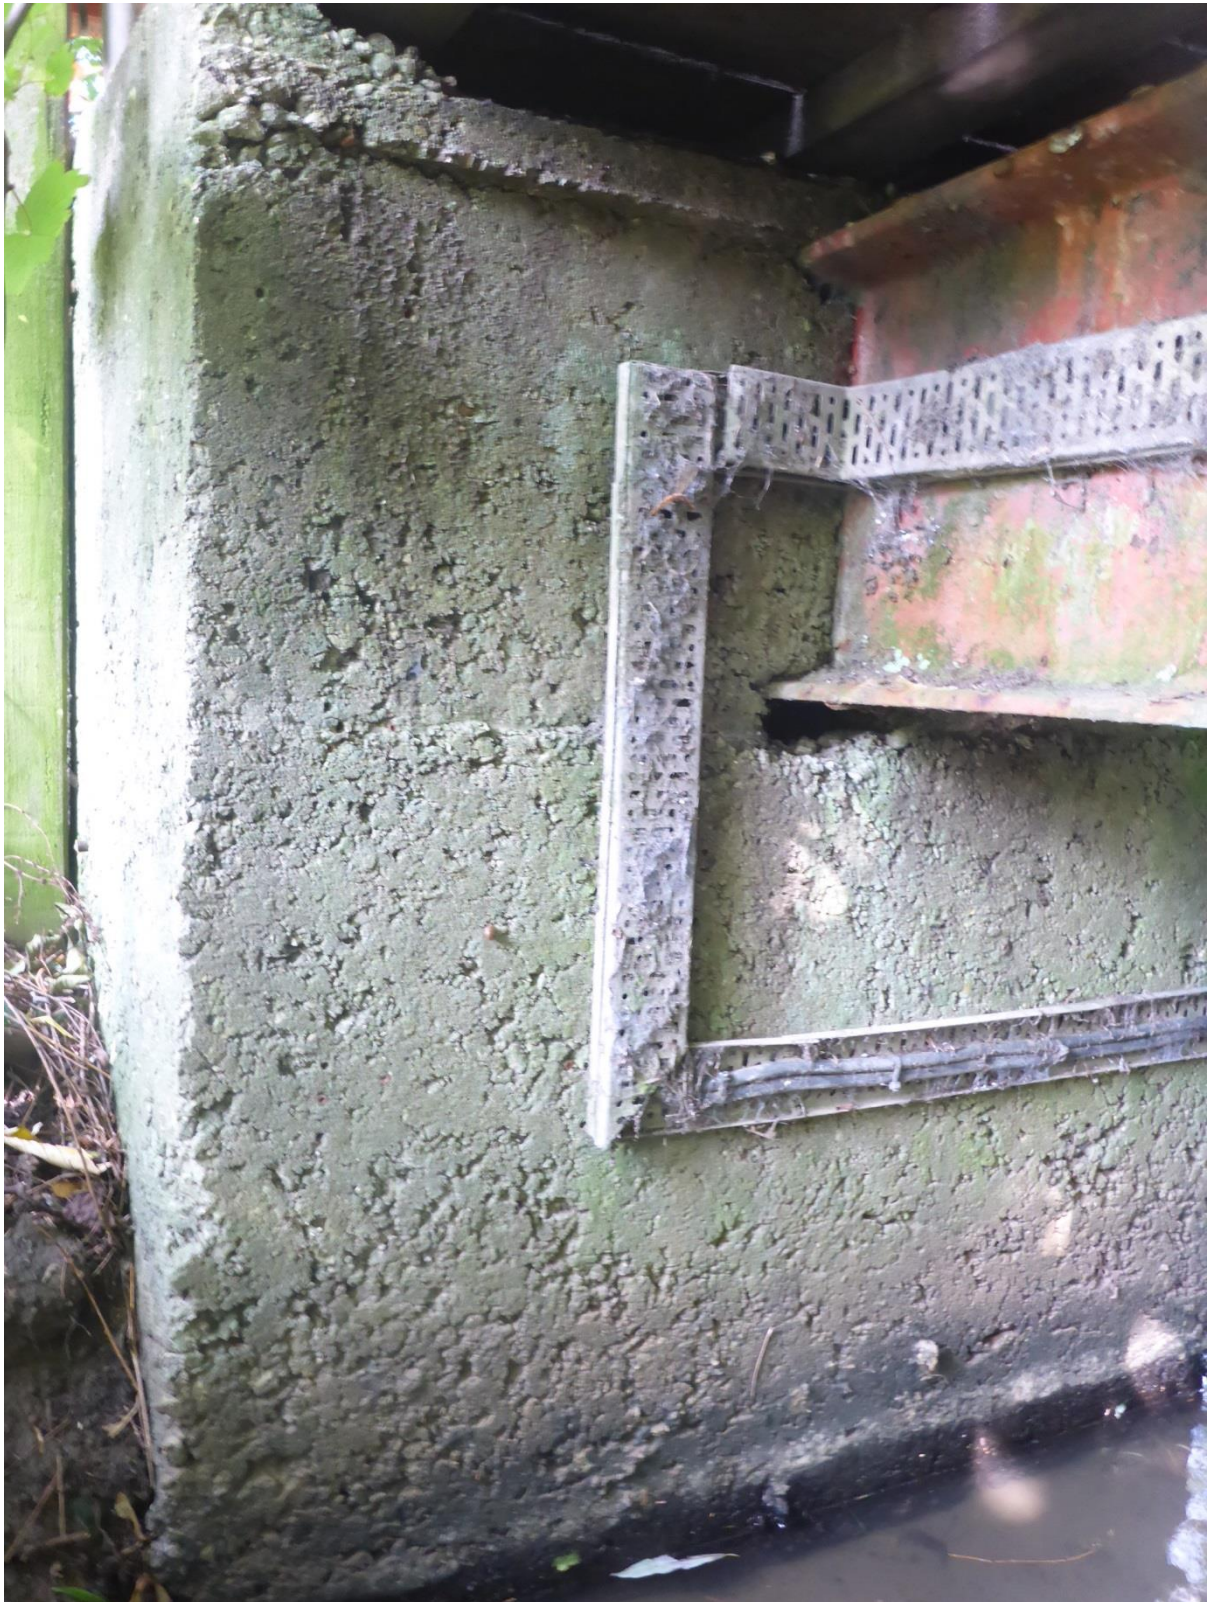
6. West Abutment

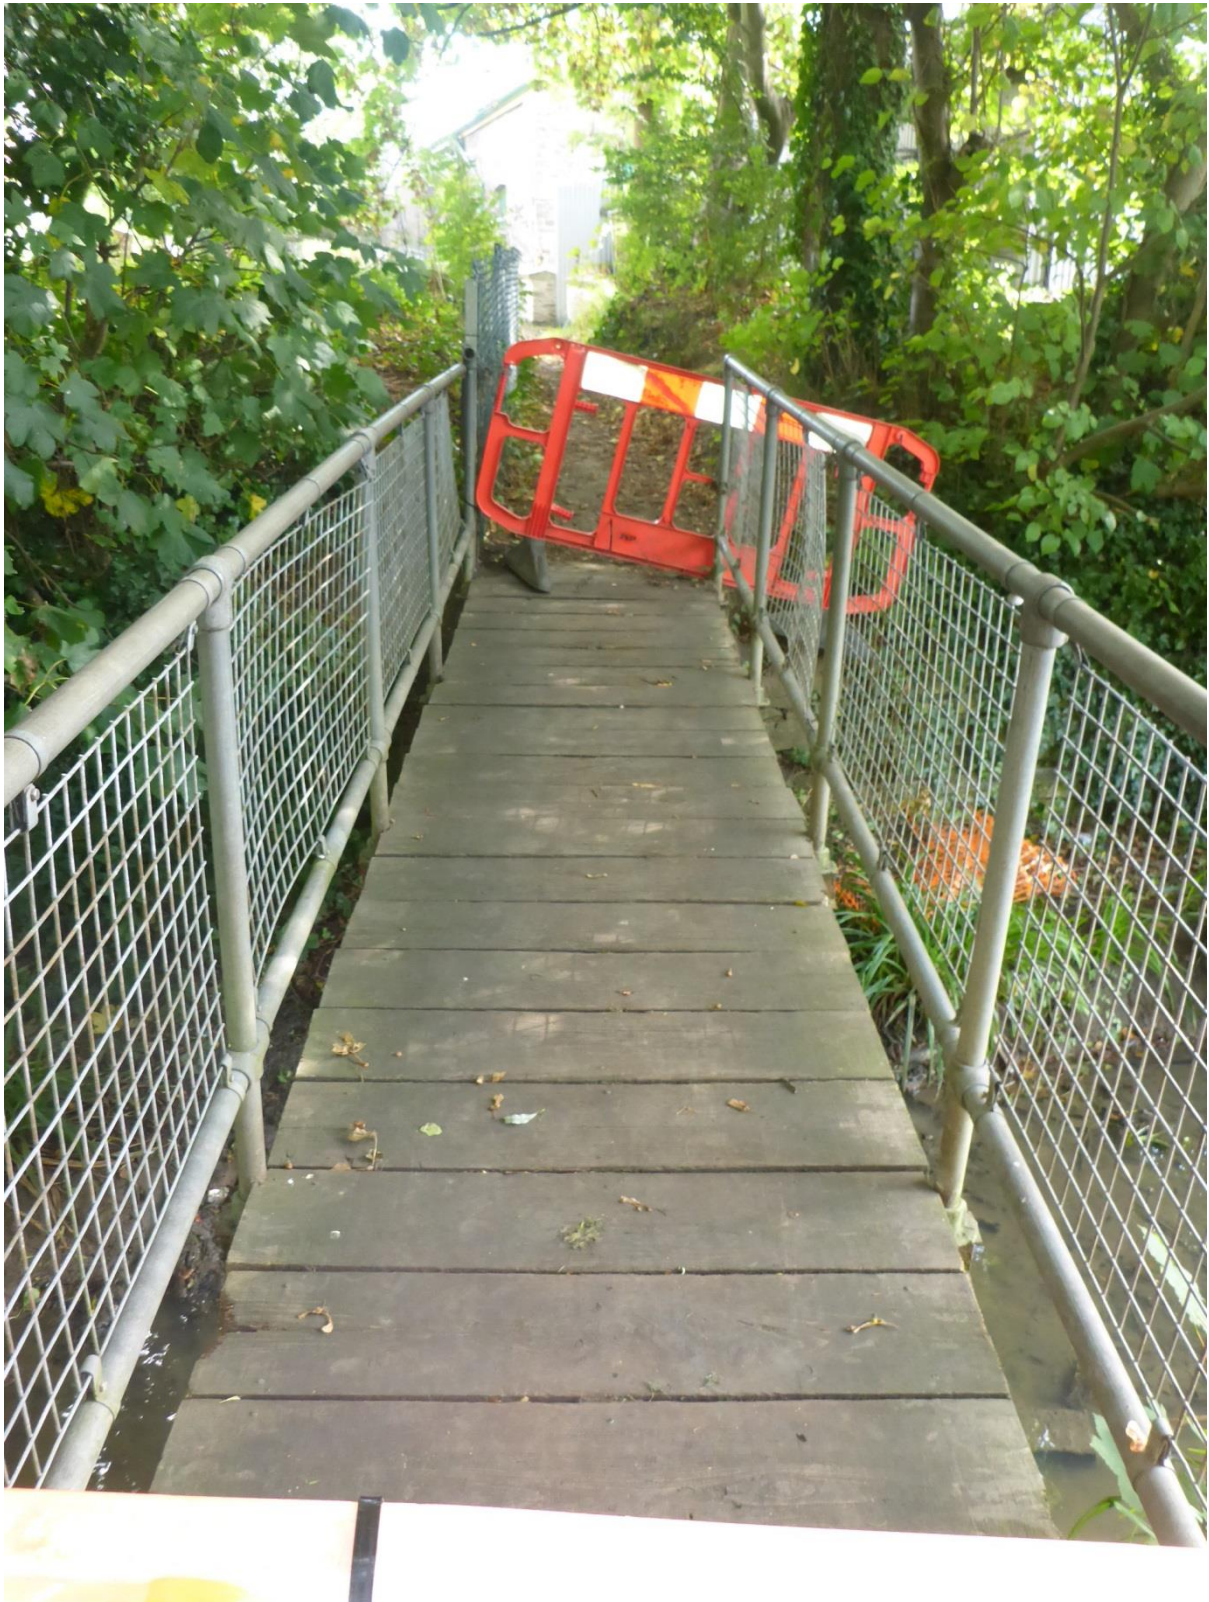
Although the main I beam span is in reasonable salvageable condition the transverse I beams are completely degraded or in the advanced stages. In addition the timber purlins and deck planks are beyond a serviceable condition. Despite the bridge being barriered off there is evidence it is still being accessed by the public. Consideration should be given to removing the bridge deck as soon as possible to prevent any further usage. Thus mitigating the risk of collapse from the continued public access.

7. Deck View East

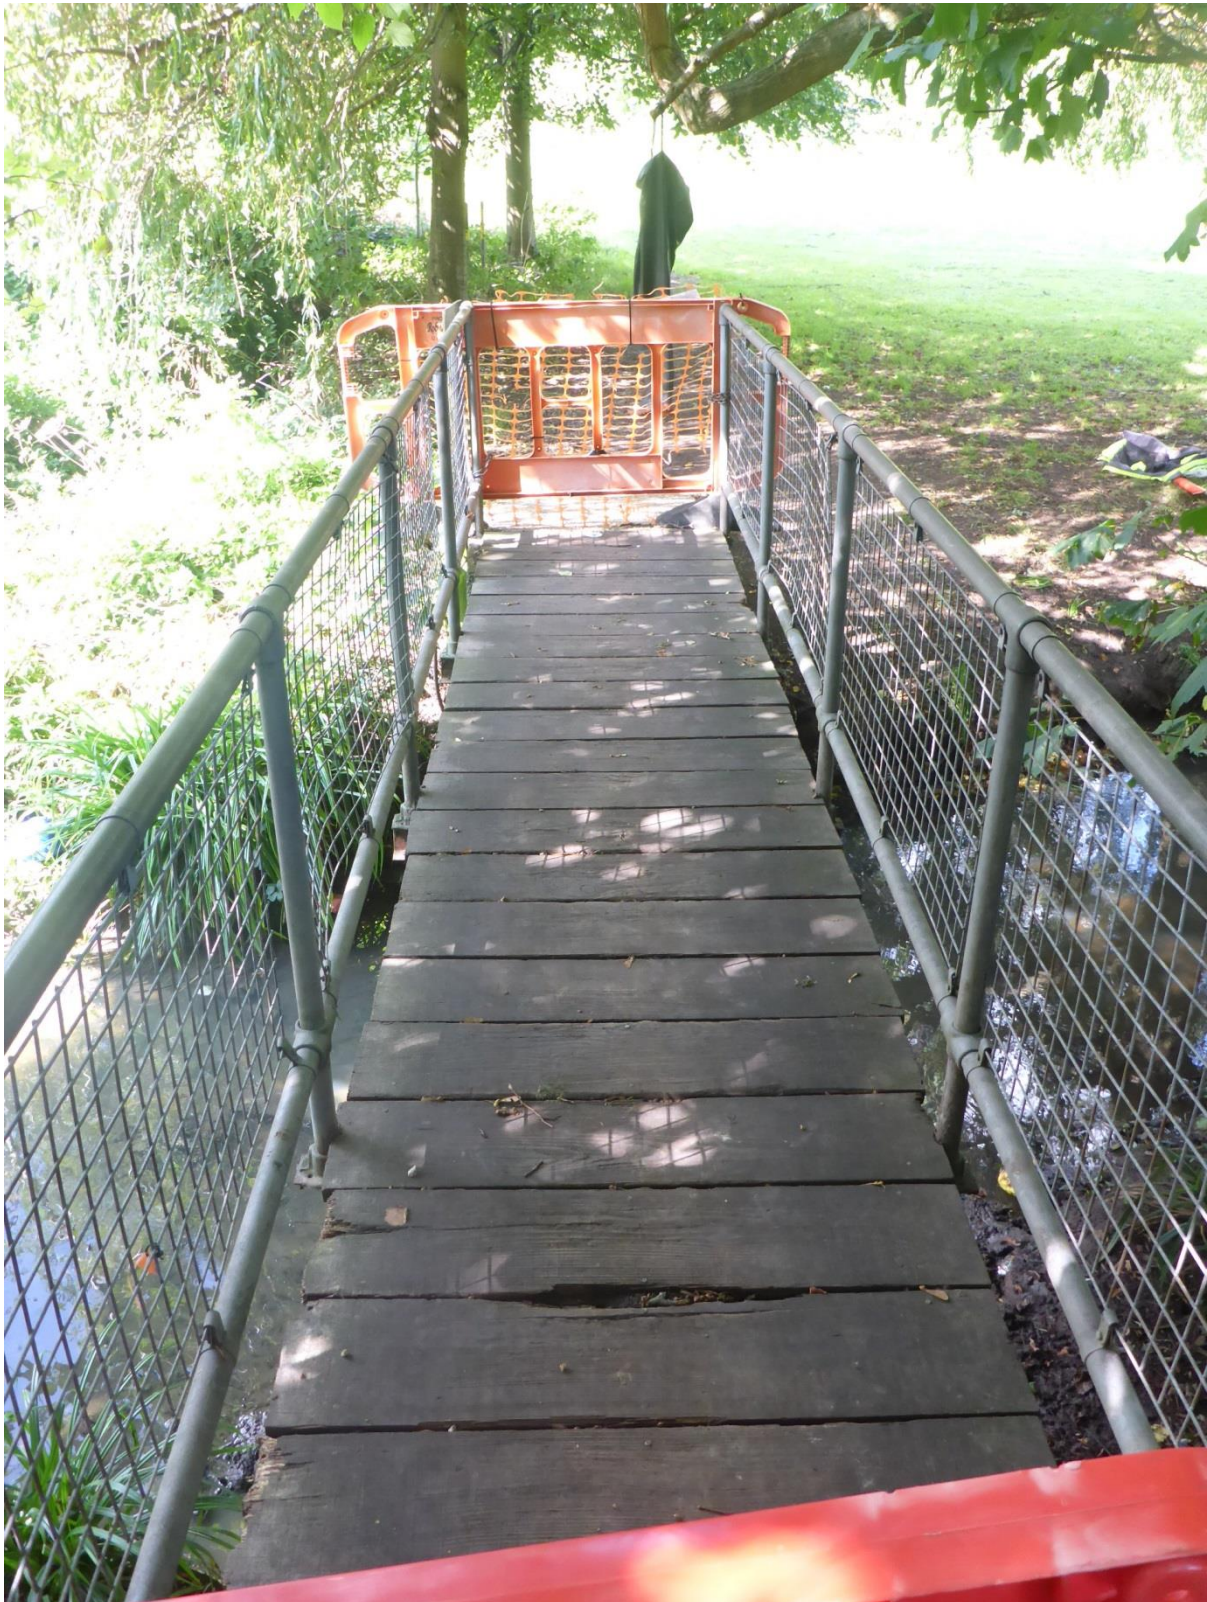
8. Deck View West

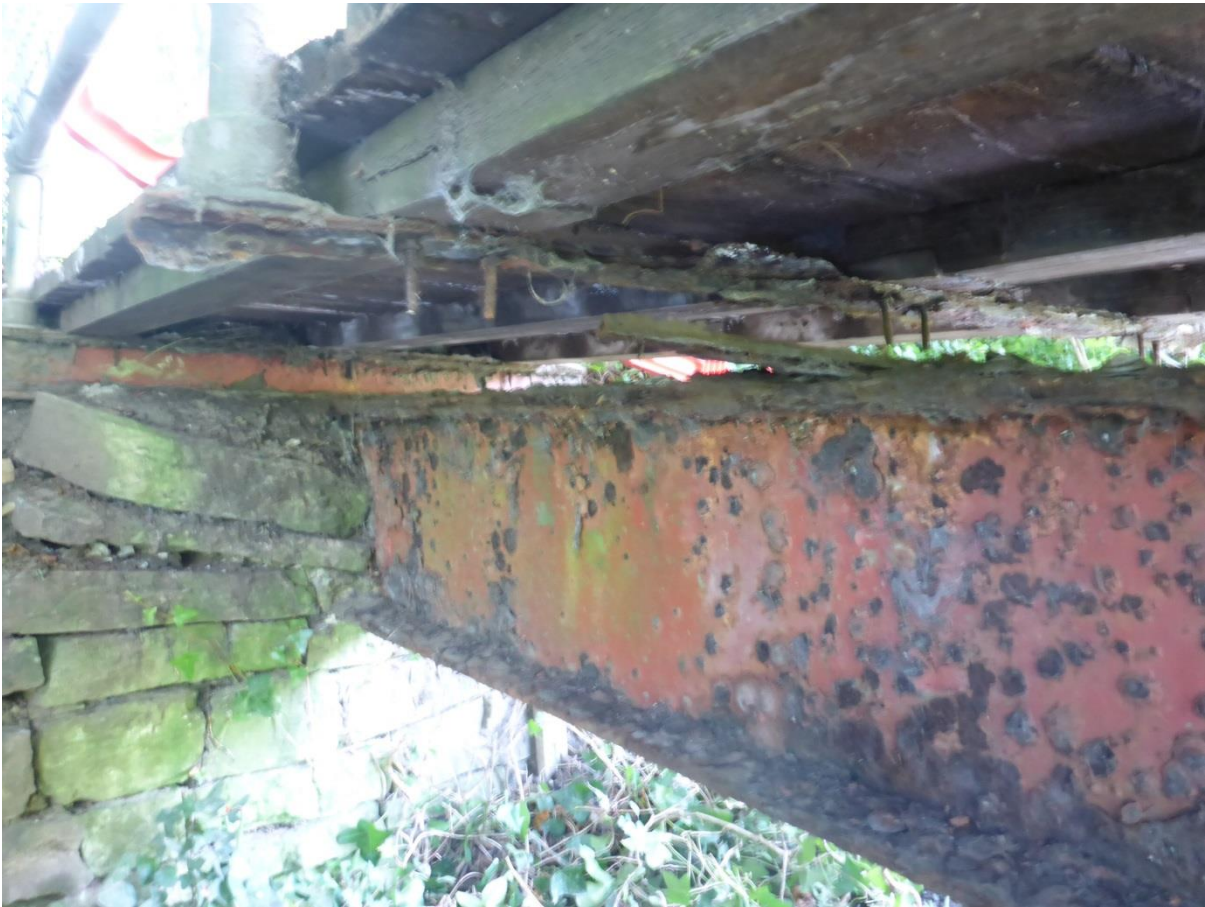
02	Secondary Deck Element	5	E	R	U	5 No. 100 x 75mm Steel I Section Transverse Beams. Webs of the two beams at the quarter spans have corroded away and majority of the flanges also missing. These beams are no longer supporting the timber deck or providing support for posts of the parapet handrails. Remaining beams severely corroded with significant section loss, particularly at welded connection bearing on the single beam span.	
	03	Secondary Deck Element	3	C	R	H	3No. 100 x 50mm Longitudinal Timber Purlins supporting 24 No. 1.070m long x 220 x 32mm Timber Deck Planks. Purlins and planks in early stages of decay with some areas of rot in surface and ends of deck planks. Algae and fungal growth covering underside of timbers.	
Load-Bearing Substructure	04	Foundations	2	A	B	NP	Little or no evidence of structural movement in the concrete abutments construction indicate any foundation defect.	
	05	East Abutment	3	D	R	H	Mass Insitu Concrete Bank Seat faced with coursed random cut dry stone wall, which forms part of a training wall to watercourse. The I section main beam passes through the stonework and is encapsulated into the concrete behind. Top of the stone work either side of bridge has fallen away causing retained material to spill over the wall.

9. Corroded Traverse Beam

Due to the minor construction and span of the bridge, combined with the inconvenience of trying to re use the single main beam it is recommended the whole bridge span should be replaced with a new alternative design, whilst retaining the existing abutments as much as possible.

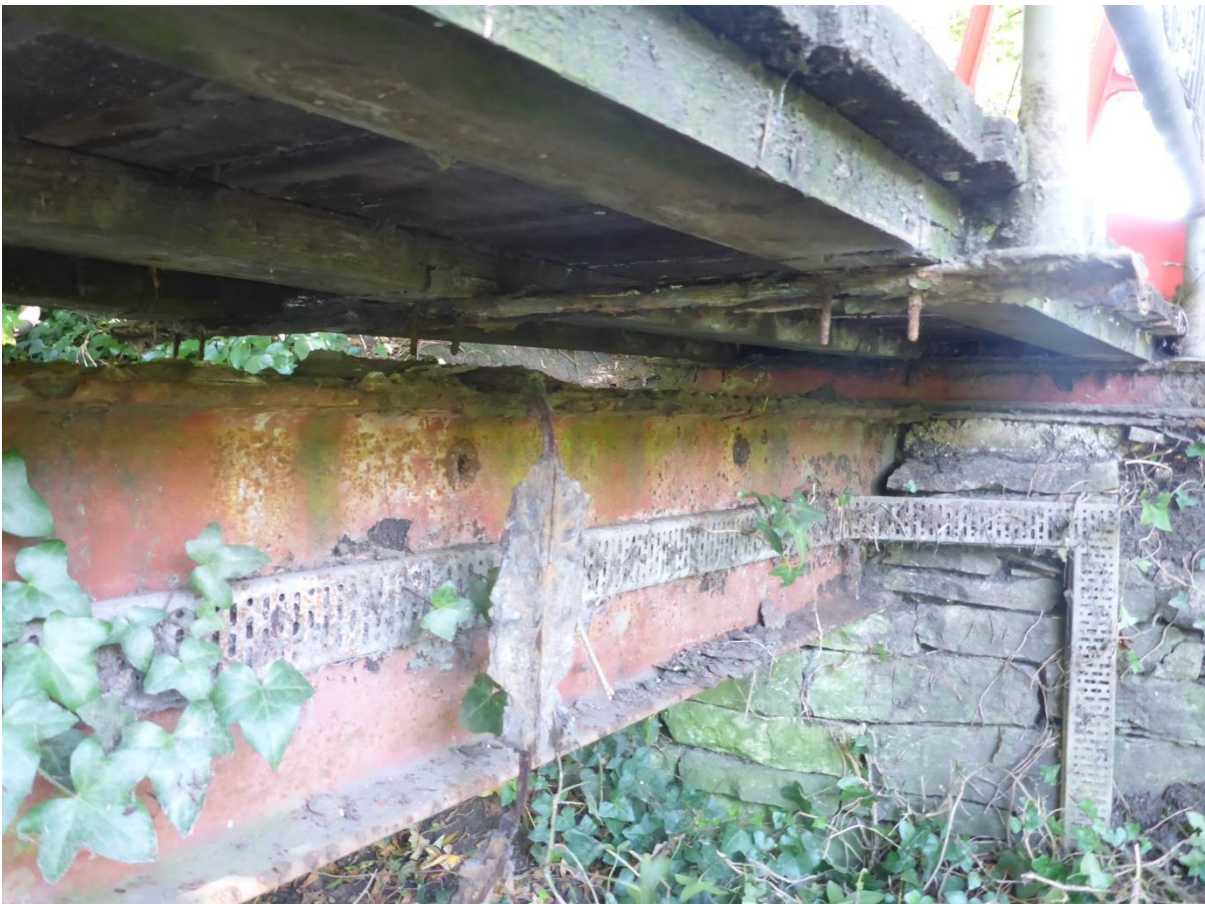
10. Corroded Traverse Beam

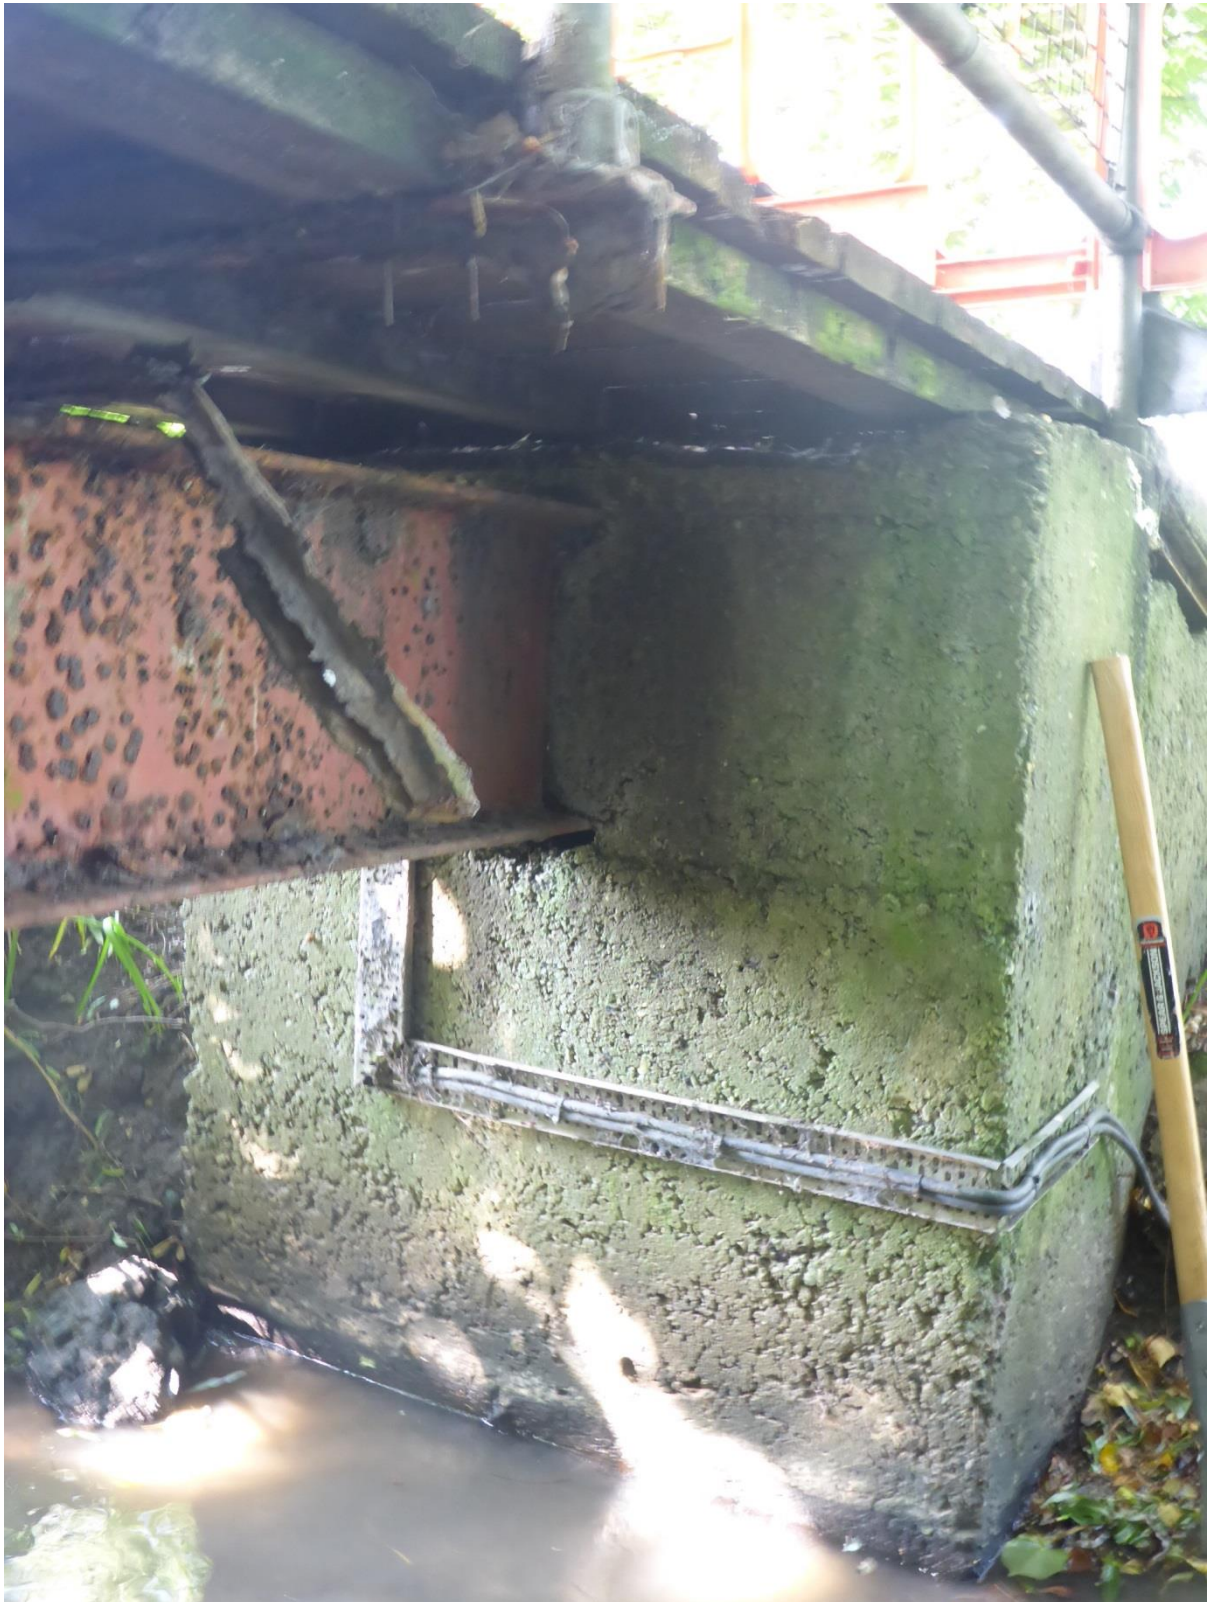
11. Corroded Traverse Beam

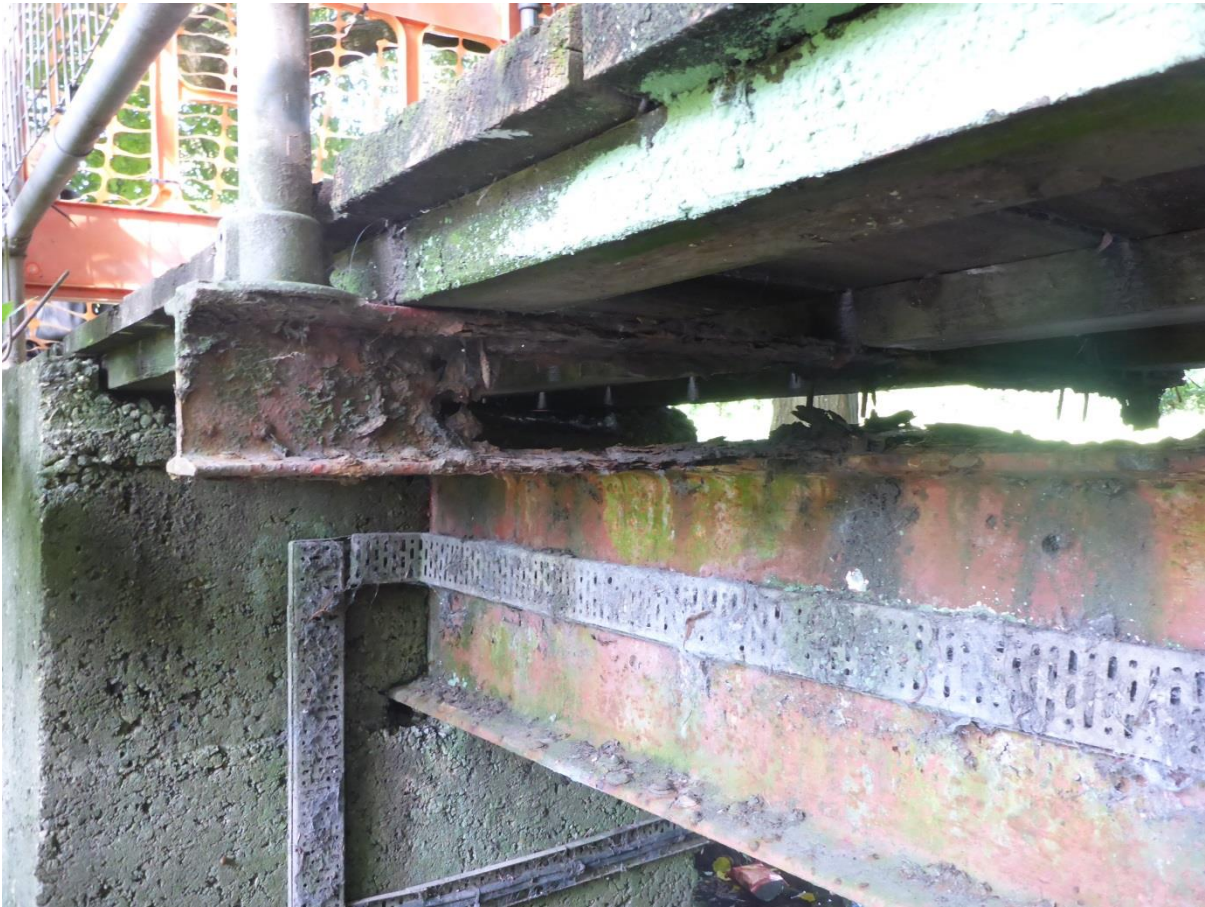
12. Corroded Traverse Beam

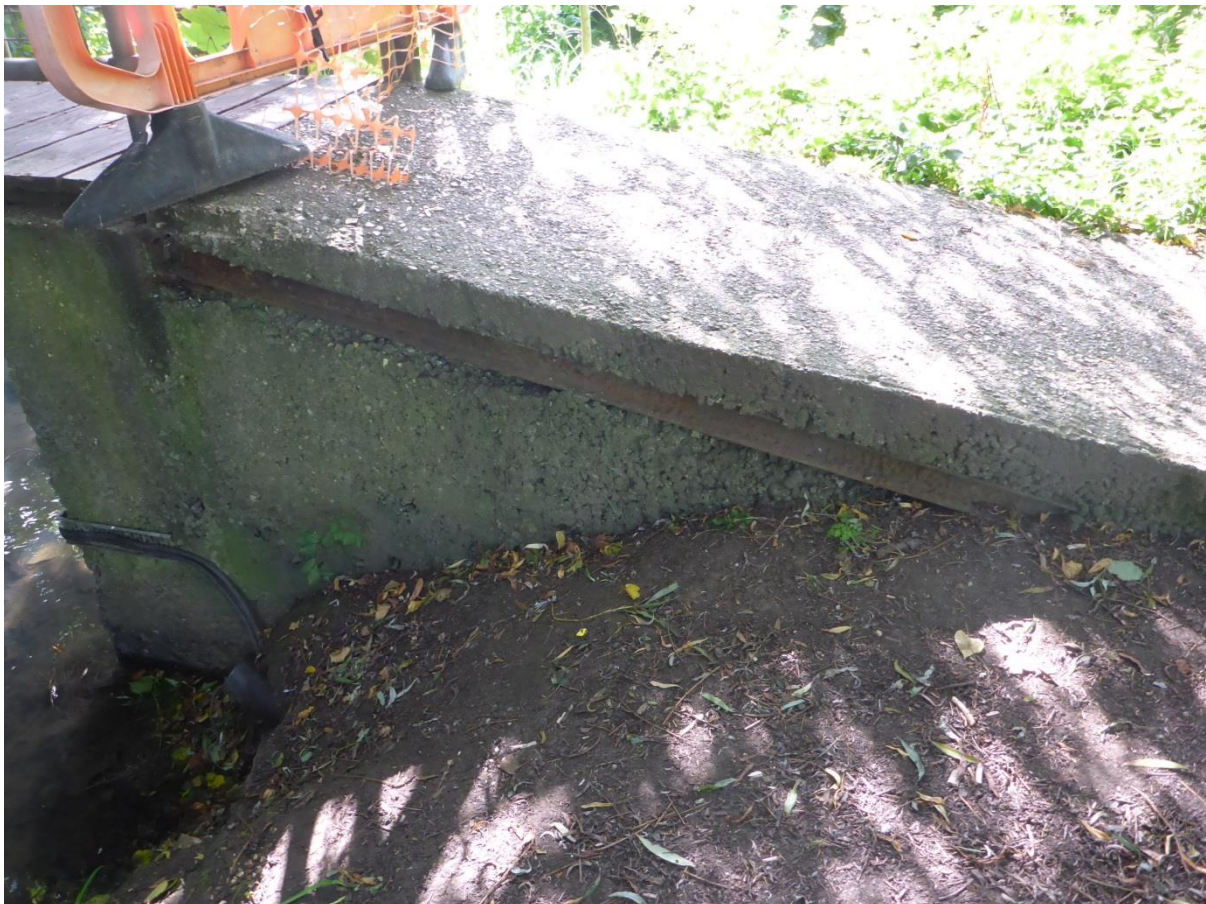
13. West Approach Ramp

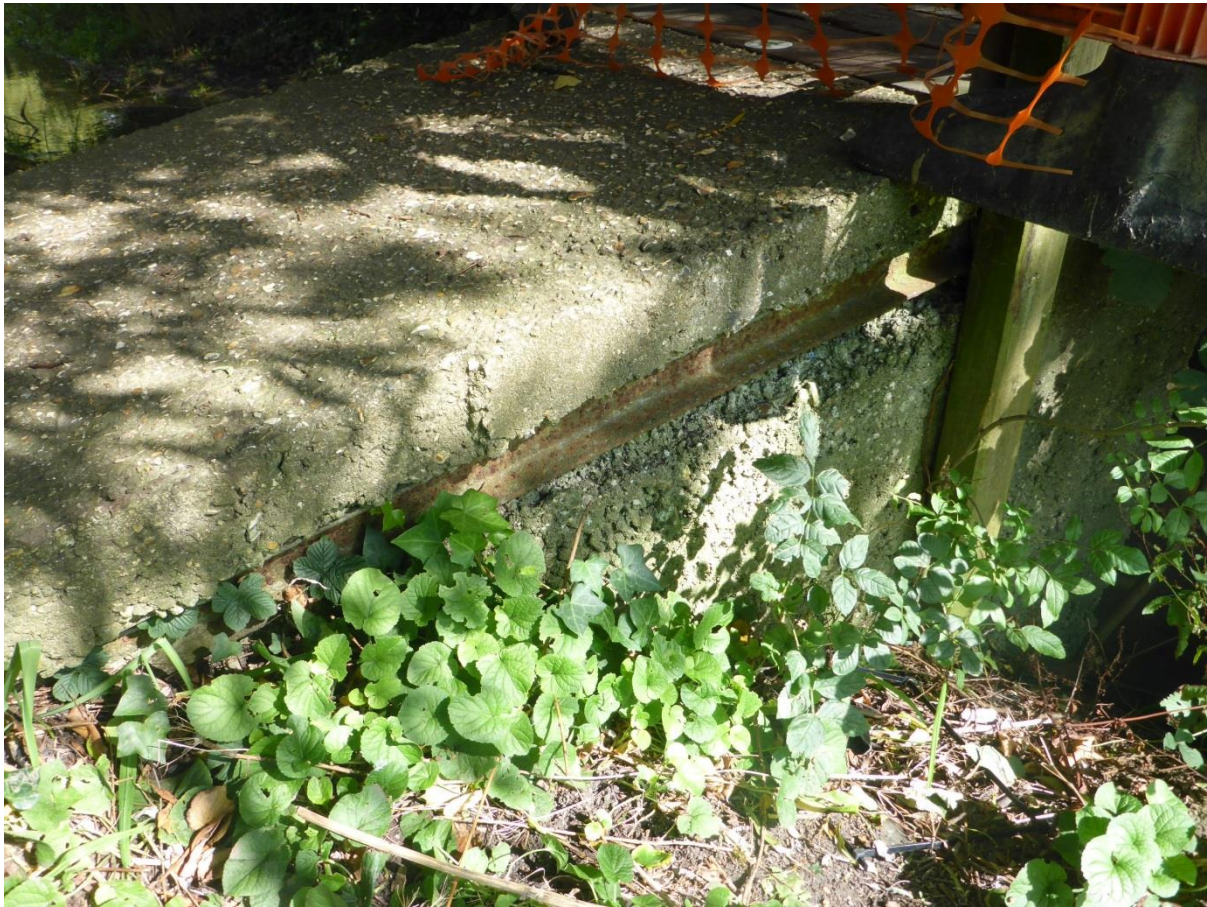
14. West Approach Ramp
