**DINAH'S HOLLOW STABILISATION  
OPTIONS REPORT**

*Dorset County Council*

**285400AF-HLT/1**

<b>Report Title</b>	:	<b>Dinah's Hollow Stabilisation Options Report</b>
<b>Report Status</b>	:	<b>Issue 2</b>
<b>Job No</b>	:	<b>285400AF-HLT/1</b>
<b>Date</b>	:	<b>November 2014</b>

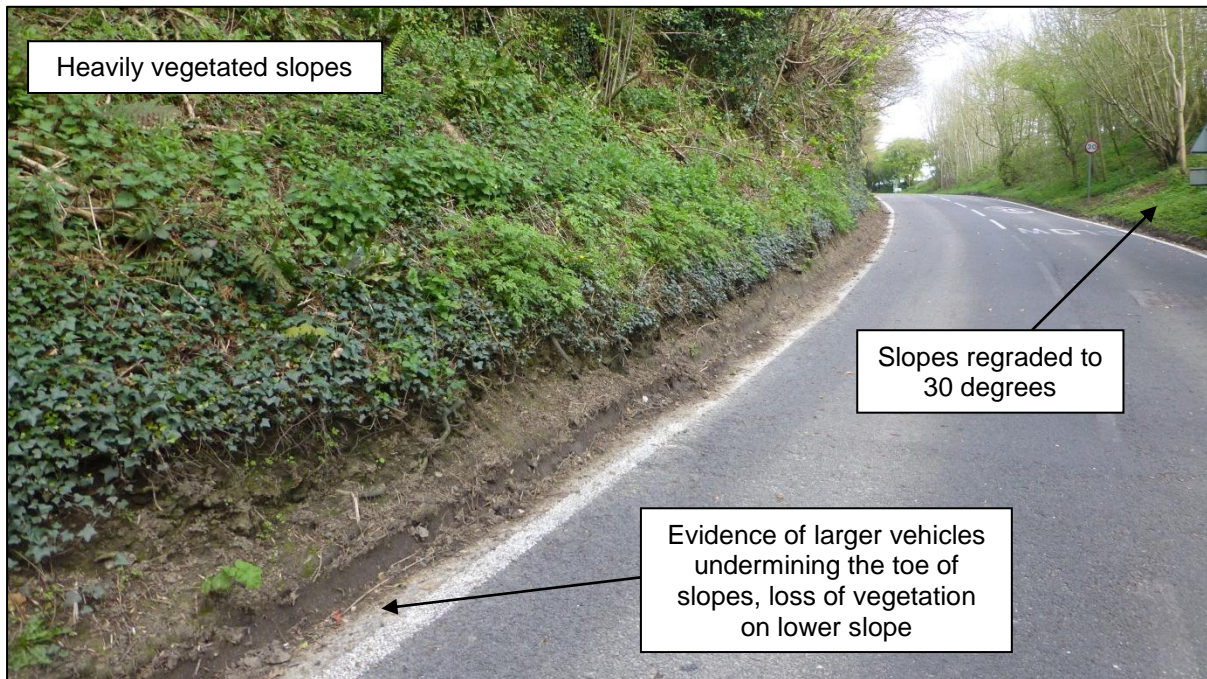
**Figure 4: Western Slopes showing Signs of Undermining**

- 3.2.6 Heavy goods vehicles encroaching on the toe of slopes when passing each other have resulted in the slopes becoming undermined.

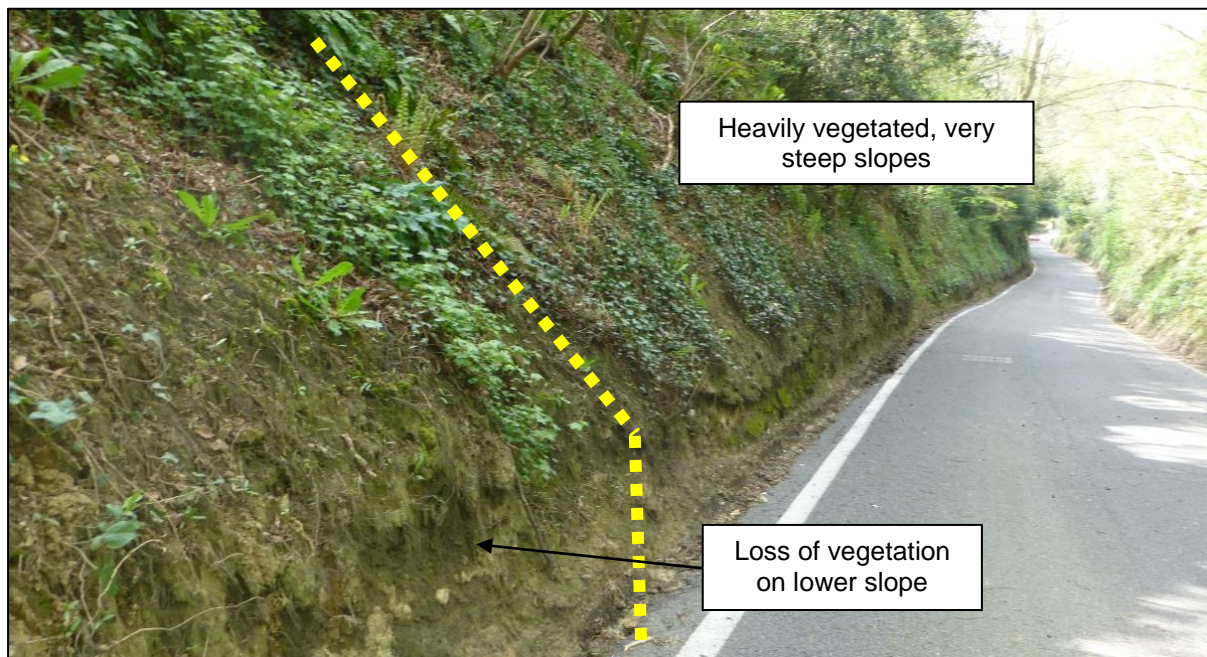
**Figure 5: Eastern Slopes showing Signs of Undermining**

- 3.2.7 It was seen that surface water run-off down the edges of the carriageway has also caused some erosion at the toe of the slope.
- 3.2.8 The anecdotal evidence seems to be that surface water runoff comes down the road from as far distant as Cann Common. The current camber of the road within Dinah's Hollow sheds the surface water to both edges of the road.
- 3.2.9 There was evidence of shallow, localised slips which will be discussed in further detail further on in this report within the Geomorphological section. Records of highway maintenance callouts have shown these to occur on a fairly regular basis. The material appeared to be extremely weakly cemented sandstone.
- 3.2.10 Records of the callouts can be found in Appendix I.

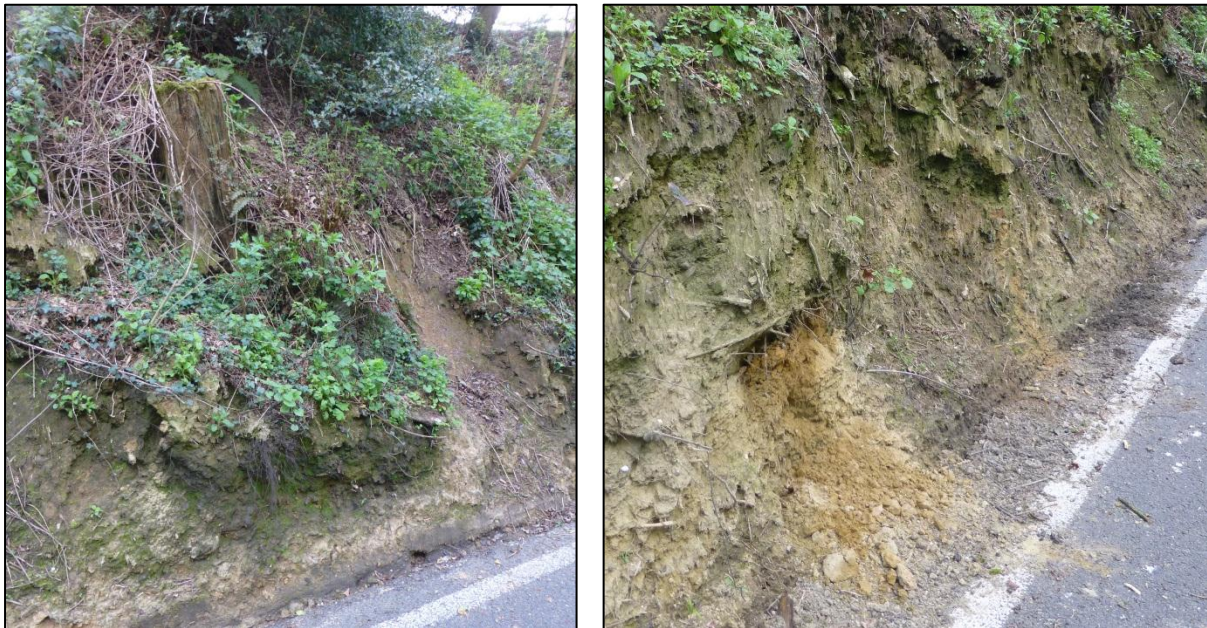
**Figure 6: Shallow, Local Instabilities on Eastern Slope**

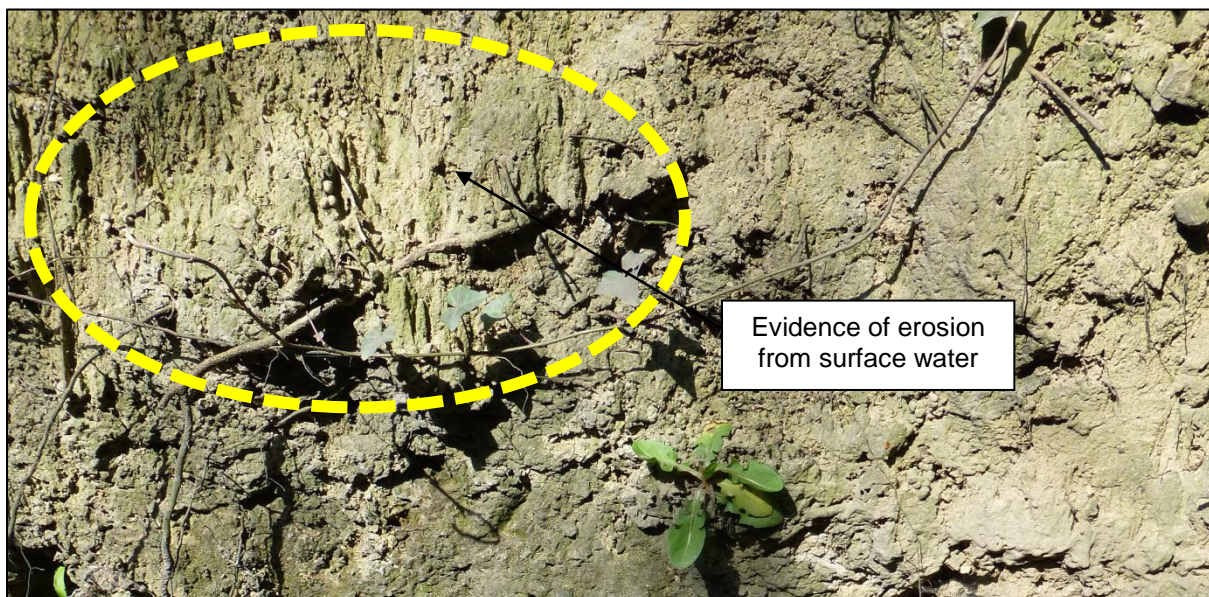
- 3.2.11 The material making up the slopes shows signs of erosion due to surface water travelling down the slopes, presumably during periods of very heavy rain.

**Figure 7: Upper Greensand, Evidence of Surface Erosion**

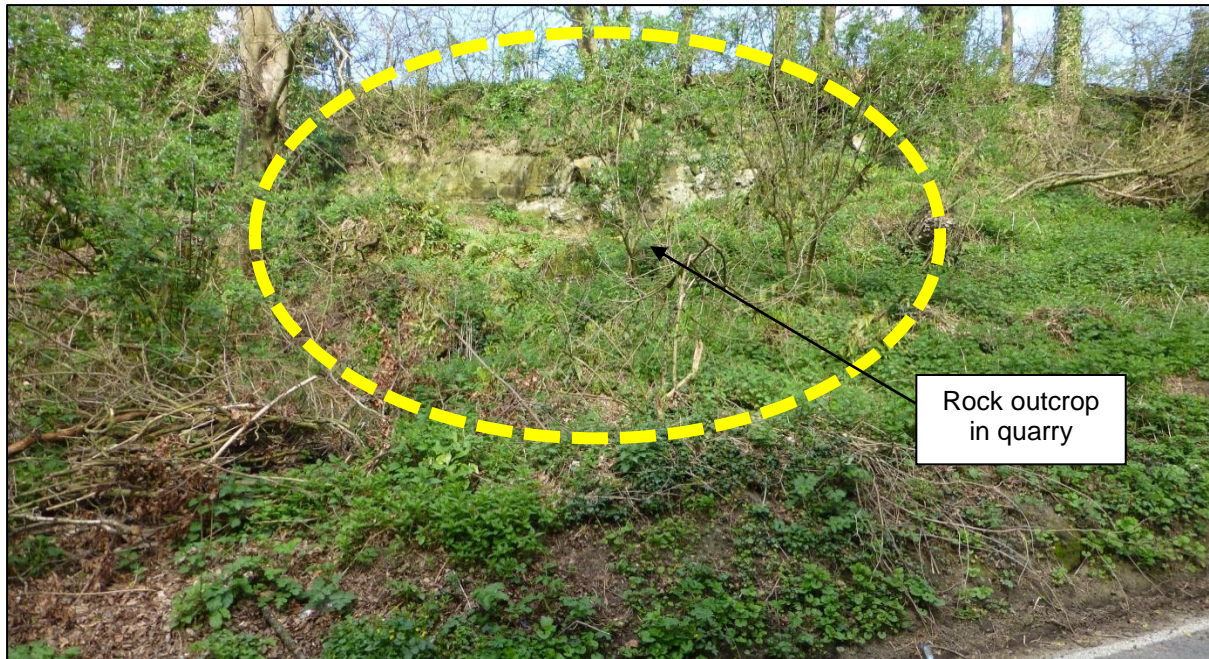
- 3.2.12 A rock outcrop was evident in the location of the historic quarry on the western slopes as shown below and further rock outcrops were observed adjacent to the road north of the quarry. The material is believed to be the BHC.

- 3.2.13 The rock observed in the quarry and rock exposures to the north along the carriageway is described as: Weak to medium strong thinly to medium bedded yellow grey medium grained SANDSTONE. Some thin beds are extremely weak. Distinctly

weathered. Medium to wide spaced, wide to very wide aperture discontinuities some of which may be as a result of quarrying or excavation for the road.

**Figure 8: Historic Quarry on Western Slopes**

- 4.3.17 Within the historic quarry and on the rock exposure adjacent to the road north of the quarry Individual rock anchors could be installed, as necessary, to prevent the failure of discrete blocks. The number, dimensions and location of any rock anchors will be considered further at detailed design stage.

- 4.3.22 It is recommended that scaling, the removal of loose rock or blocks at an increased probability of failure, generally using hand tools is undertaken prior to the installation of any rock anchors or bolts. Care must be taken when scaling to ensure that overhangs are not created leaving material above unsupported and at an increased risk of failure.

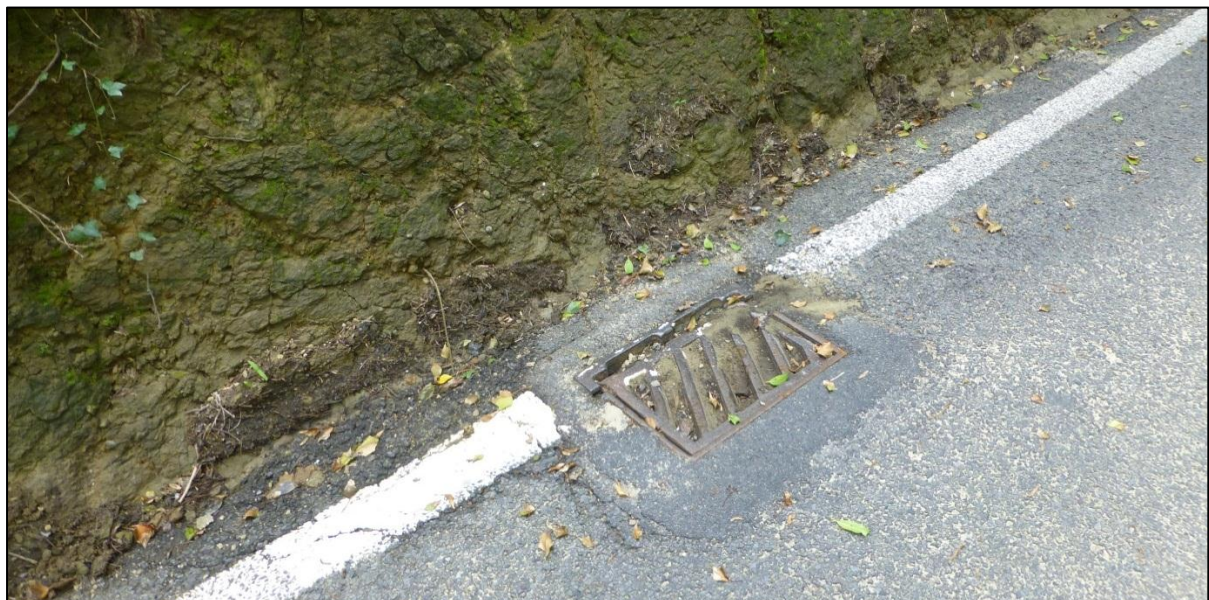
3.2.14 The minimal highway drainage noted during the walkover, was observed to be blocked up with large amount of material assumed to have washed off the slopes, as shown below.

**Figure 9: Blocked drain within Carriageway**

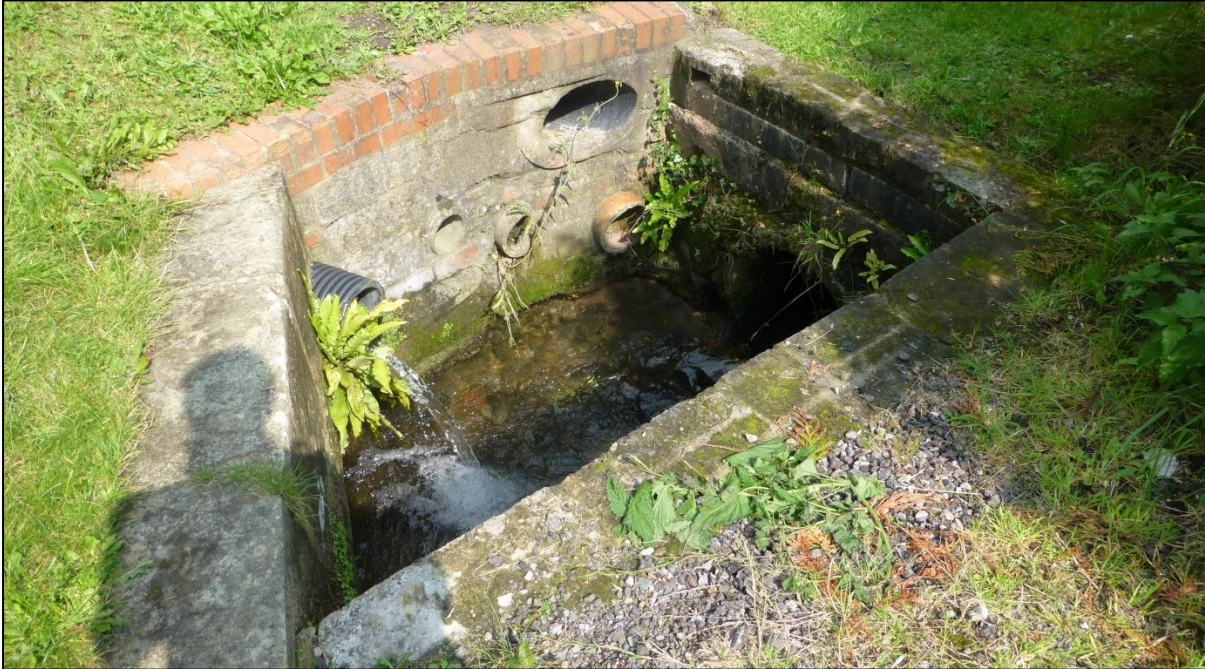
- 3.2.15 A drainage survey has been carried out by DCC to establish the amount and type of highway drainage within Dinah's Hollow and the immediate vicinity. This includes the outfalls shown below, situated next to the watercourse at the base of the valley and Spring Cottage.

**Figure 10: Drainage Outfall near Spring Cottage**

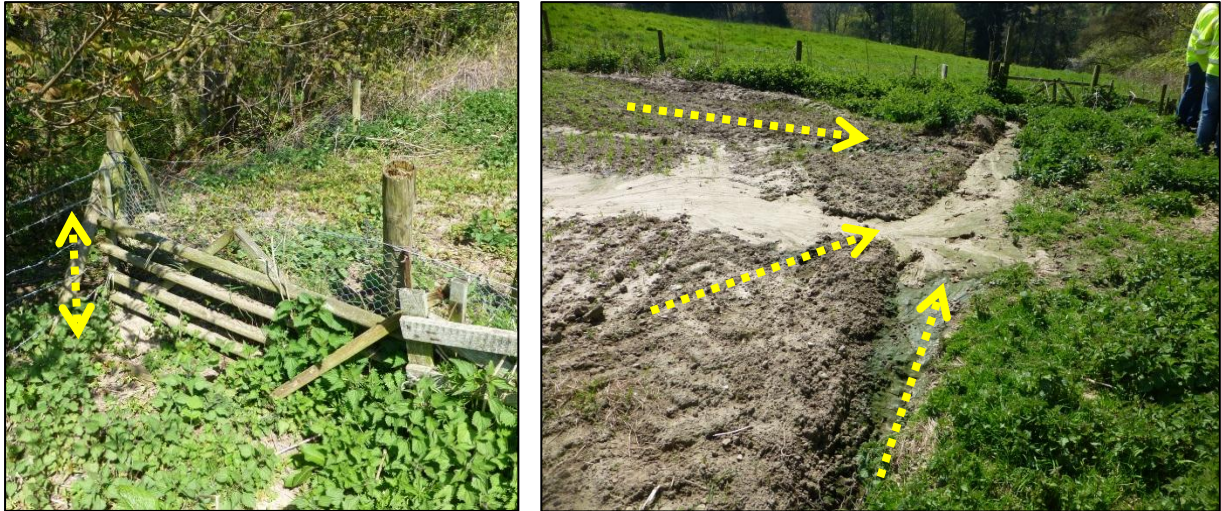
- 3.2.17 The topography of the land is sloping towards Dinah's Hollow and the valley in a south westerly direction.
- 3.2.18 Evidence of soil erosion assumed to have been caused by surface water run-off is apparent in the south-west corner of the field, where deposits of sediment have been "trapped" by the fencing.

**Figure 12: Accumulated Sediment at crest of Eastern Slope**

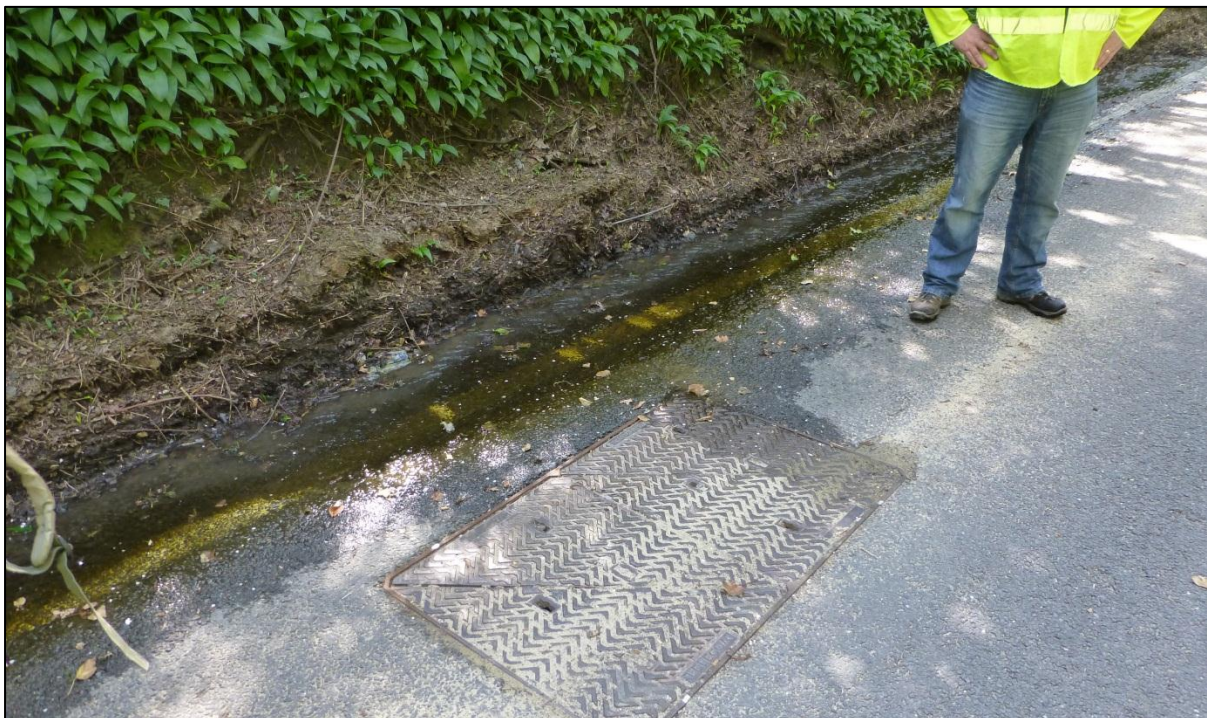
- 3.2.19 Groundwater seepage was noted on the eastern slopes almost immediately below the accumulated sediments discussed above.

**Figure 13: Seepage Running along Eastern side of Carriageway**

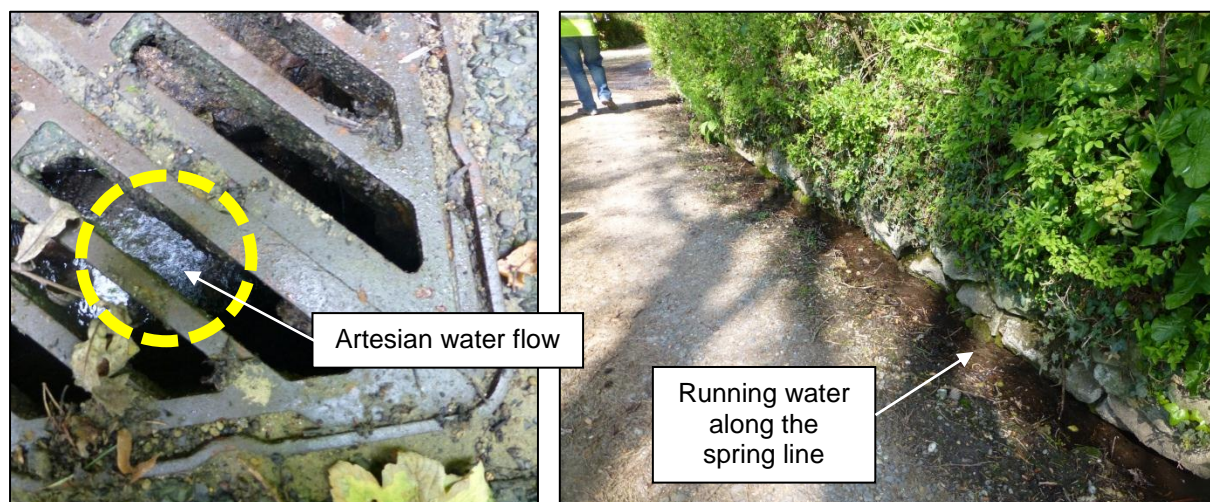
- 3.2.22 A spring line was noted along the edge of the driveway to Parham's Farm and a potential artesian water flow was present in one of the drainage outflows as shown below in the photos.

**Figure 16: Artesian Water Flow and Spring Line**
