C13 DINAHS HOLLOW DRAINAGE SURVEY

Drainage Survey Dinahs Hollow South

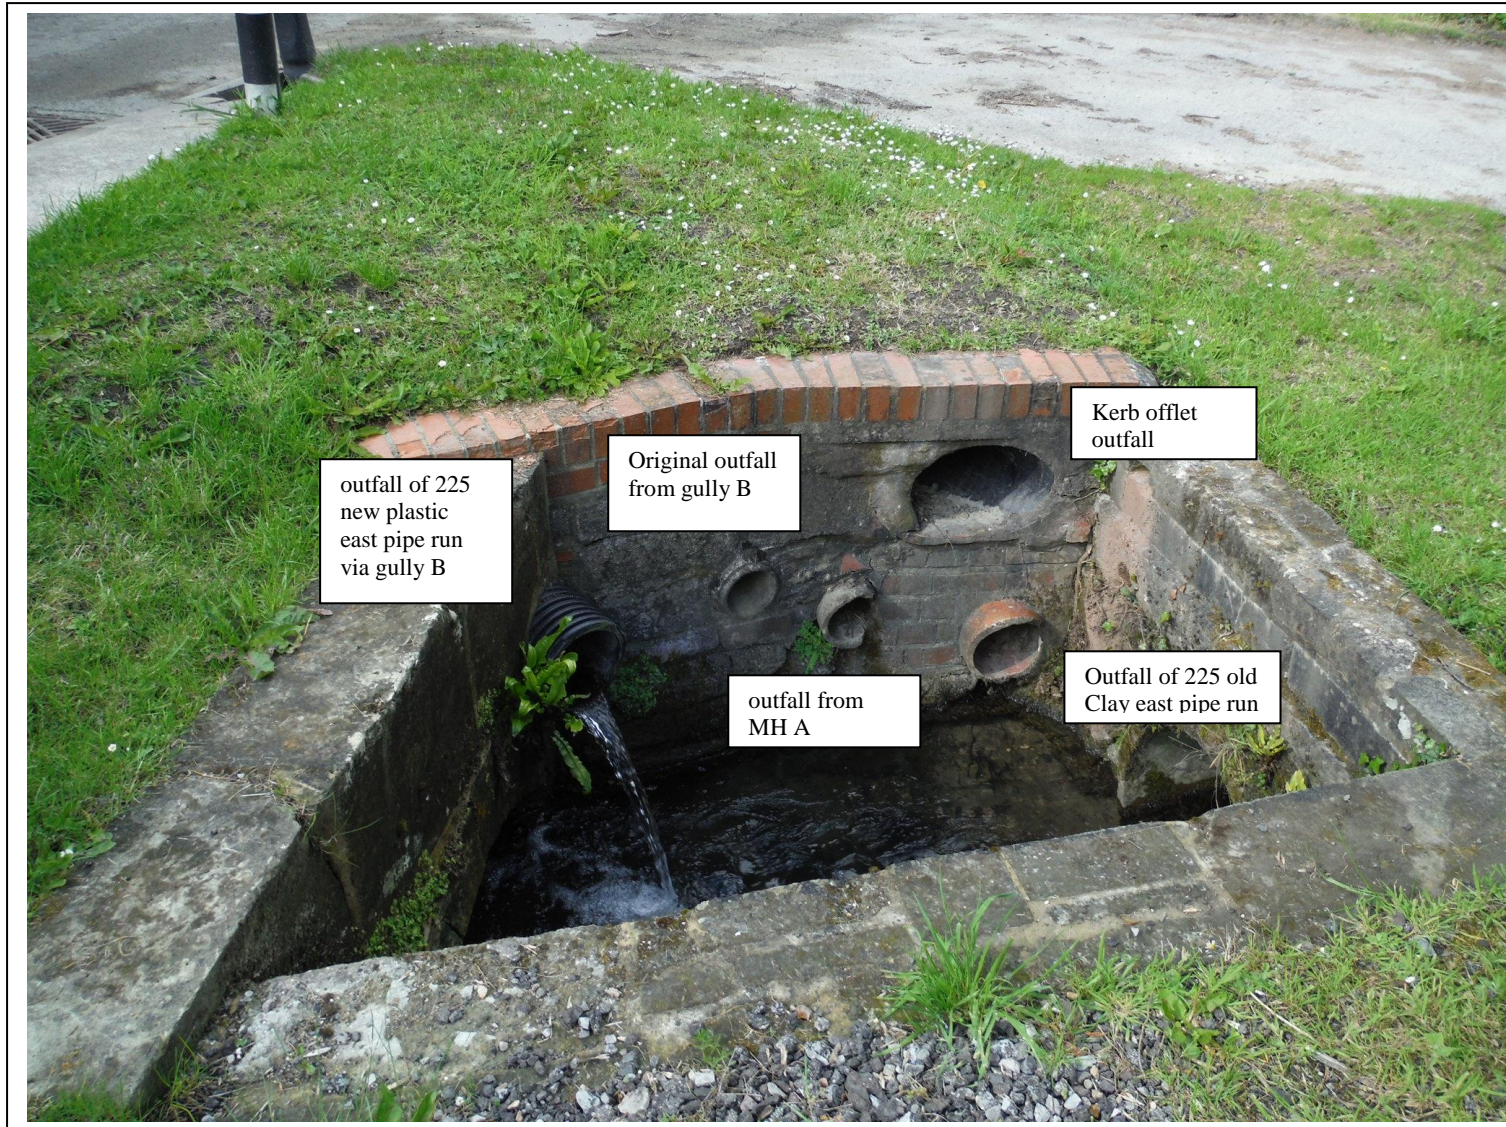
There are three further pipes outfalling into the headwall at the stream. (See photograph.)

The first is the outfall from an offlet drain located just north of the stream. The second is the original outfall from gully B. The third is from manhole A (see sketch). Manhole A is believed to have formerly been a gully that picked up water from the adjacent stone track. It was apparently frequently blocked with stone and therefore the grill cover was changed to a manhole cover. There is an inlet pipe into manhole A but this pipe is blocked a short distance north of the manhole and could not be unblocked with the jetter.

Outfall of pipe work draining south end of Dinahs Hollow into open outlet area on the east side of the road.
(To be read in conjunction with drainage survey sketch.)
