Site/Project: Dinah's Hollow Melbury Abbas Slope Stabilisation

Title: Dinah's Hollow Geomorphological Mapping Plan

Drawn: BRG	Checked: KH
Designed: KH	Approved: LJK
Date: 29/10/2014	Scale: 1:200
Project Number: 285400AF-HLT	Drawing Number: DH/002A
Sheet: 1 of 2	Revision:

Dinah's Hollow  
Melbury Abbas  
Slope Stabilisation

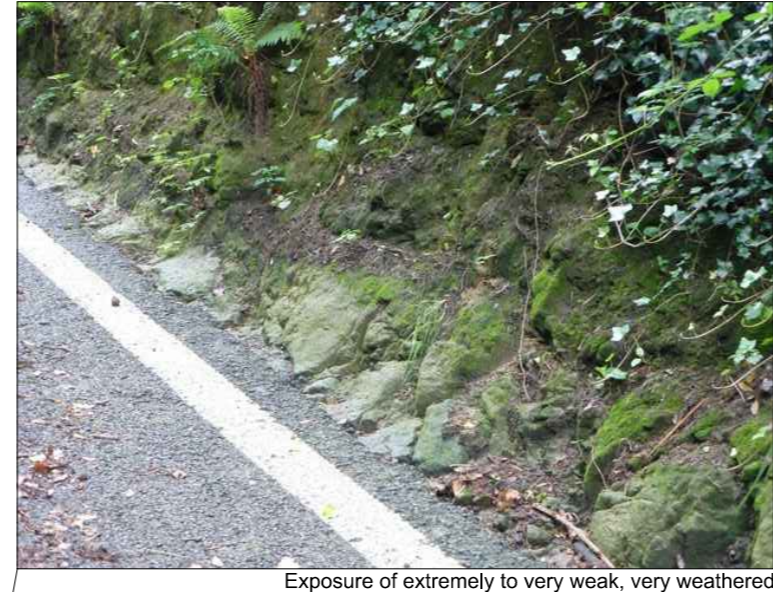
Exposure of extremely to very weak, very weathered sandstone from road level to 1.3m above the carriageway

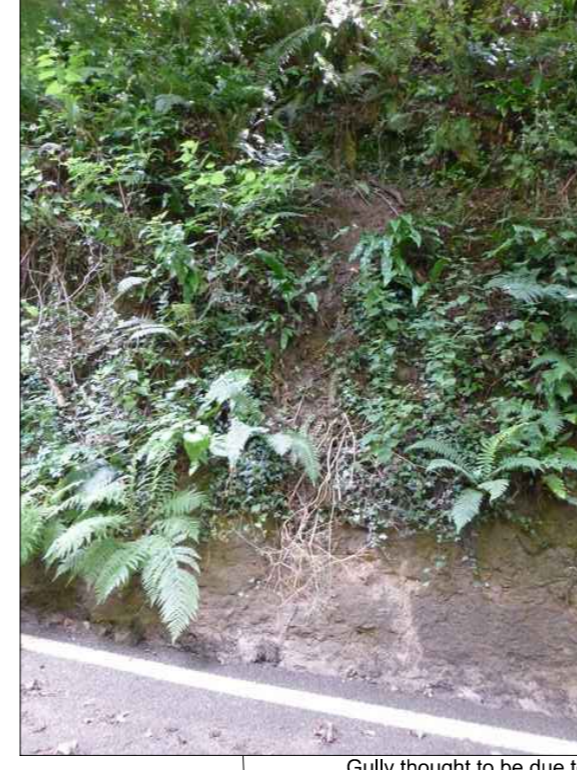
Gully thought to be due to concentrated surface water flow

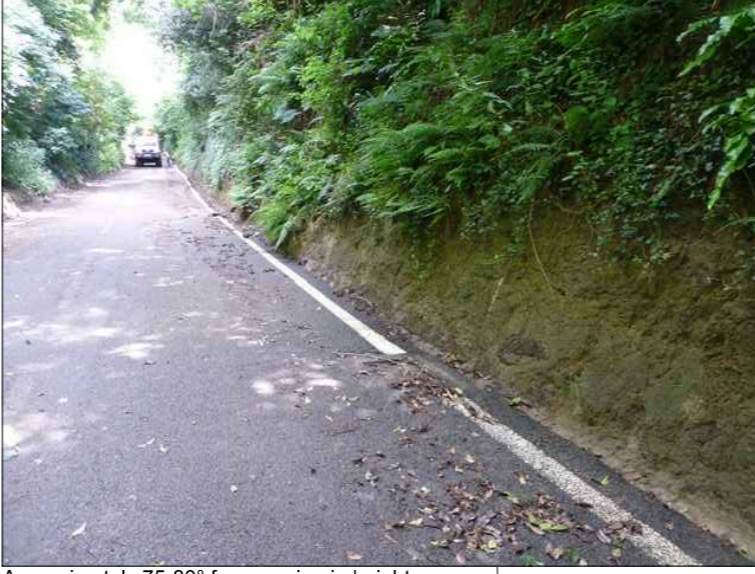
Approximately 75° face varying in height from 0.1-1.2m at the toe of the slope

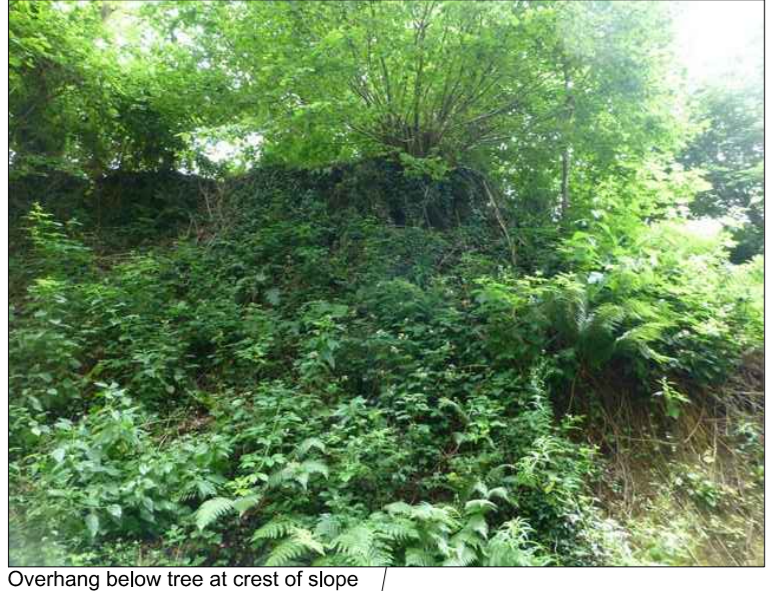
Overhang below tree at crest of slope

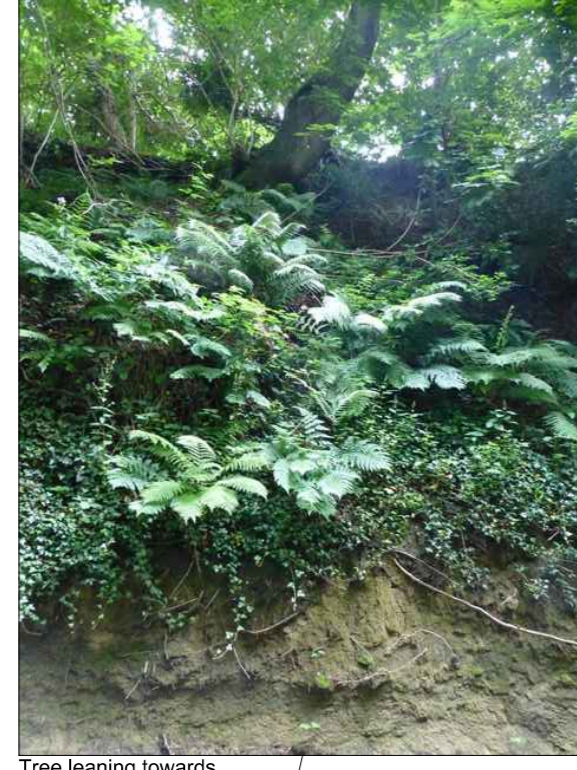
Tree leaning towards the carriageway

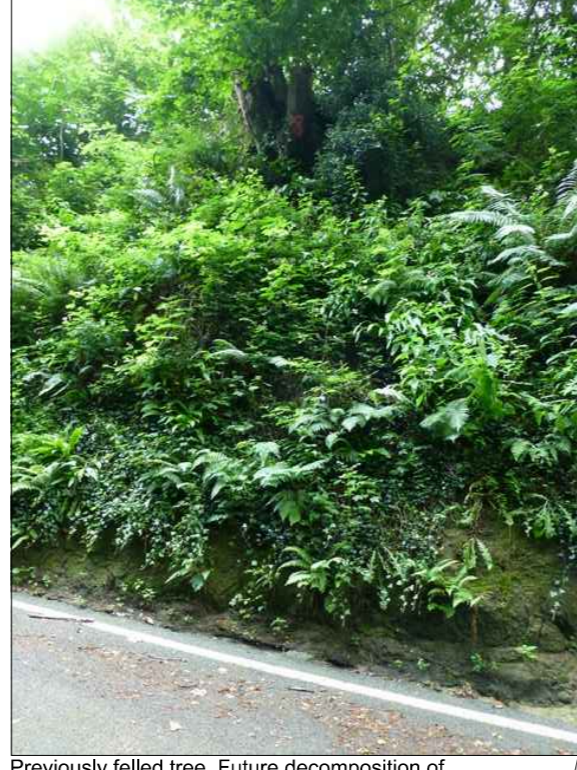
Previously felled tree. Future decomposition of the stump may lead to loss of soil support and subsequent slope failure

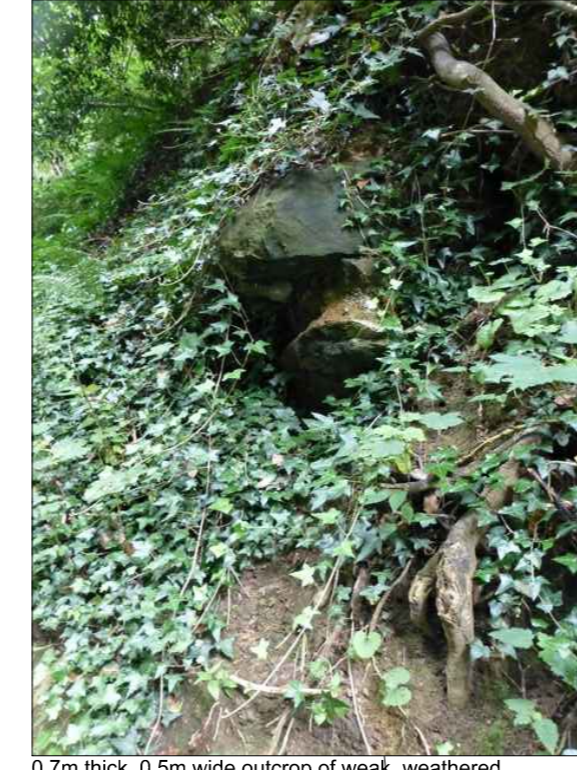
0.7m thick, 0.5m wide outcrop of weak, weathered sandstone 1.6m above the carriageway

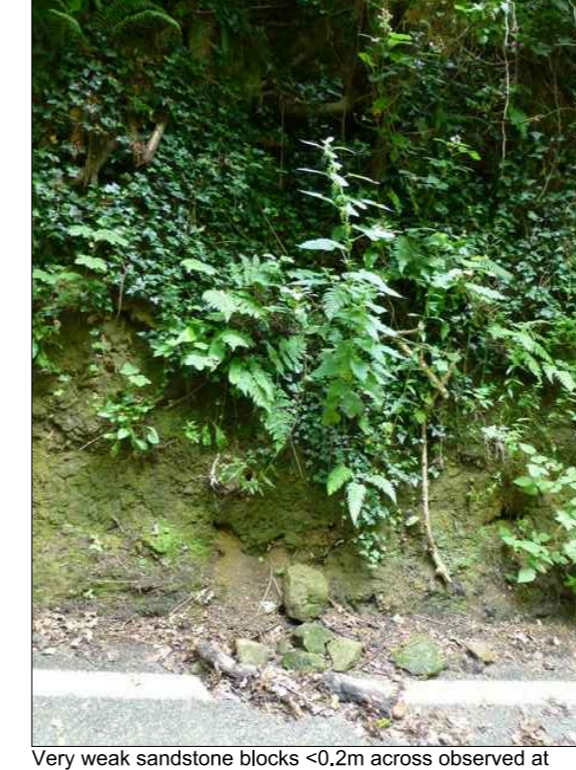
Very weak sandstone blocks 0.2m across observed at the edge of the carriageway from surface failure above

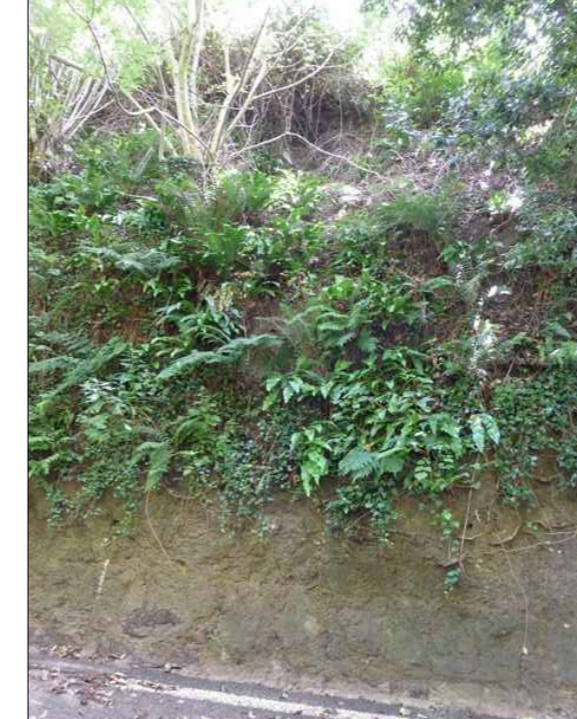
Bowl shaped depression near the crest of the slope, possible historical slip

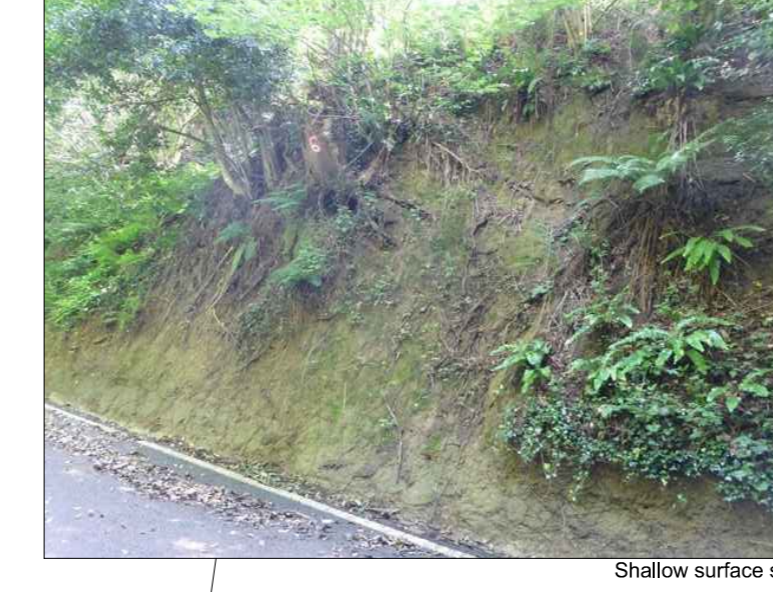
Shallow surface slip

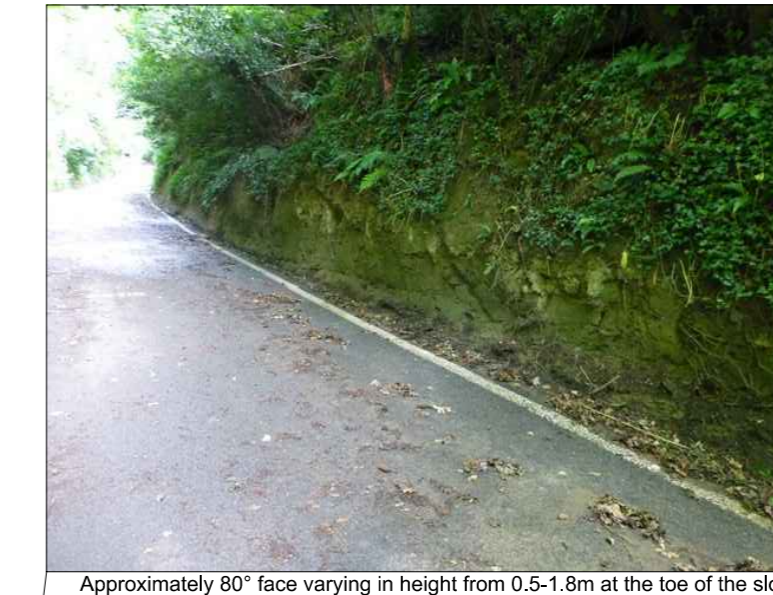
Approximately 60° face varying in height from 0.5-1.5m at the toe of the slope

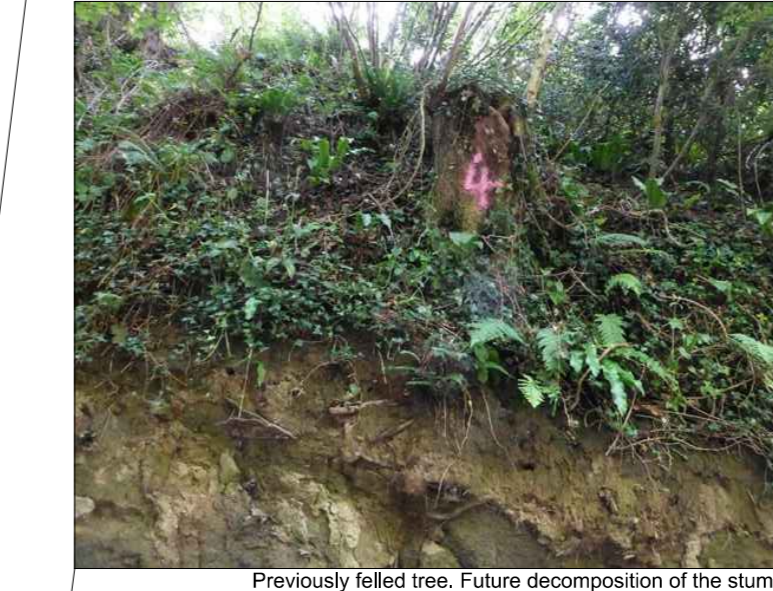
Previously felled tree. Future decomposition of the stump may lead to loss of soil support and subsequent slope failure

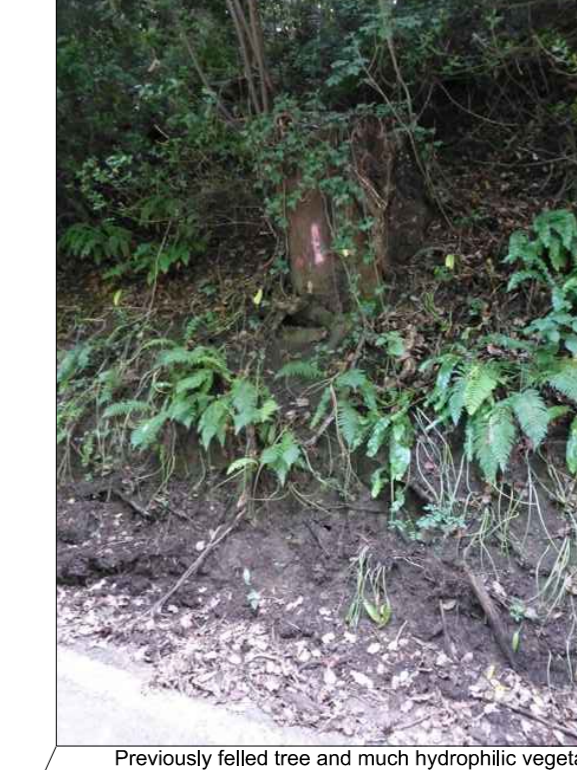
Previously felled tree and much hydrophytic vegetation. Future decomposition of the stump may lead to loss of soil support and subsequent slope failure

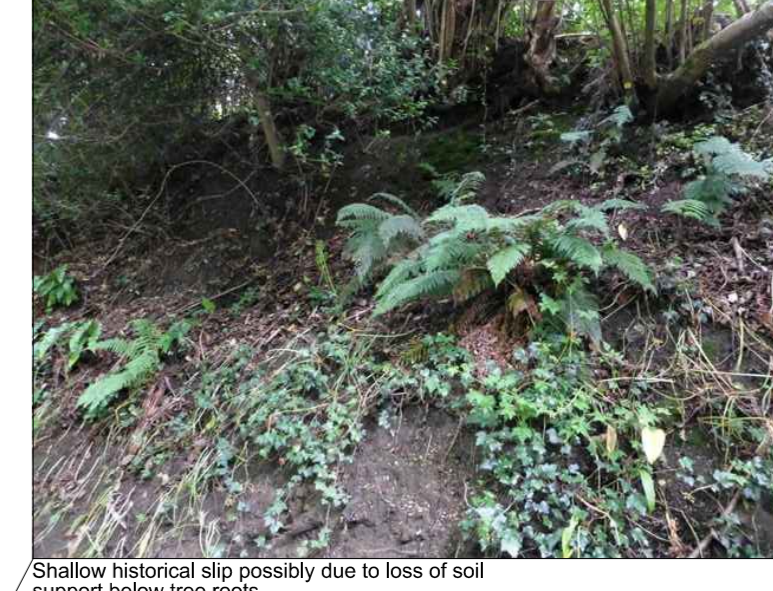
Shallow historical slip possibly due to loss of soil support below the road

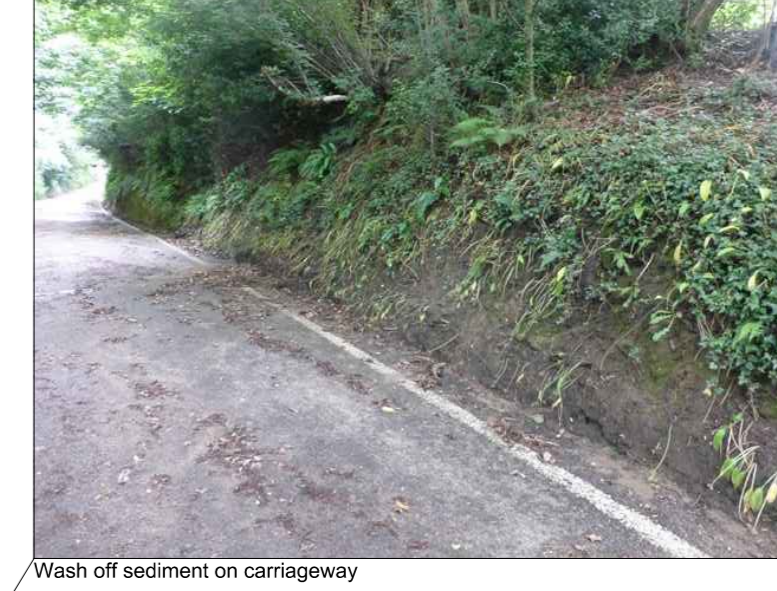
Wash of sediment on carriageway

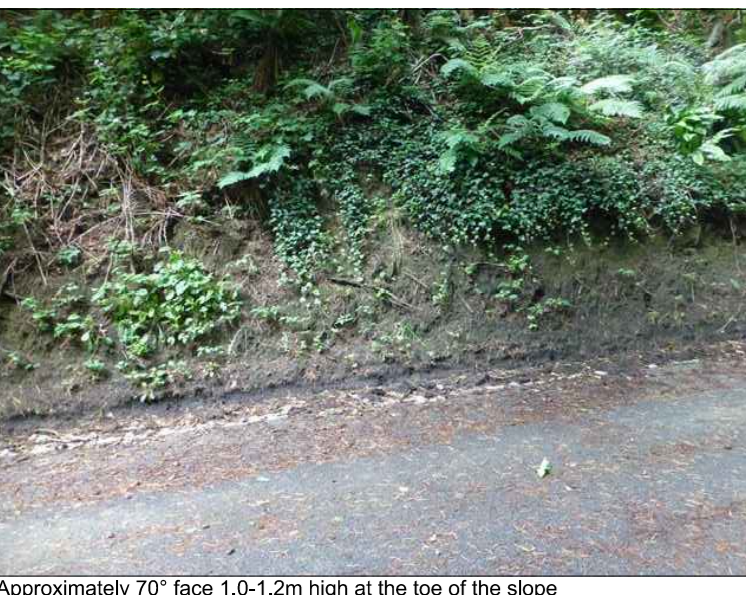
Approximately 70° face 1.0-1.2m high at the toe of the slope

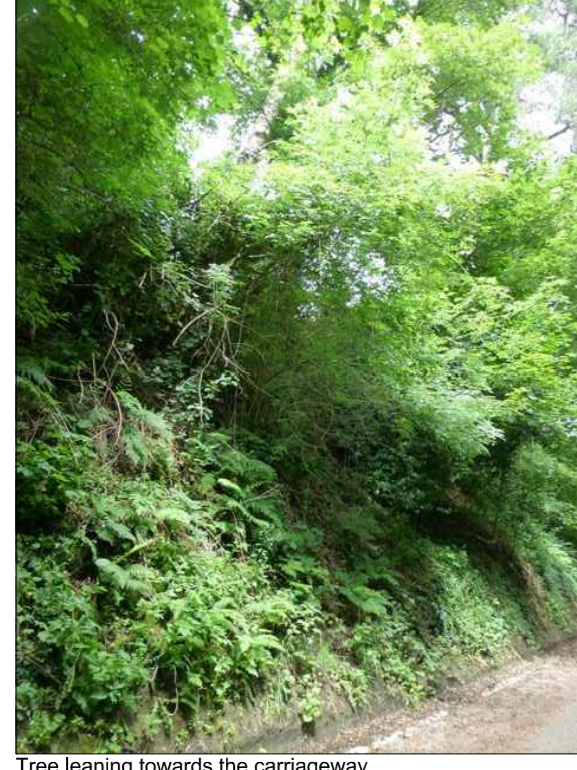
Tree leaning towards the carriageway

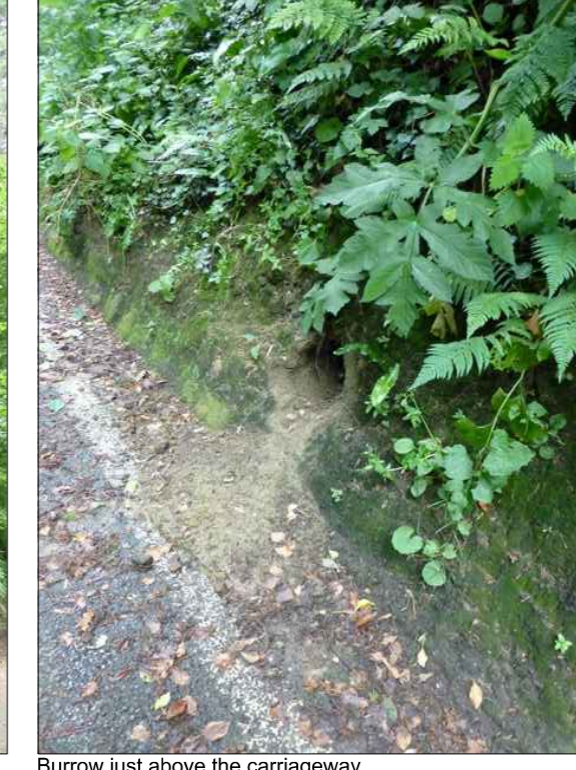
Burrow just above the carriageway

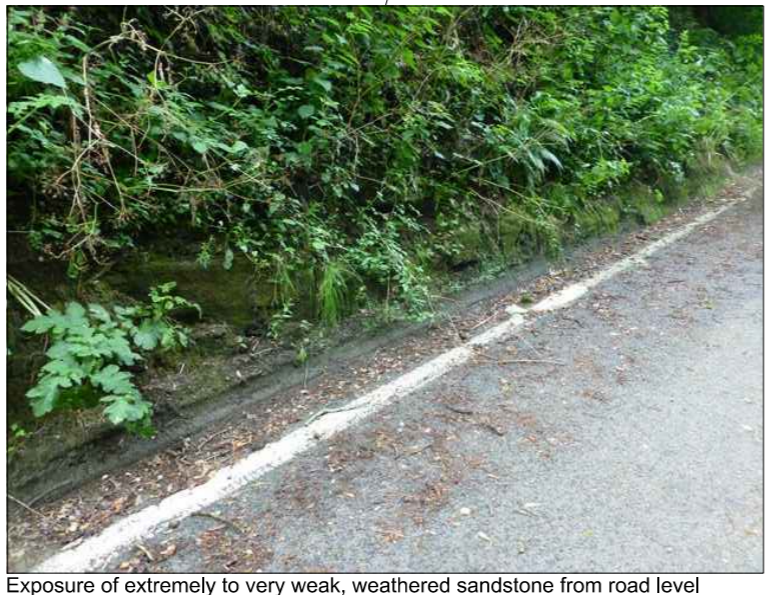
Exposure of extremely to very weak, weathered sandstone from road level to 0.5m above the carriageway

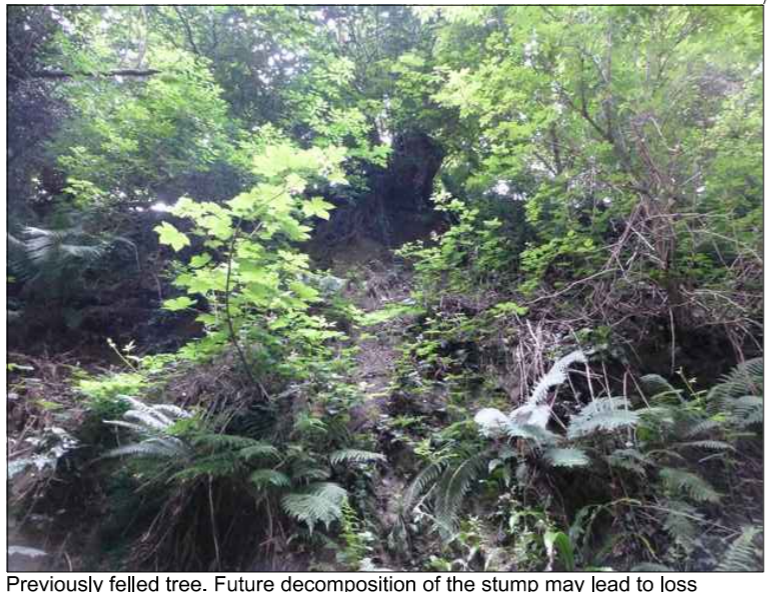
Previously felled tree. Future decomposition of the stump may lead to loss of soil support and subsequent slope failure

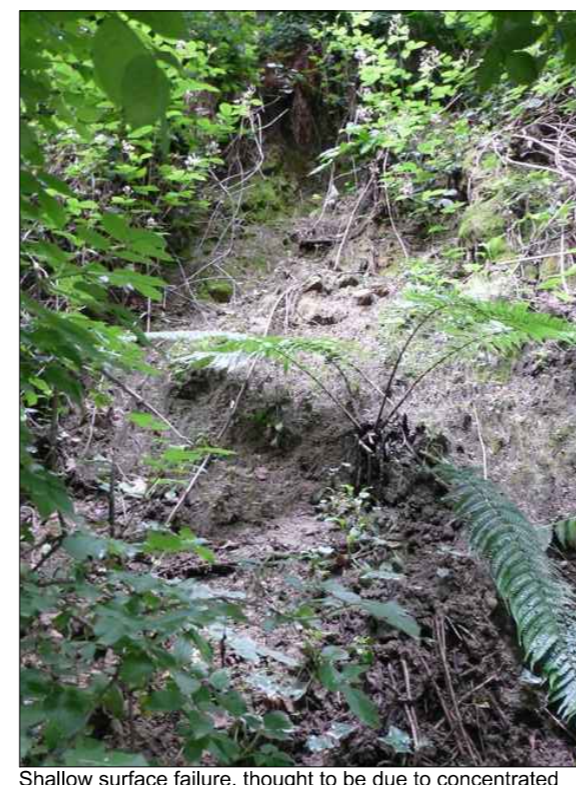
Shallow surface failure, thought to be due to concentrated surface water flow. Failed material observed on the carriageway

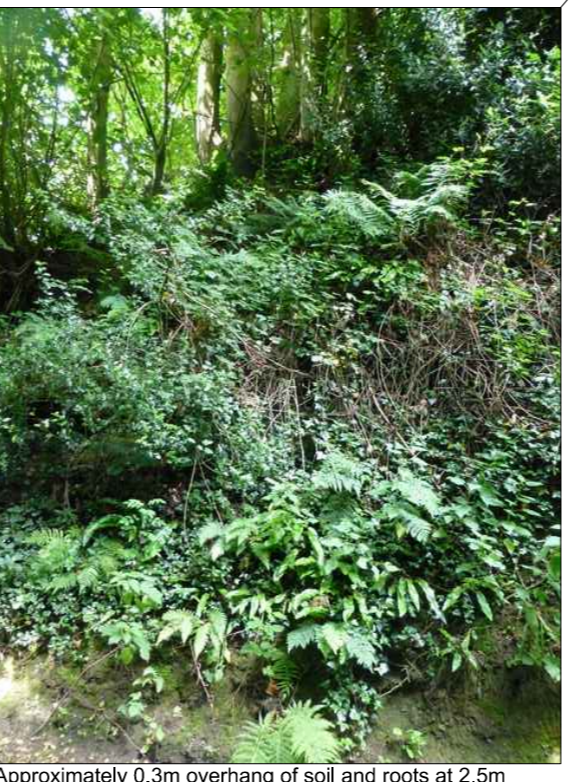
Approximately 0.3m overhang of soil and roots at 2.5m above the carriageway

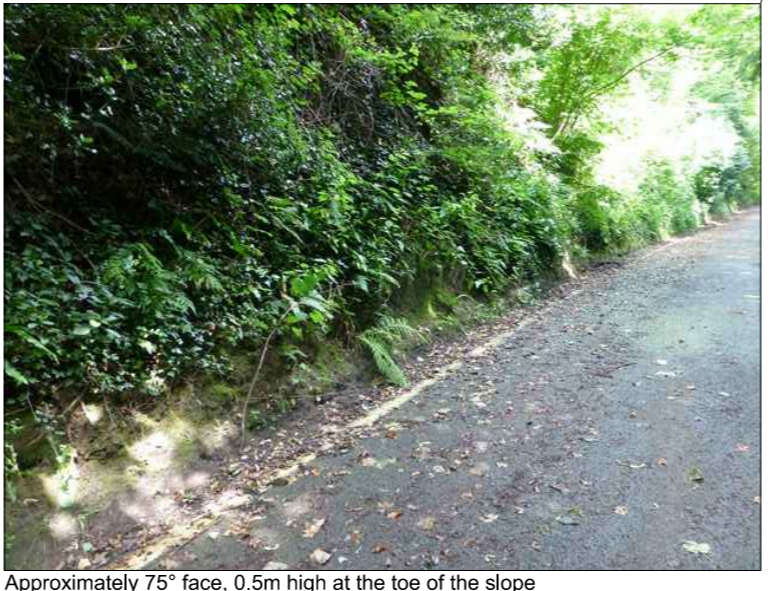
Approximately 70° face, 0.5m high at the toe of the slope

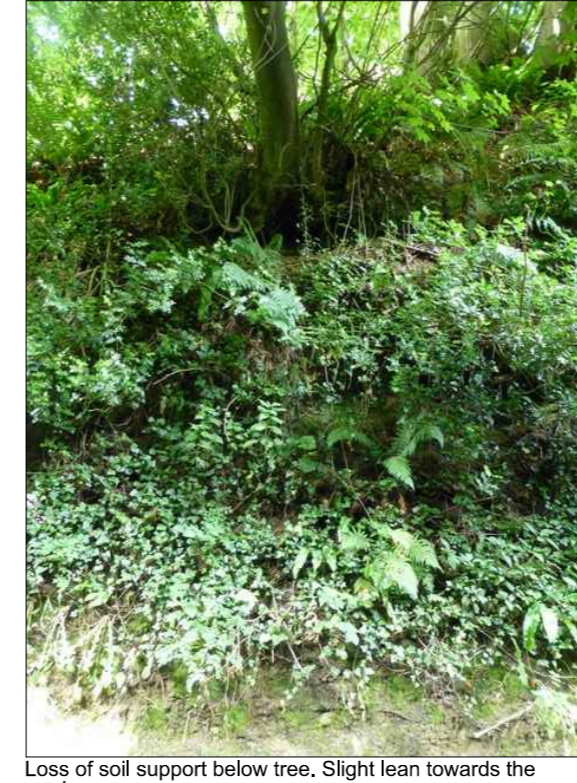
Loss of soil support below tree. Slight lean towards the carriageway

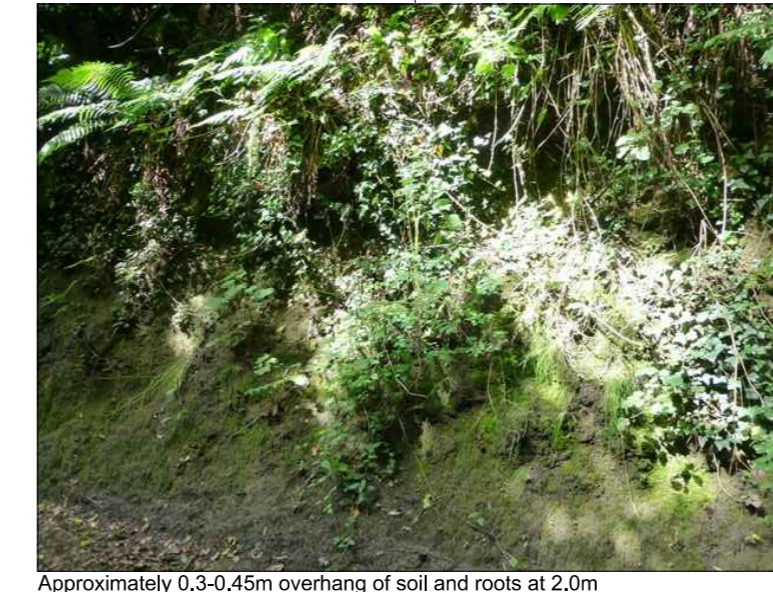
Approximately 1.3-1.6m overhang of soil and roots at 2.0m above the carriageway

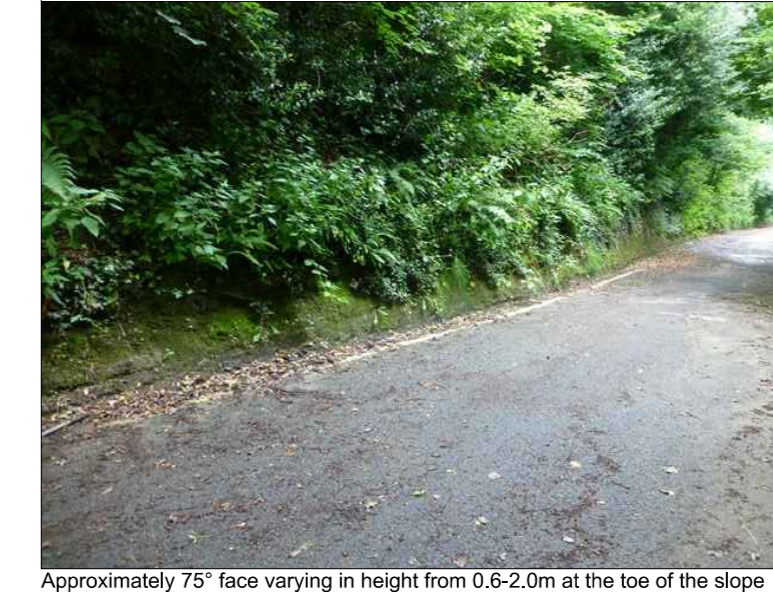
Approximately 75° face varying in height from 0.6-2.0m at the toe of the slope

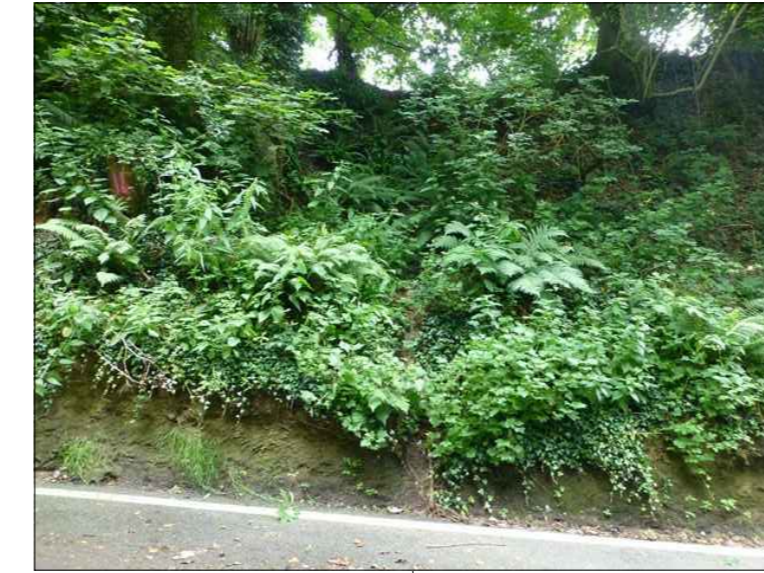
Gully thought to be due to concentrated surface water flow

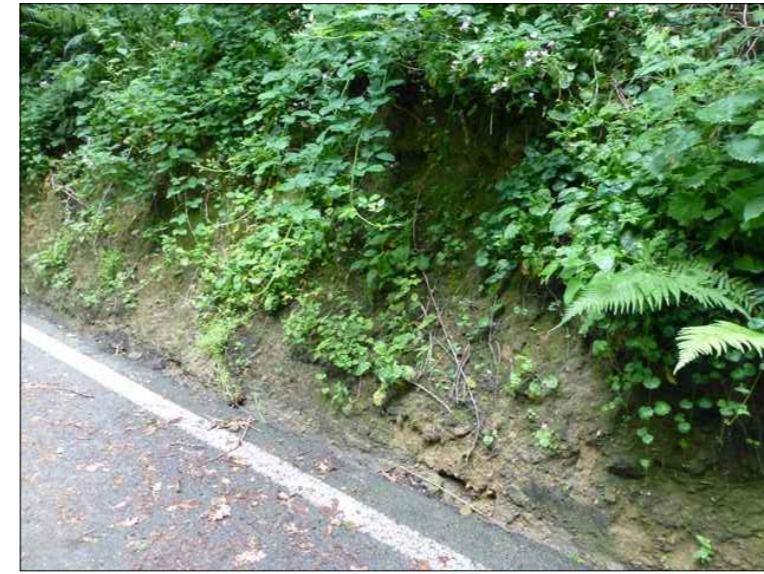
Low level shallow surface slip

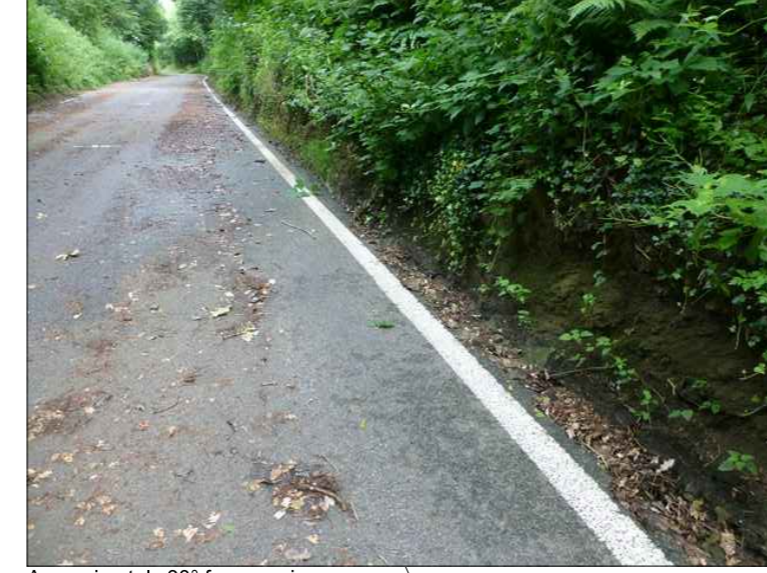
Approximately 50° face varying in height from 0.5-2m high at the toe of the slope

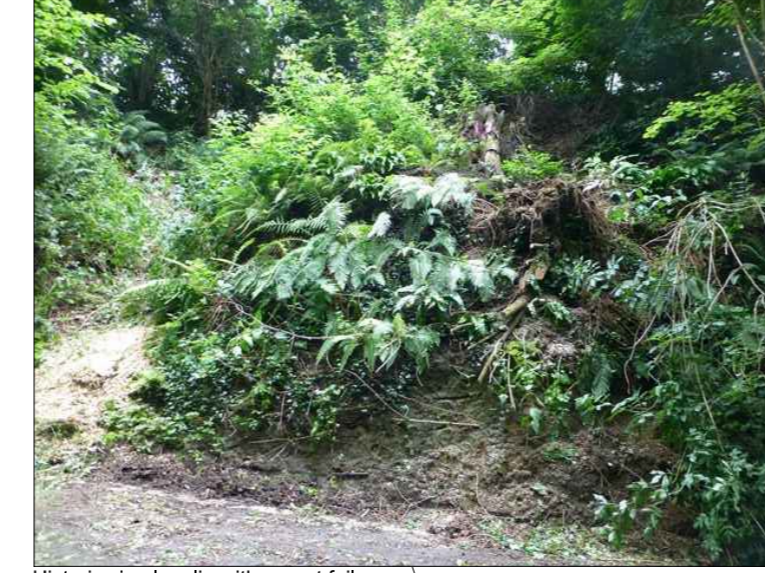
Historic circular slip with recent features of vegetation

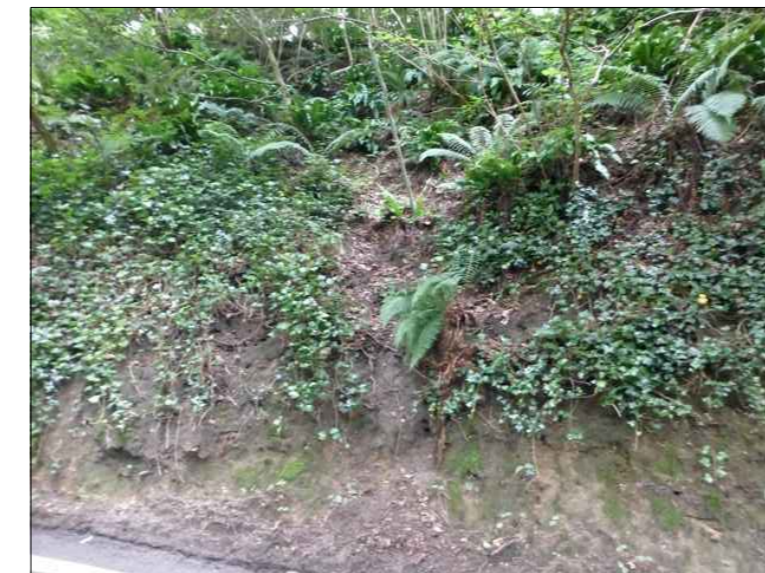
Gully thought to be due to concentrated surface water flow

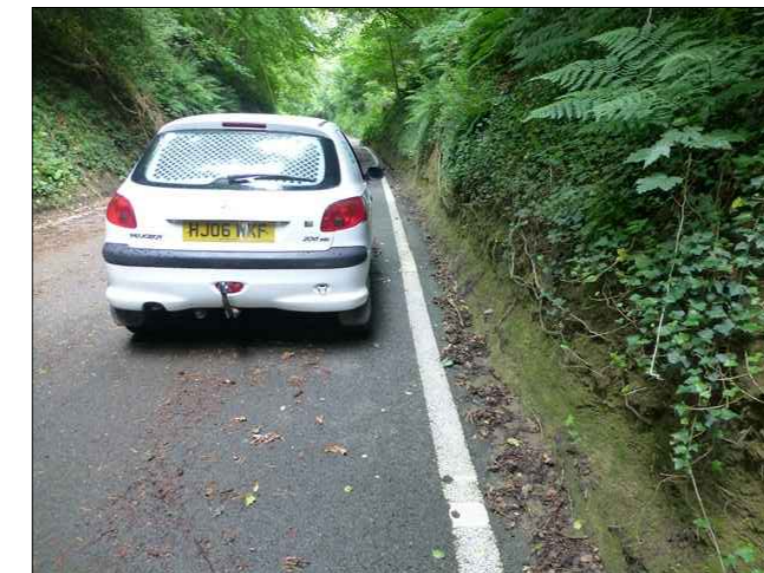
Approximately 60° face varying in height from 0.25-1.6m at the toe of the slope

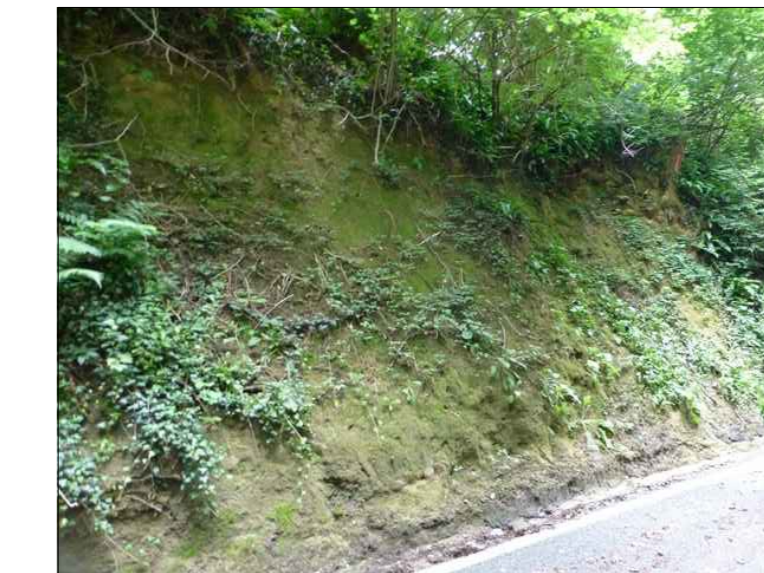
Shallow surface slip

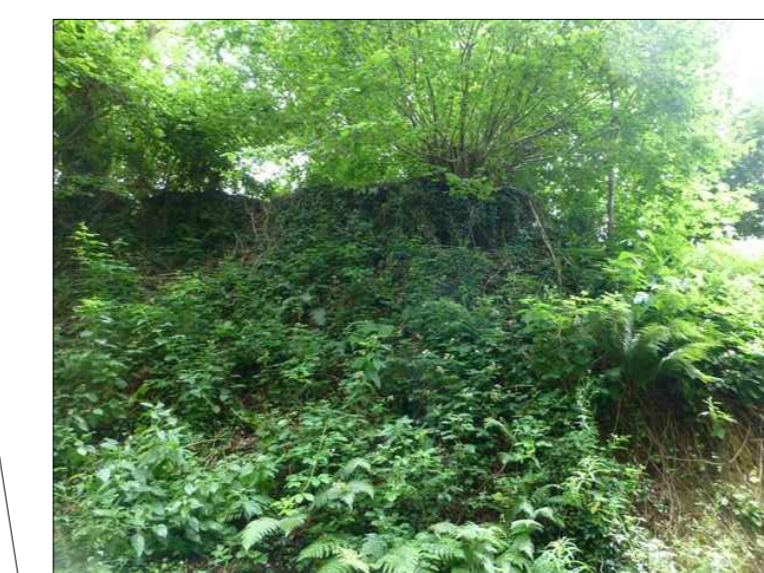
Overhanging tree at crest of slope

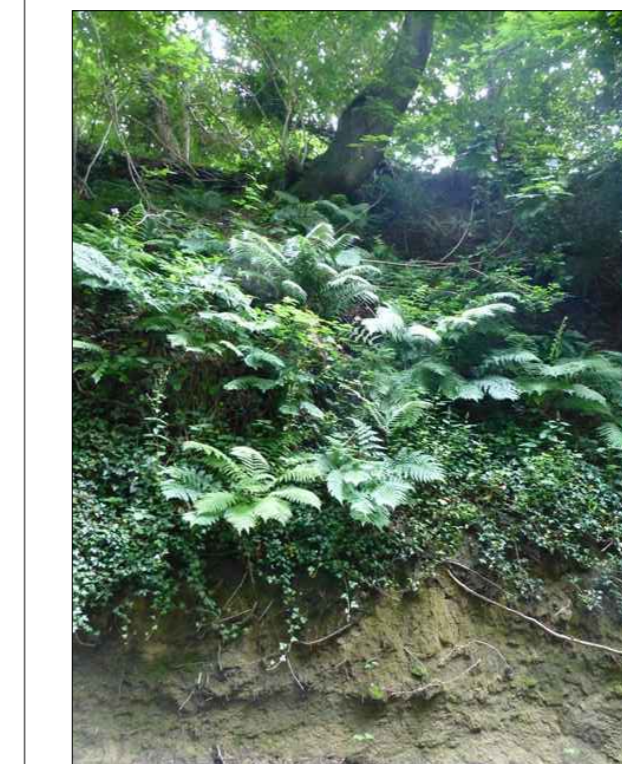
Trees leaning towards the carriageway

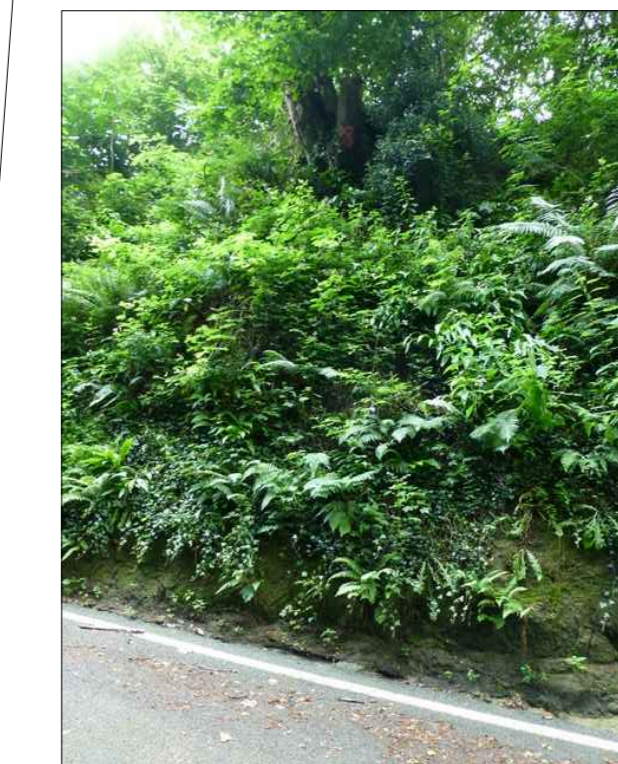
Previously filled tree. Future decomposition of the stump may lead to loss of soil support and subsequent slope failure

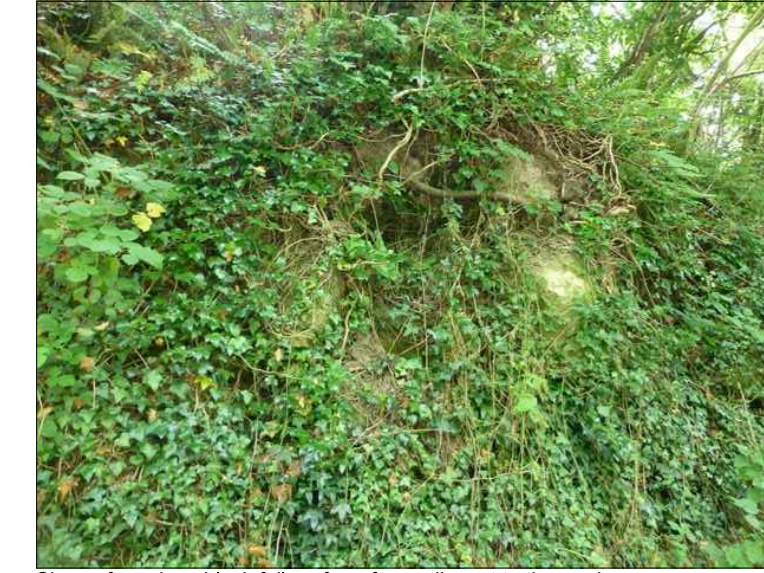
Signs of previous block failure from face adjacent to the carriageway

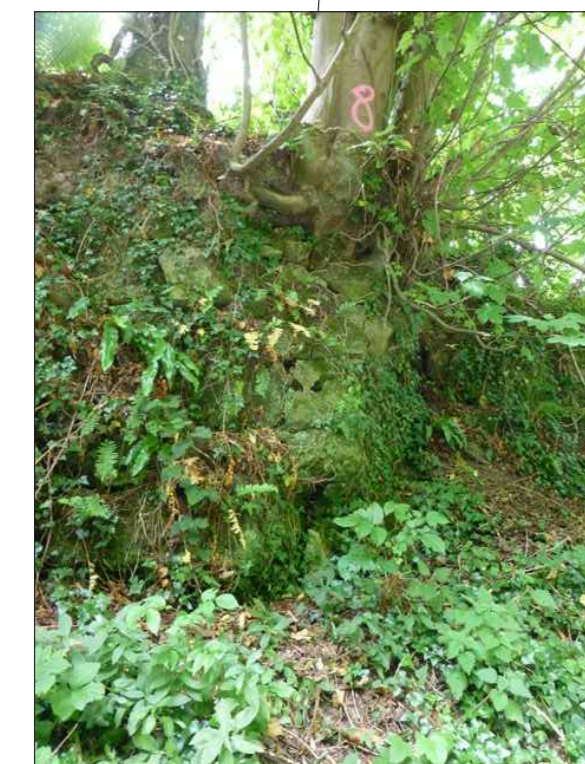
Overhanging rock blocks on face adjacent to the carriageway

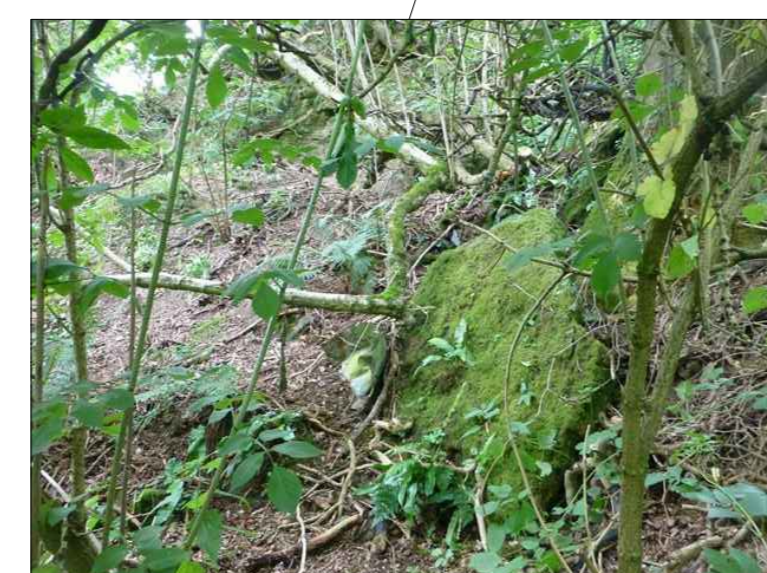
Evidence of previous block failure from the face in the historic quarry

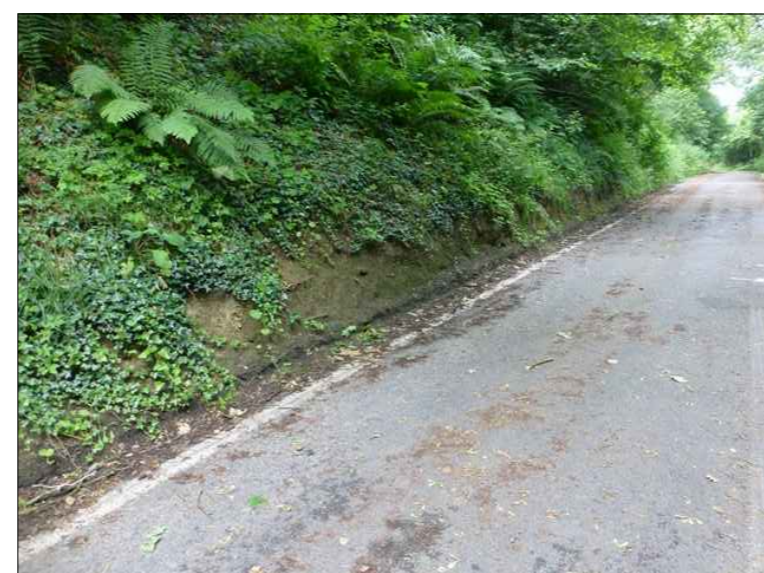
Approximately 75° face 0.7m high at the toe of the slope

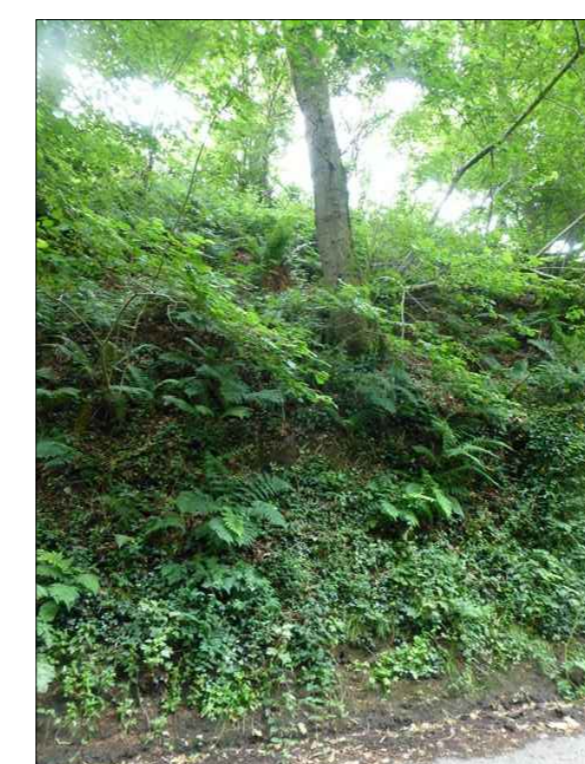
Leaning tree

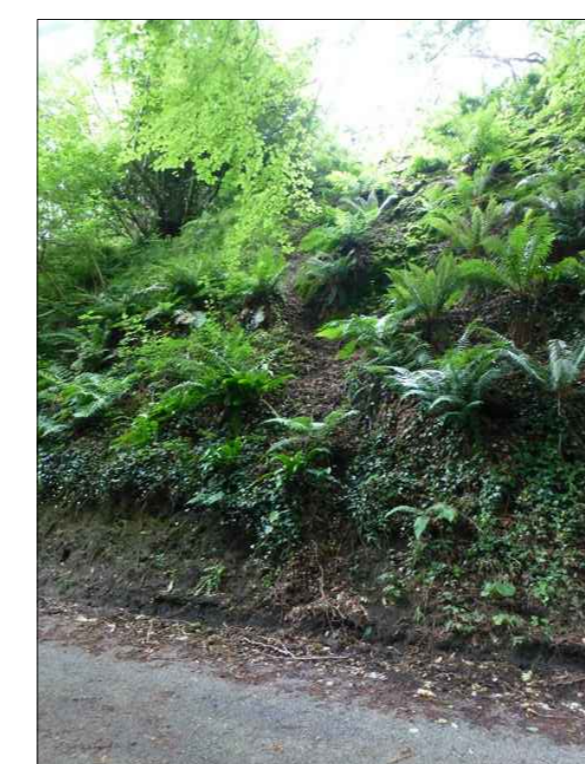
Gully thought to be due to concentrated surface water flow

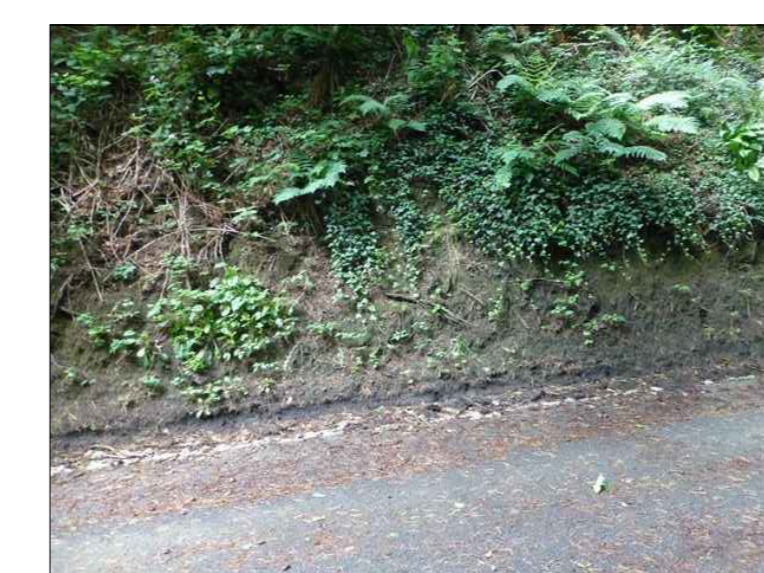
Approximately 70° face 1.0-1.2m high at the toe of the slope

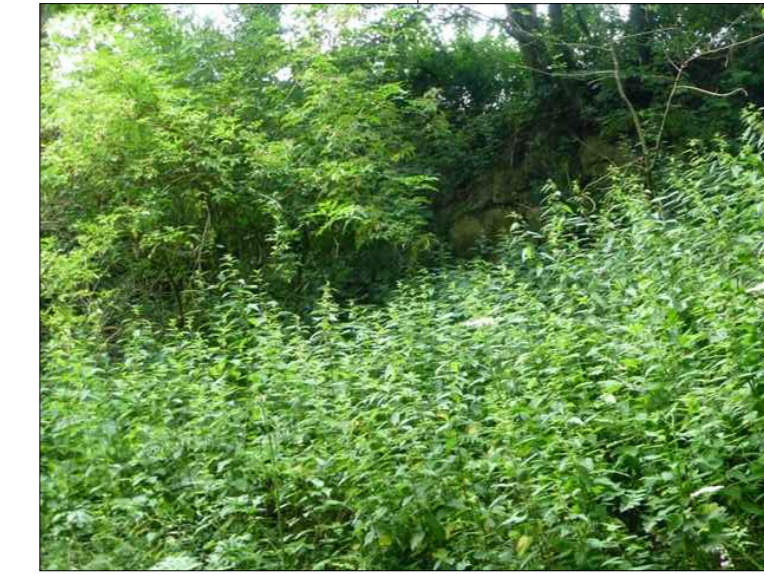
Very weak to moderately strong slightly weathered sandstone observed within the historic quarry

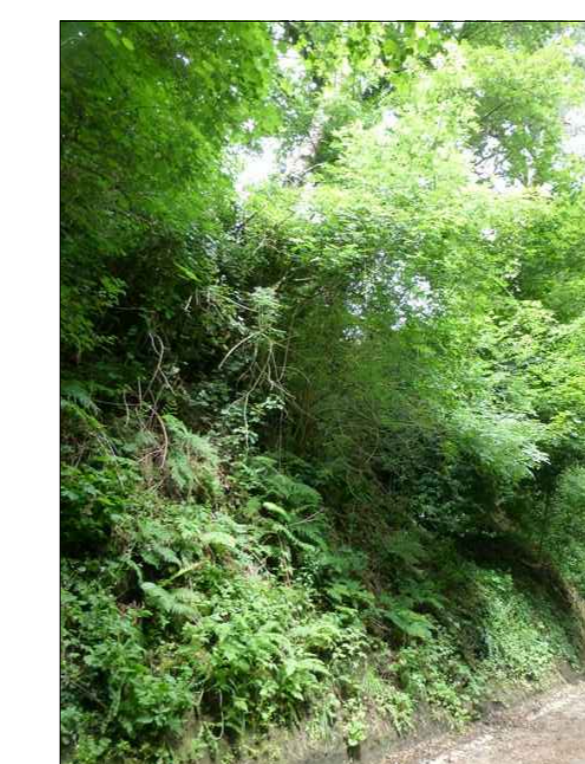
Trees leaning towards the carriageway

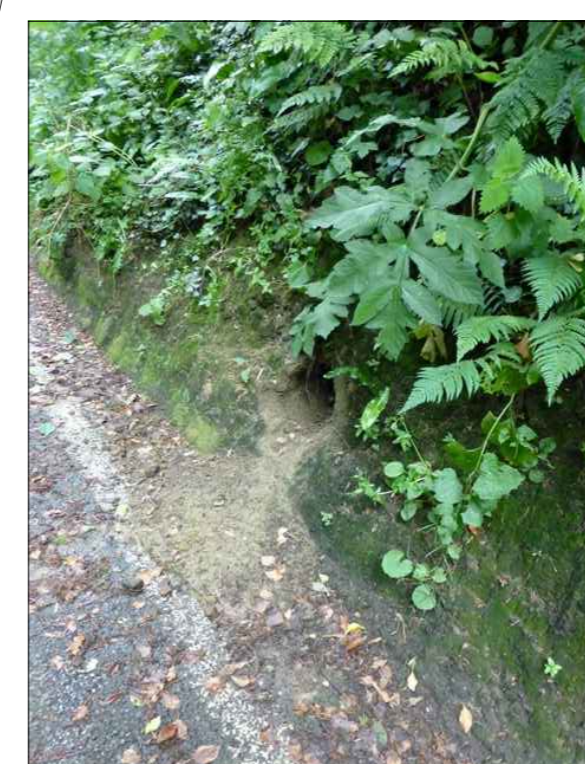
Burrow just above the carriageway

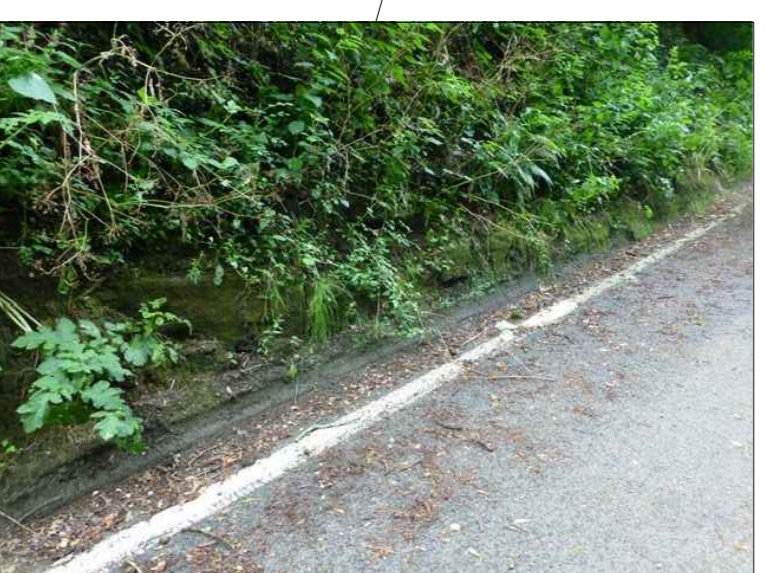
Exposure of extremely to very weak, weathered sandstone from road level to 1.5m above the carriageway
