**DORSET
PROPERTY
SURVEYS**

Client: Redmans Sand Ltd
Address: Redmans Quarry, Three Legged Cross BH21 6SD
Drawing Title: Reinstatement land contours and cross-sections
Dwg. No: DPS-17-0125 Z
Scale: Profiles 1:500 printed on A3
Date: 20th February 2018
Revision:

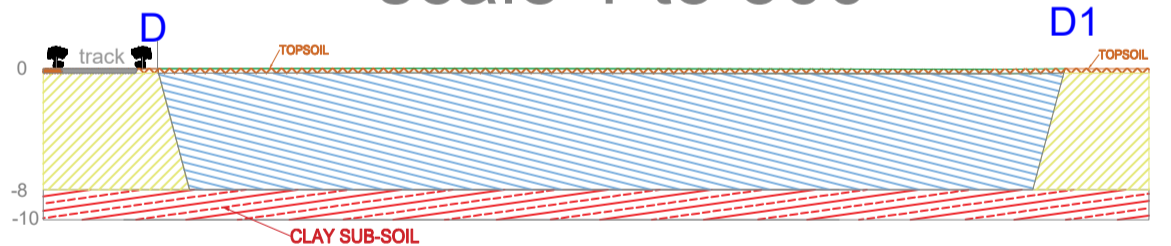
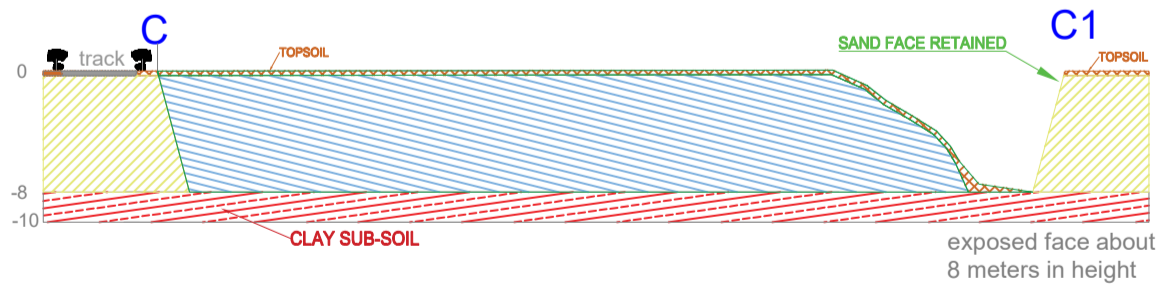
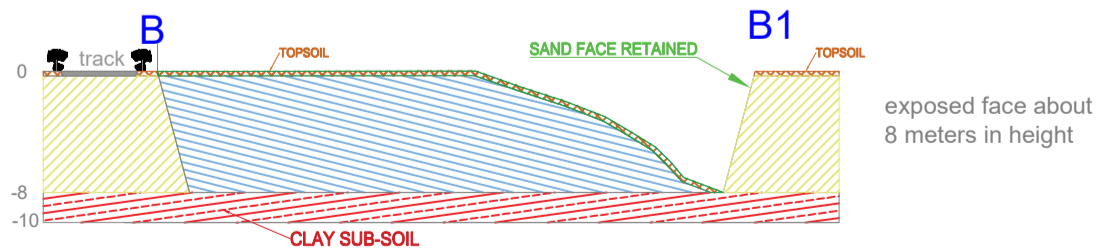
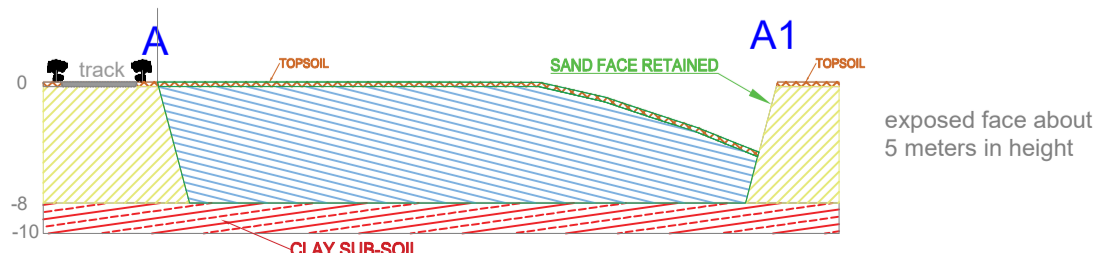
Four cross-sections through reinstated quarry in the approximate positions shown on the plan showing the reinstated profile at those points. All four cross-sections are roughly east - west. These cross-sections show the sand face being retained along the eastern side of quarry, with the exposed sand face extended northwards and southwards, which will triple the length of exposed face. Clay subsoil can be moulded at the base of the eastern face to prevent seepage from the reinstated area, if this is considered to be necessary. This will depend on the nature of material used for backfilling the void.
