## **Policy Group – 21 June 2017**

### **Purbeck District Conservation Areas review**

# **Morden Conservation Area Appraisal document**

## **Appraisal document**

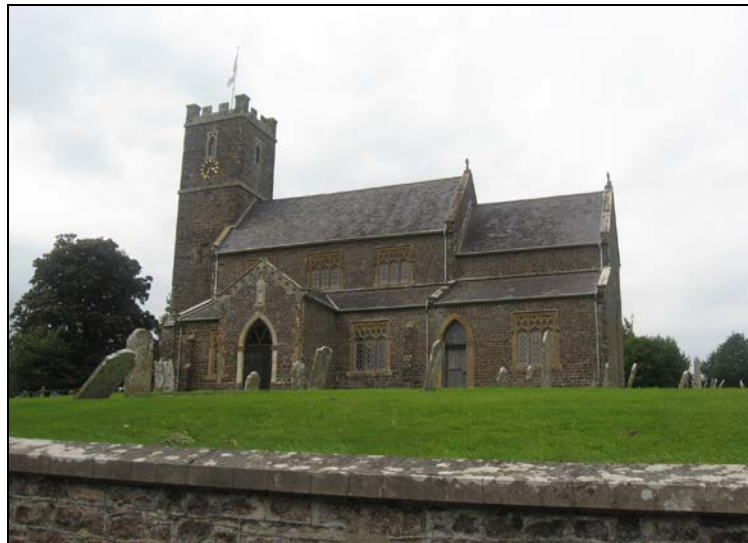
**FIG. 1:** *St. Mary's Church, Higher Street. A picturesque and well positioned building, the church is of particular interest as for being almost entirely constructed from heathstone.*

17. According to the English Place Name Society the name 'Morden', recorded as 'Mordune' in the 1086 Domesday survey, means 'hill in marshy ground'.
18. The lower part of the tower of St. Mary's Church has been dated to the thirteenth century (see FIG. 1 below). The top of the tower and remainder of the building were constructed in the 1870s.

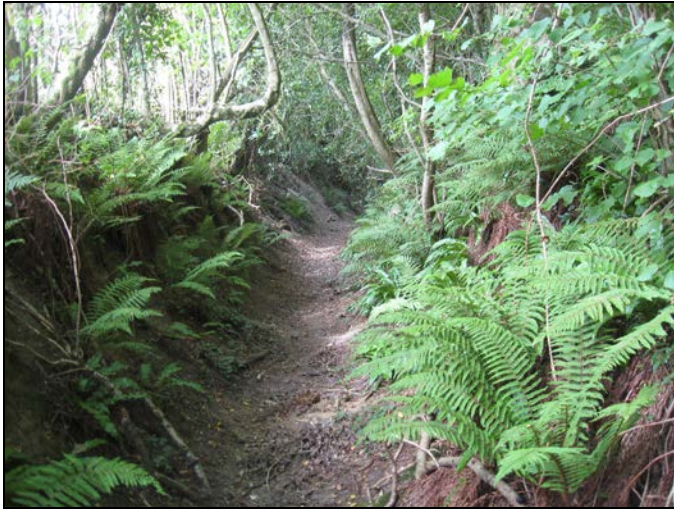
**FIG. 2:** *Collins's Lane. The lane is a sunken track which remains a right of way. It connects Goodwin's Lane with Lower Street.*

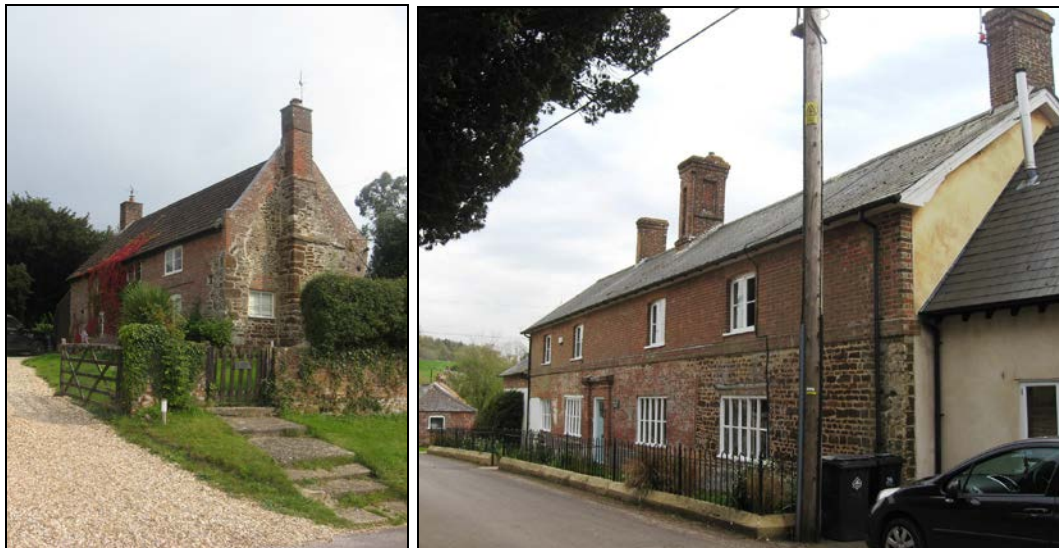
**FIG. 3:** *Buildings of the sixteenth and seventeenth centuries. Left: 60 Higher Street, the heathstone end gable of which is seventeenth century. Right: Home Farm a building of sixteenth century origin likewise rebuilt in the eighteenth century.*

18. References to Ridgeway Mill which formerly stood just south of Whitefield occur by 1550. A number of extant buildings within the conservation area have been identified as of sixteenth and seventeenth century origin. The rate of survival would have been higher had a wave of late 1960s-1970s demolition not claimed at least five others (see further discussion below). The earliest domestic buildings still in existence are thought to be Home Farm House in Higher Street (FIG. 3 below), West Morden Farm House and Paddock Cottage (see FIG. 22), which are each of late sixteenth century origin. Evidence for rebuilding of earlier heathstone houses in brick can be seen at Home Farmhouse, No. 60 Higher Street – a building of the seventeenth century (FIG. 3 below) – and Hill Farm Cottage, which is of unknown date.

24. As referenced on old OS maps (see FIG. 4 below) 'Morden' is the principal part of the settlement centred on Higher Street.
25. As noted above, the eighteenth and nineteenth centuries saw some earlier buildings rebuilt and altered. In the cases of 60 Higher Street and Home Farmhouse (FIG. 3 above) the work is evidenced in the contrasting materials used, whilst rebuilding of the parish church employed materials to match, and substantial extension of the Old Vicarage (see FIG. 31) masked the original building. No. 76 Higher Street (FIG. 30) was an addition of the eighteenth century, and Church Villa a stylistically notable contribution of the early nineteenth century.

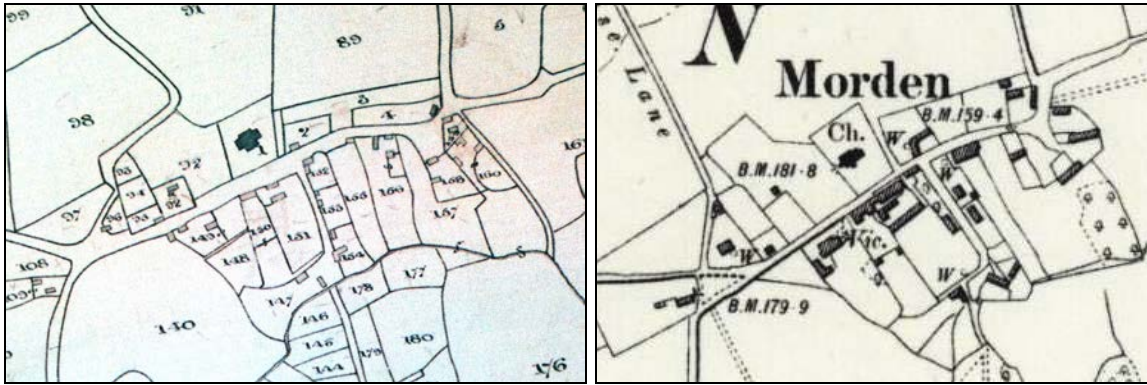
**FIG. 4:** Morden. Left: 1847 tithe map showing little change since the 1770s. Right: 1900 OS. Reproduced with the permission of the National Library of Scotland.

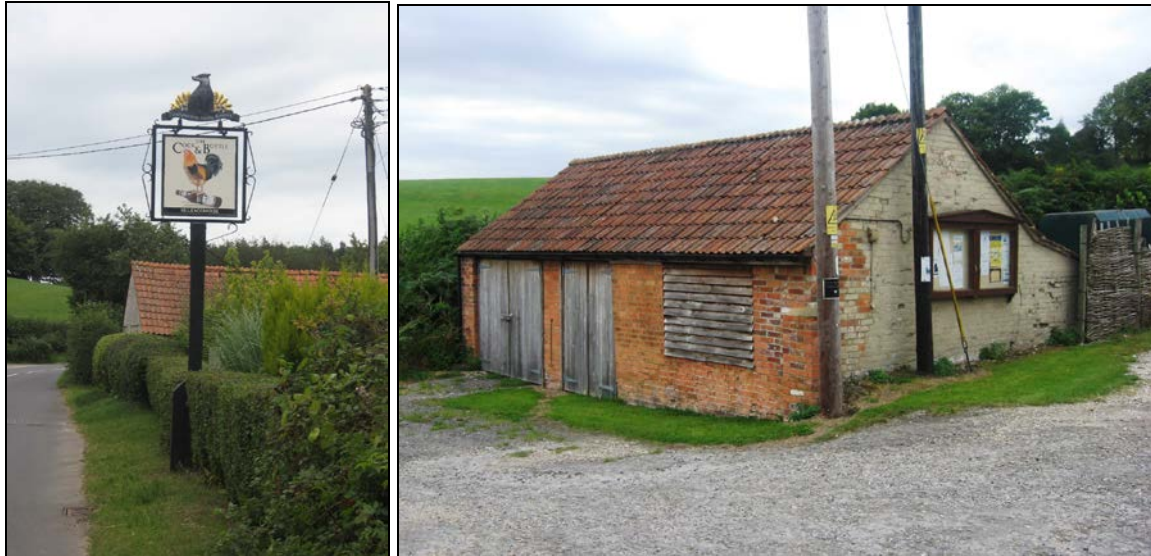
**FIG. 7:** Features of interest in East Morden. Left: Cock and Bottle Inn sign. Whilst the sign itself is not particularly old, both the unusual name and image have a long history which adds interest. Right: Old smithy opposite Fire Station Cottage, now used as a store. A pound was formerly attached to the gable on which the parish notice board is now located – see FIG. 6 above for map location.

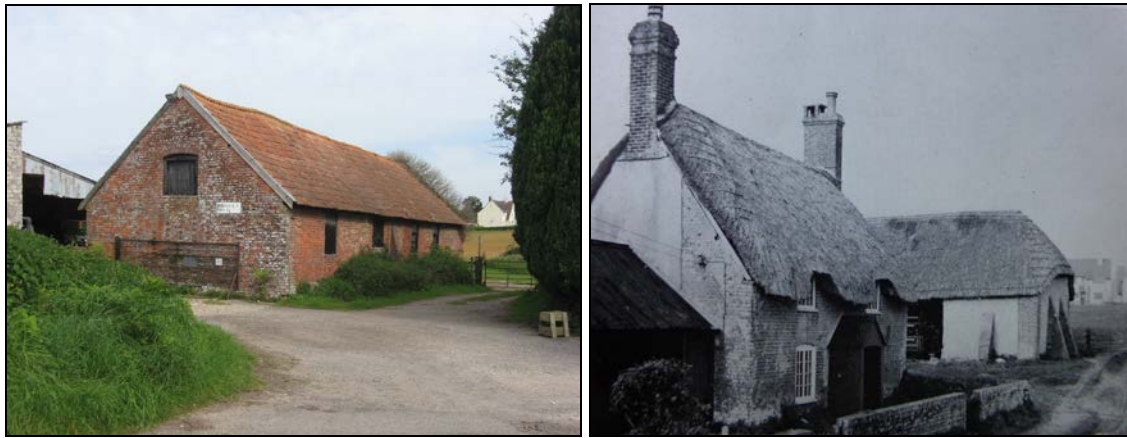
**FIG. 8:** Eighteenth century farmhouse and barn. Photo (right) taken from the 1970 RCHM survey – see FIG. 6 for position shown on a map. Note modern houses on New Road in the background. The thatched buildings were subsequently demolished though a few related buildings (left) remain in use by Sellar’s Farm.

33. Housing development since the 1960s has seen addition of clusters of generic modern houses and bungalows. Sellar’s Farmhouse is also a relatively modern addition showing greater resemblance to Sticklands than the thatched cottage which previously stood on the site (FIG. 8 above). Just off the maps shown in FIG. 6, the character and setting of Brooks Farm has been significantly gentrified.

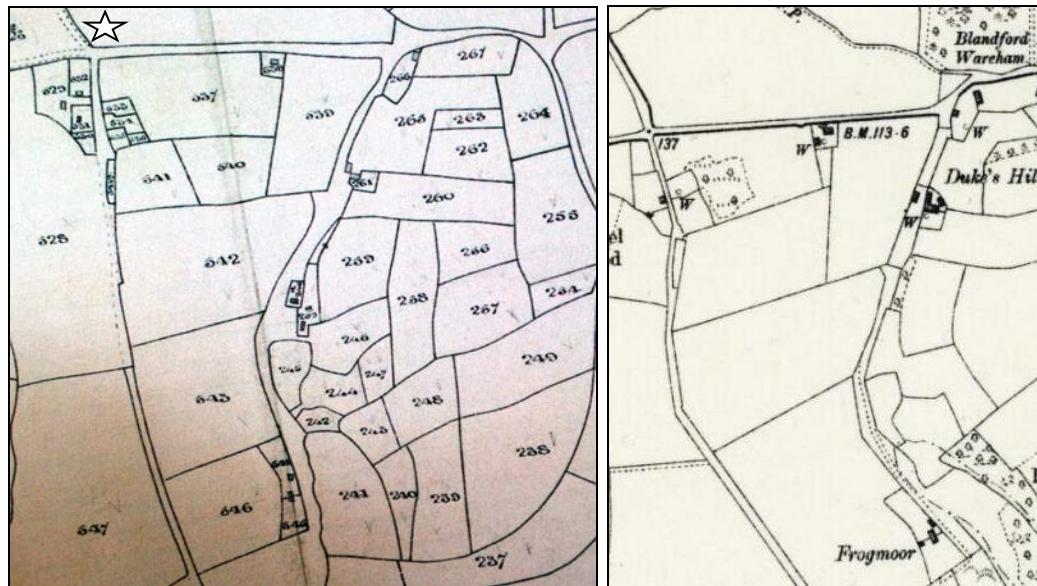
**FIG. 10:** *Frogmoor and Hector's Corner. Note, Hector's Corner is the junction marked with a star. Left: 1847 tithe map. Right: 1900 OS. Only three of the dwellings shown in 1847 survive. The lane running to Frogmore remains a right of way but lacks enclosure south of Frogmore Farm. Maps reproduced with the permission of the National Library of Scotland.*

35. Frogmore Farm, a building of eighteenth century date, today stands at the end of a short lane running south from Lousey Wood. Several dwellings historically stood on this lane which extended south to a pair of cottages labelled 'Frogmoor' on the 1900 OS (see FIG. 10 below). To the south of Frogmoor lay former common land, now a plantation of conifers. Two cottages located on the centre section of the lane disappeared during the second half of the nineteenth century, though the pair of eighteenth century cottages at Frogmoor, and another seventeenth century dwelling at the top of the lane survived long enough to be identified by the 1970 RCHM survey.

36. The cottages at Frogmoor and the top of the lane recorded in the 1970 survey were each subsequently demolished. The lane itself remains a right of way though is no longer fully enclosed south of Frogmore Farm. Most of the field boundaries shown in FIG. 10 no longer exist. The site of the two dwellings at Frogmore is currently a pheasant pen.

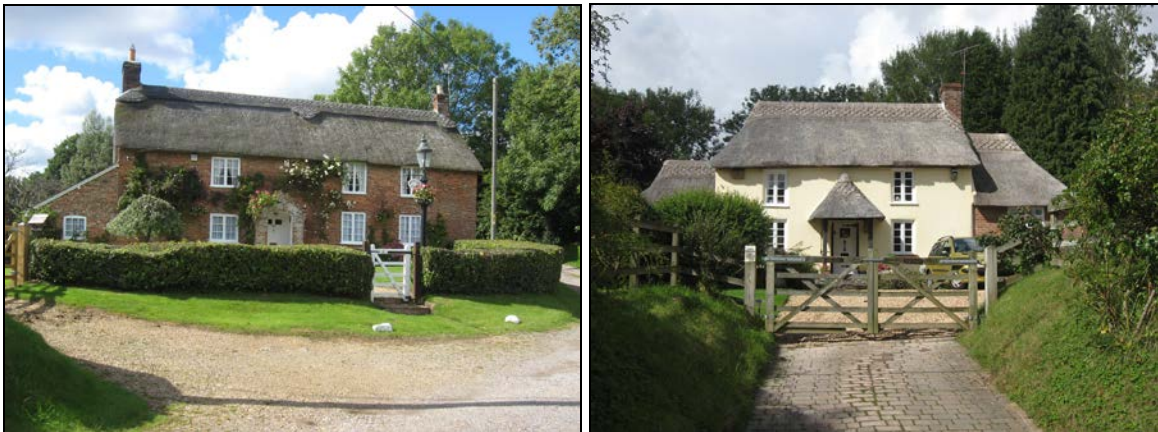
**FIG. 11:** *Thatched buildings at Whitefield. No 153 and Whitefield Farmhouse. Note the contrast in ridge styles – a flush ridge is the local traditional finish.*

38. The 1847 tithe map identifies the presence of a brick kiln at Whitefield, close to the site subsequently occupied by the old Methodist chapel.
39. Whitefield Farmhouse (FIG. 11 below) is of seventeenth century origin. Nos. 152, 153 (FIG. 11 below) and 154 were originally built as three identical cottages during the eighteenth century, and the group was noted by the 1970 RCHM survey. Subsequent alteration, which has radically transformed No. 152 in particular, has changed the character of the group.

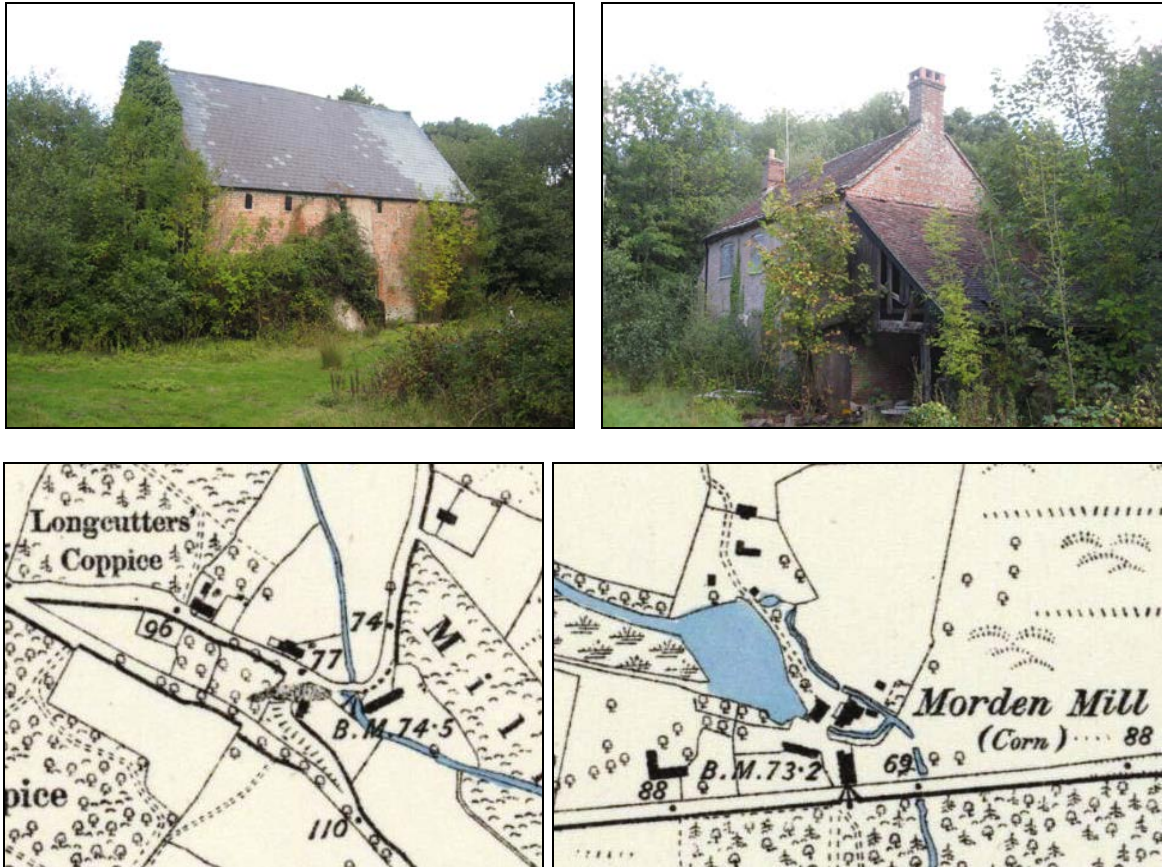
**FIG. 13:** *Ridgeway Mill and Morden Mill. The maps above are excerpts from the 1887 OS map. Left: Ridgeway Mill and adjacent cottages. No trace remains of any of these buildings. Right: Morden Mill, adjacent cottages and buildings. Three of these buildings survive in a decaying state – the mill and mill house are pictured top. Note the attached timber framed and clad outbuilding – a common feature of Estate properties around the conservation area. Maps reproduced with the permission of the National Library of Scotland.*

41. As noted above, Ridgeway Mill was recorded as early as 1550 and stood amongst a cluster of cottages to the south of Whitefield. Post-war the scene was unchanged except for loss of the cottage east of the mill. The 1970 RCHM map recorded two surviving eighteenth cottages north and northwest of the mill, though the mill itself may have been lost by this time. Both cottages were also subsequently demolished. No trace exists of any of the buildings shown in FIG. 13, the sites having been engulfed by woodland.

42. Morden Mill and the adjacent mill house (FIG. 13 above) are of eighteenth century date. The mill was originally water powered but was later adapted to be driven by machine. Much of the internal workings remain intact. Until relatively recently the mill and the adjacent mill house were occupied. Now disused and uninhabited the buildings and their historically well-ordered context have slipped into decay. Of the other structures shown on 1887 OS map (FIG. 13), only the stable range survives, now also derelict.

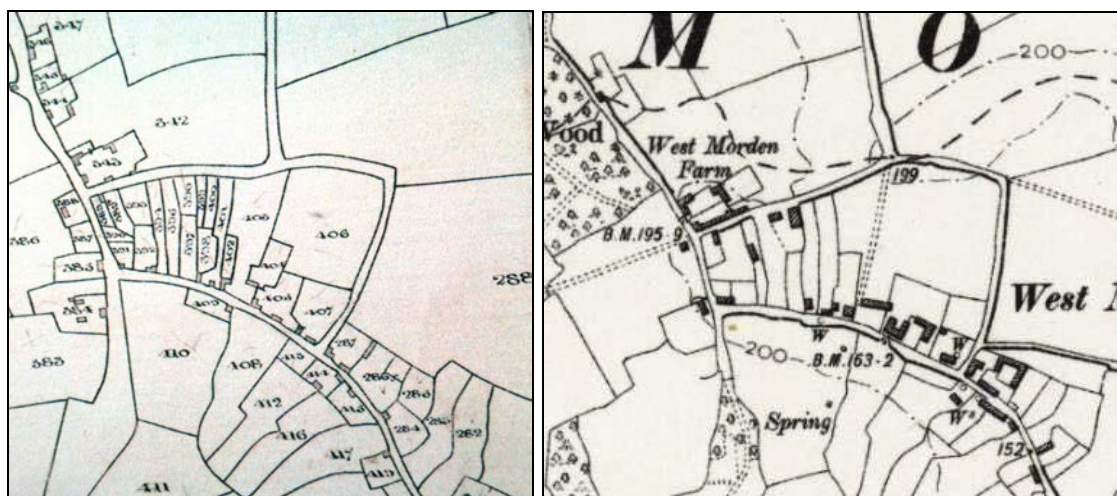
**FIG. 14:** West Morden. Left: 1847 tithe map showing little change since 1760s. Right: 1900 OS. Maps reproduced with the permission of the National Library of Scotland.

44. Comparing maps of the area between 1847 and 1900 (FIG. 14 below) there was some contraction in the number of dwellings, four cottages disappearing from the west side of the hamlet: one south of No. 43, one west of No. 36 and a couple north of West Morden Farm. Other notable changes included the development of farm buildings at King's Corner Farm and opposite West Morden Farm.

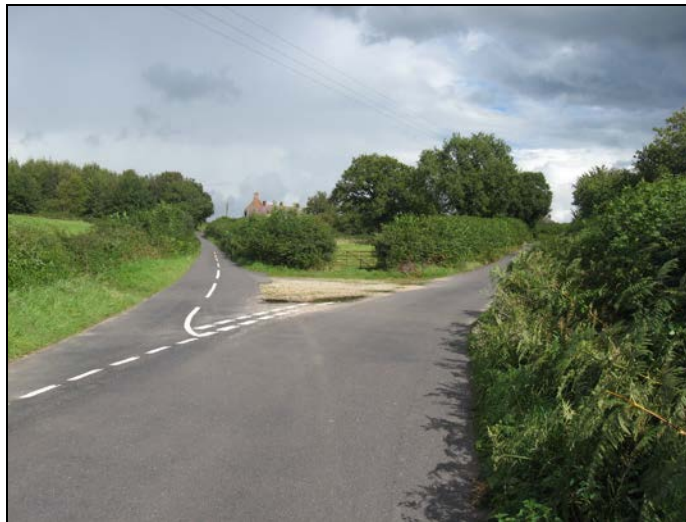
**FIG. 15.** *Junction. Heading away from Whitefield the road splits left to West Morden, right to East Morden, the routes forming two sides of a triangular piece of former common land. Continuing right, Hector's Corner is located at the crossroad whose northern branch forms the third side of the triangle.*

50. Within the network of lanes connecting components of the settlement, junctions are frequent features. Some of these, such as Hector's Corner and Firestation Corner, are specifically named. One such junction is shown in FIG. 15 below.

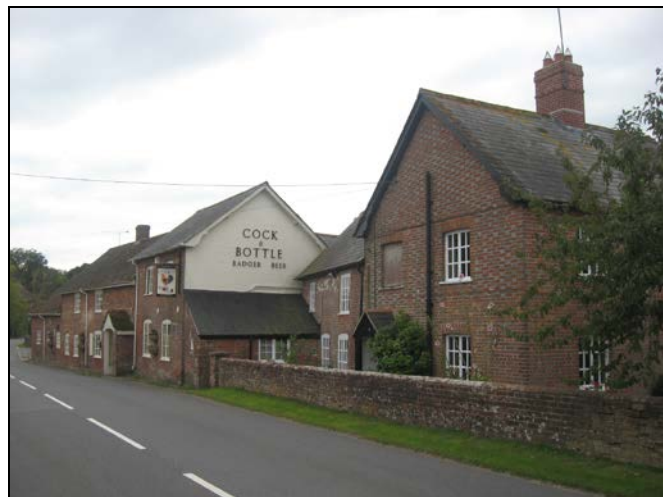
**FIG. 16:** *East Morden building frontage. This is one of only two continuously developed frontages in the conservation area. Variation in building form, orientation and height here provides visual interest.*

53. A continuous developed frontage of attached buildings occurs only opposite the parish church in Morden, and at the Cock and Bottle in East Morden (see FIG. 16 below). Further development of this type historically existed at the Lower Street entry to Collins's Lane (see FIG. 6). Elsewhere buildings are generally separated from their neighbours by appreciable spaces of various size and form.

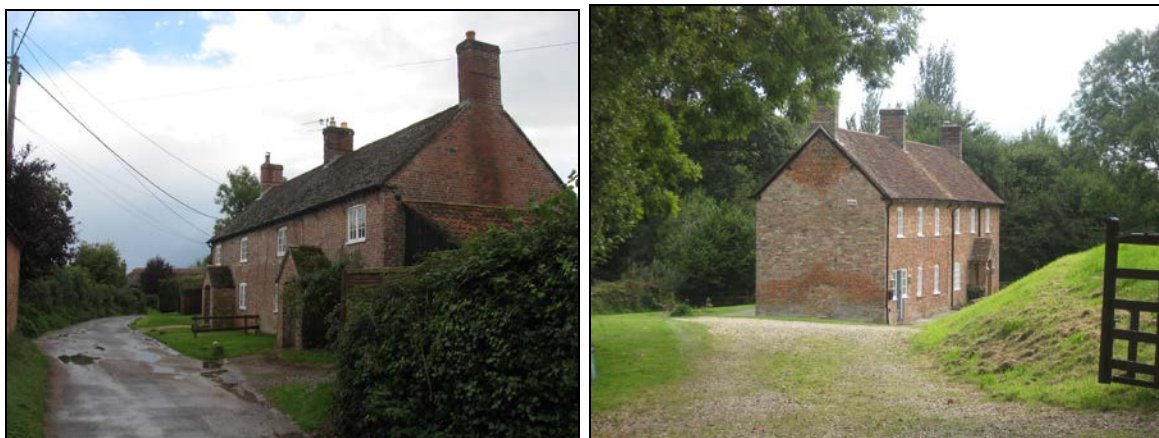
**FIG. 17:** *Simple rows. Typical two storey rows of brick cottages; simple in form, appearance and detailing. Left: Nos. 46 and 47 West Morden. Right: Nos. 103-105 (Cherry Cottage) Cockett Hill.*

57. Amongst historic buildings, simple linear plan and building forms are generally most common. These gain modest depth in those cases where rear catslide roofs are a feature of the design. Similarity in form is seen between roughly contemporary historic buildings though the finer details don't always match (see FIG. 17 below). This is likely to reflect similarity in the requirements the buildings fulfilled, their construction by the same landowner and the absence of direction by an architect.

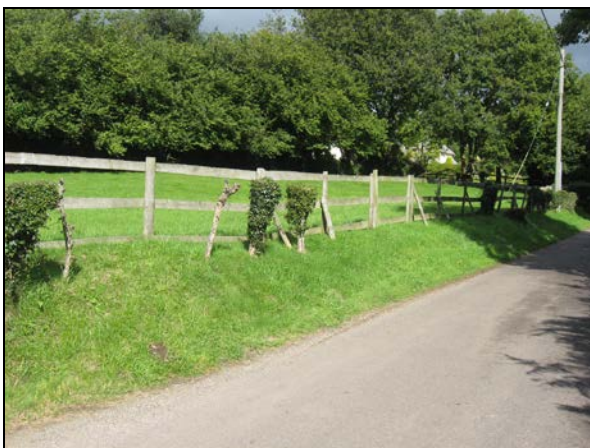
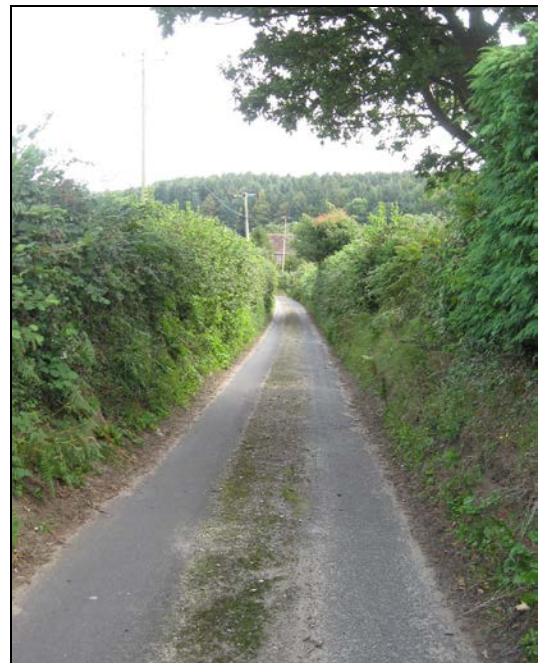
**FIG. 18:** *Hedges. Below: fragments of a hedge at Whitefield. Some field boundaries are in a similar condition. Right: hedges contribute to the heavily enclosed feel of Gallop's Lane.*

62. Within fields themselves a few notable hedges exist, such as that running between Shrubbetts and New Lane. Compared to the boundaries shown on old maps however the number of hedges appears to have been substantially reduced, and there are surprisingly few hedgerow trees. There is no evidence of traditional hedgerow management anywhere in the conservation area, and this has resulted in progressive thinning and generally poor condition particularly where also heavily flailed. Continuing to treat hedges this way may lead to their eventual loss.

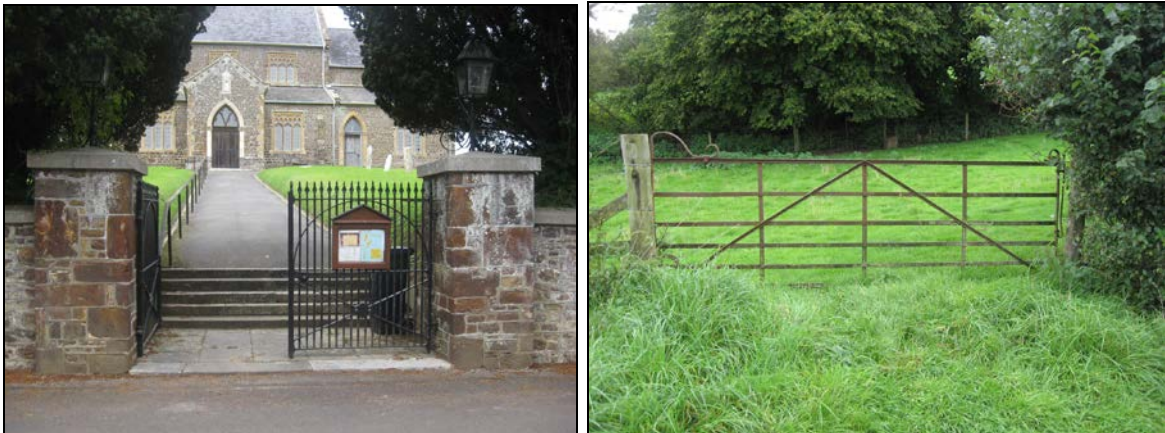
**FIG. 19:** *Gates. Left: the entrance gateway to the parish church. Note the lanterns either side. Right: a typical estate gate. Numerous examples of this design can be seen around the conservation area.*

63. Gates are typically used to close field accesses. The use of particular design of iron estate gate, numerous examples of which can be seen around the conservation area (see FIG. 19 below), is a distinctive local feature. The condition

of these gates varies, many remaining in use, others overgrown. Most would benefit from a protective coat of paint.

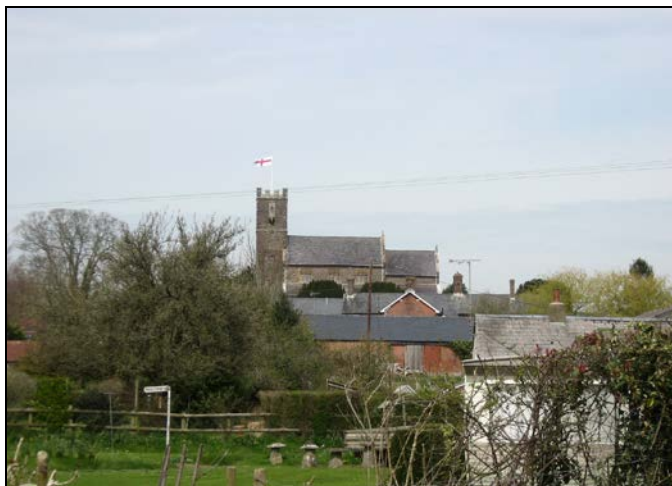
**FIG. 20:** *The parish church viewed from the south. The church towers over buildings below which gradually rise up the slope.*

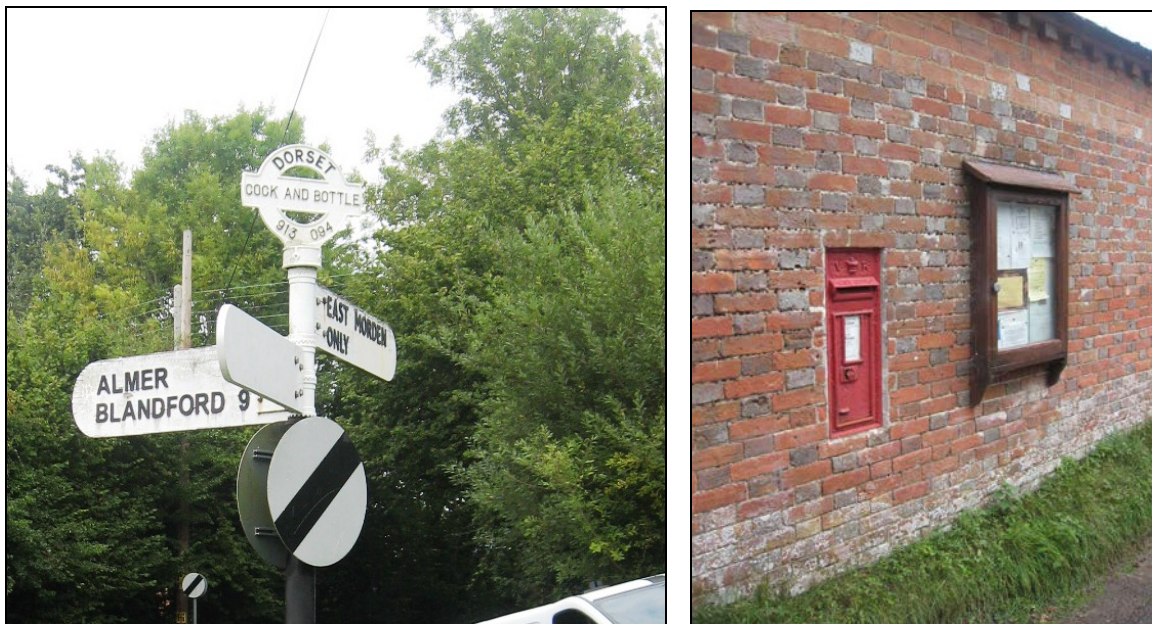
**FIG. 21:** Street furniture. Left: Pillar box in West Morden. The Victorian box is fitted into the wall of an agricultural building at King's Corner Farm. Note the chequered Flemish bond brickwork using red stretchers and blue headers. Right: Finger post at the Cock and Bottle. The post has clearly been refurbished and retains a distinctive roundel which records the location. The appearance of the post is spoiled by the speed sign attached below. Surprisingly the speed limit here is 60 mph.

75. Three finger posts are located in the conservation area. That adjacent to the Cock and Bottle (FIG. 21 above) is in good condition and retains its distinctive roundel. That adjacent to the old school (see FIG. 37) is in poor condition and has lost its roundel, though retains its historic cast lettering. Old maps record presence of a milestone on the site, though this appears to have been removed. A third finger post at the junction of the B3075 with the roads to East Morden and West Morden is in reasonable condition though lacks a roundel and appears to have lost some of its pointers.

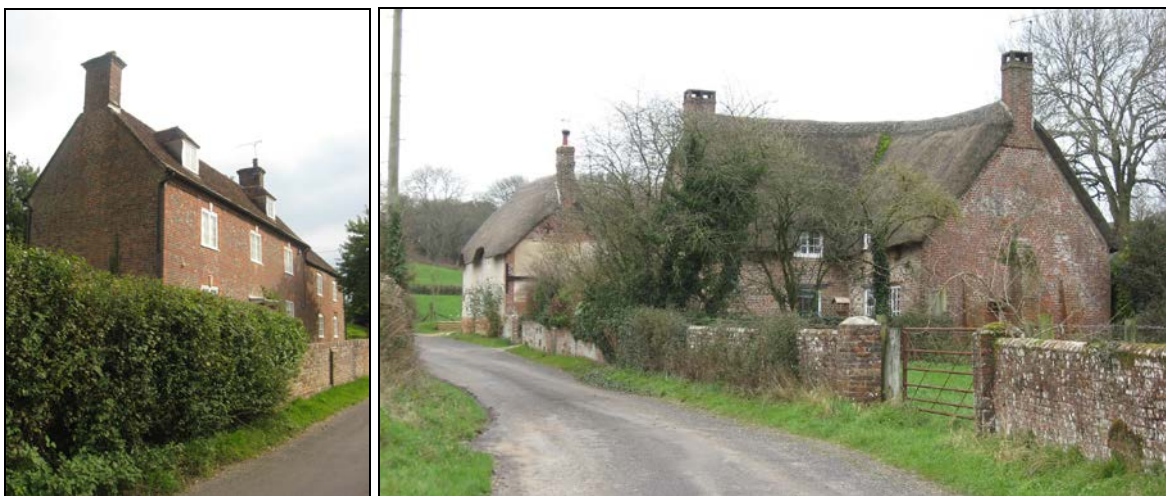
**FIG. 22:** *Architectural variation. Left: Stickland’s Farmhouse, the original part of which features a bold symmetrical frontage with high quality brickwork and detailing. Right: Paddock Cottage and No. 36 West Morden (‘Wayside’), two vernacular structures showing possible variation in historic status.*

80. Solid roofed brick cottages of the late eighteenth and nineteenth centuries appear more orderly in composition but generally ‘plain’ in appearance. Detailing is simple, and typified by segmented arches over openings, but is not consistent between buildings, indicating continued absence of formal design. Such buildings represent a later phase of the vernacular. A sense of formal ‘style’ is infrequent, the best examples being Stickland’s Farmhouse (FIG. 22 below), a building of clearly high status, and remodelled elements of the Old Vicarage (FIG. 31). Nos. 149 (see FIG. 27) and 155 Whitefield also provide interesting examples of simple styling applied at a more modest scale.

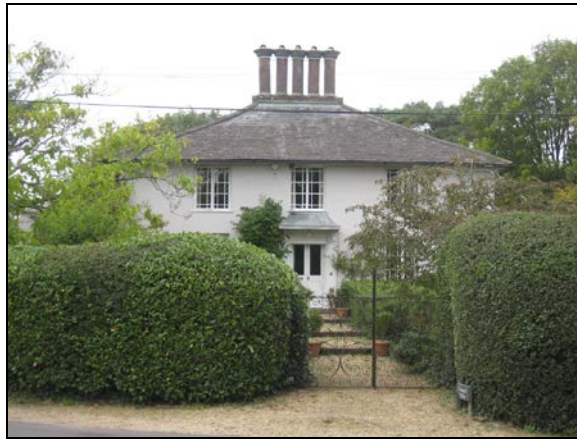
**FIG. 23:** *Church Villa. This early nineteenth century building has an ornate Regency design. The chimney stacks are a particularly notable feature.*

81. The conservation area contains two interesting examples of Regency design represented by Church Villa and Merraway, the latter originally named Morden

Villa (see FIG. 23 below). Church Villa has a particularly distinctive appearance given its unusual chimney stack design, whilst both buildings feature a range of stylised components.

110. Window designs featuring margin lights are important stylistic elements in the designs of Church Villa and Merraway (see FIG. 23). At Merraway these are also used in the porch, whilst the frontage additionally features an oculus.
111. Brick arches are typically formed over openings in brick buildings within the conservation area. The type of arch varies with architectural style, and to a lesser extent also the status of the building. Fine flat arches in gauged brick typical of formal Georgian design are seen at Stickland's Farmhouse, at Nos. 149 and 155 Whitefield, and more unusually at Paddock Cottage (see FIG. 27 and 28). Curved segmented arches of one or two brick thickness are however most common, giving a plainer, more functional appearance to domestic and agricultural buildings alike (see examples in FIGs. 17, 28, 32, 30, 33, 36).

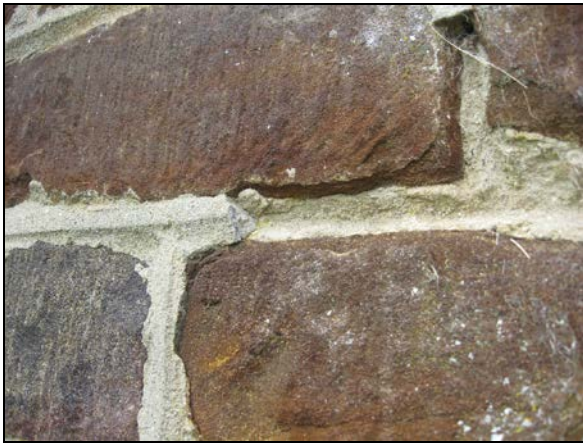
**FIG. 24:** *Heathstone. Blocks of heathstone seen at the parish church. This detail shows failure of poor quality pointing, the raised and smeared appearance of which has greatly disfigured the appearance of the building and may have accelerated decay of the stonework.*

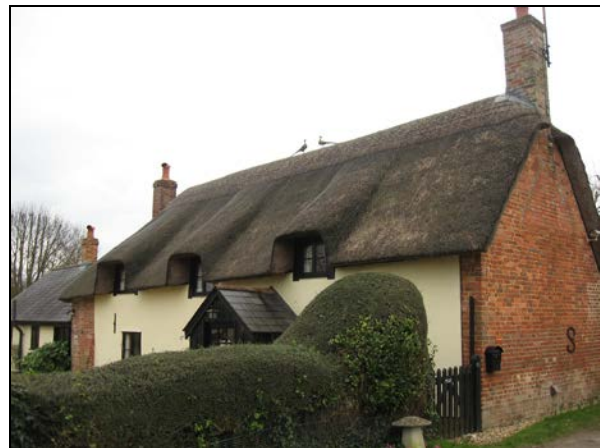
**FIG. 25:** *No. 48 West Morden. Over time brick patching or facing was often added to cob structures, as seen in the example. The thatch on this property has been renewed, the relatively thin coat accentuating the dormers. With successive recoating roofs like this traditionally gained a flush appearance.*

85. The local availability of clay rich soils and chalk provided favourable conditions for construction in cob (earth). As such cob forms an important component of the historic vernacular, and as is common in the broader context, it is used in conjunction with thatch. The frequency of cob buildings within the conservation area was much reduced by demolitions of the 1960s and 70s. Cob buildings retaining their original rendered appearance are now scarce within the conservation area, though include No. 76 Higher Street (see FIG. 30) and Nos. 153 and 154 Whitefield (see FIG. 11). Brick patching, and sometimes encasement of cob was common historically. Several of the buildings recorded in the RCHM survey subsequently demolished were described as patched. Cob with brick is still seen at Nos. 36 and 48 West Morden.

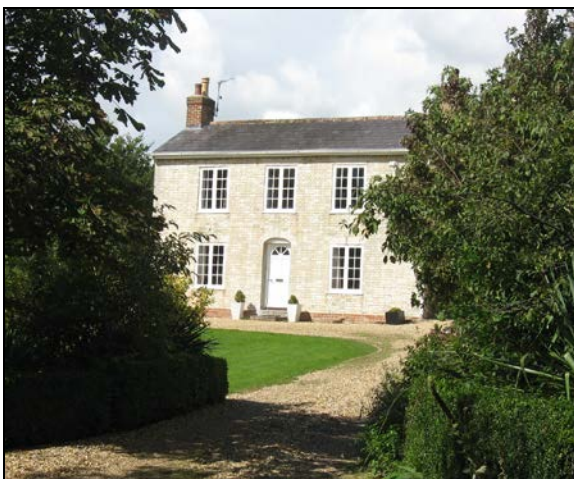
**FIG. 27:** No. 149 Whitefield. Use of white brick in this small house of formal design is entirely exceptional, though in terms of general design the frontage is similar to that No. 155 Whitefield.

87. Clay extracted at East Morden and Whitefield was of two types – Reading Clay at Whitefield and London Clay at East Morden. Old bricks within the area are typically shades of orange, except where burned for decorative effect (discussed below).
88. Brick finds use in all types of historic building within the conservation area, and currently makes the strongest visual contribution to character. Some increase in relative frequency is however the product of demolition of many cob buildings during the 1960s and 70s.
89. Header bond used at Stickland's Farmhouse is a rarity and creates a distinctive appearance (see FIG. 28). Use here is a sign of the historic status of the building which otherwise adopts a formal architectural style. The design of No.149 Whitefield is again formal in character though the use of white brick is wholly exceptional (see FIG. 27 below).

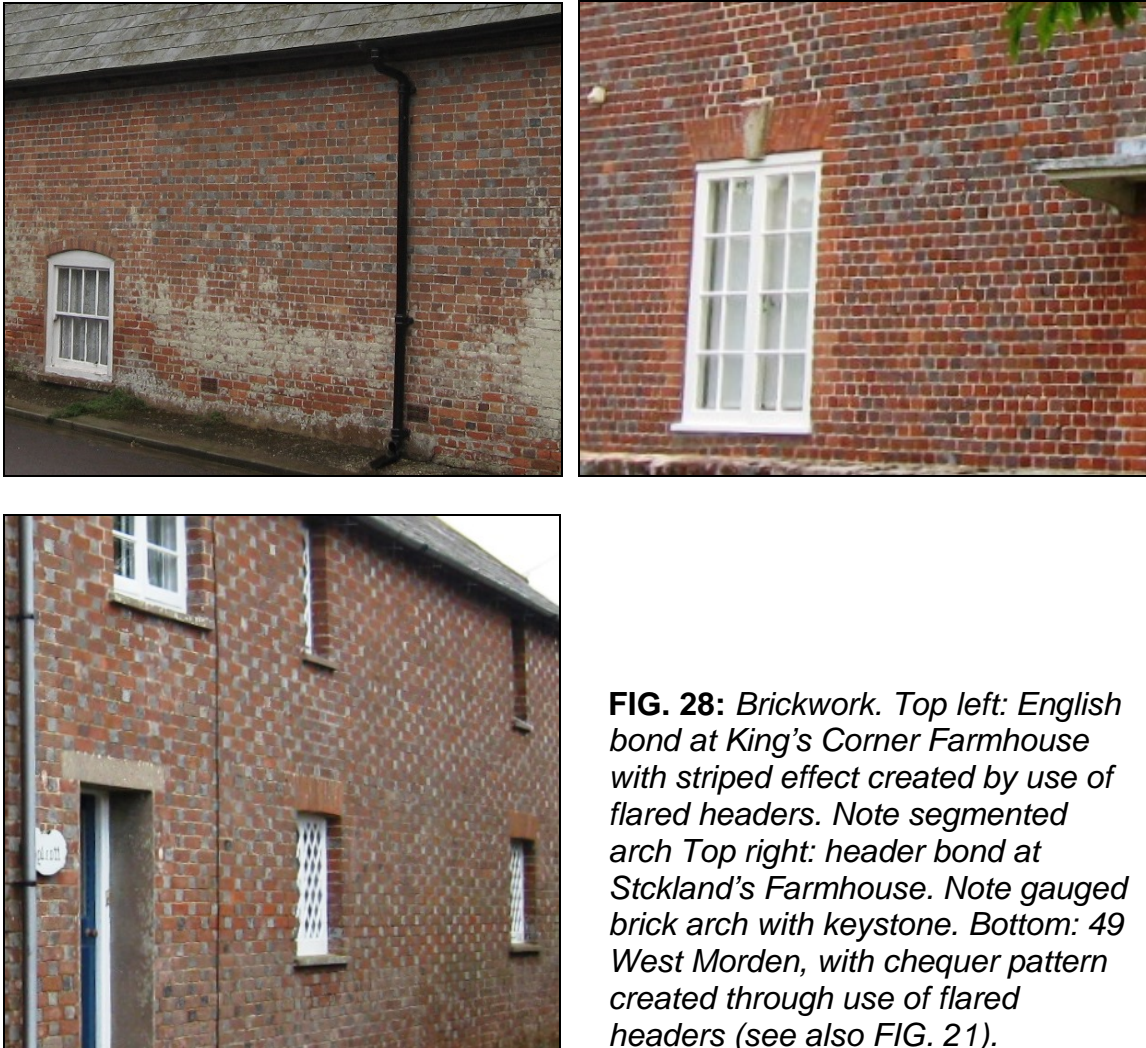
**FIG. 28:** *Brickwork. Top left: English bond at King's Corner Farmhouse with striped effect created by use of flared headers. Note segmented arch Top right: header bond at Stckland's Farmhouse. Note gauged brick arch with keystone. Bottom: 49 West Morden, with chequer pattern created through use of flared headers (see also FIG. 21).*

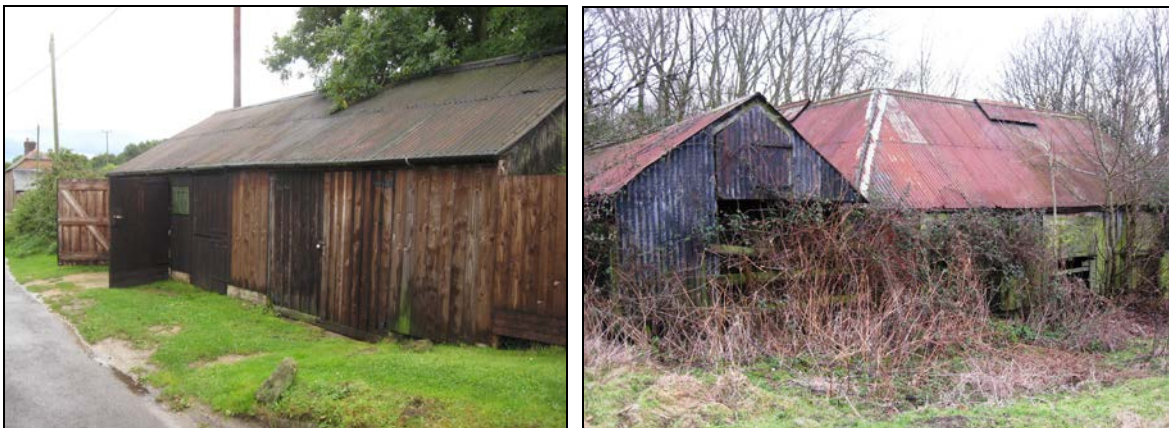
**FIG. 29:** *Timber boarding and corrugated iron. Left: this shed at 47 West Morden demonstrates the locally distinctive use of vertical timber boarding with cover strips over the joints. Corrugated iron covers the roof. This material is frequently seen around the conservation area as a partial or full cladding as in the semi-derelict structure located at Shrubets (right).*

92. Vertical timber board is frequently seen used as a cladding material for attached timber framed outbuildings or sheds (see FIG. 29 below). The board is typically black in finish, reflecting the traditional use of pitch as timber preservative. In recent years some of these outbuildings have been replaced by more permanent extensions which have been clad in the same manner (see for example No. 43 West Morden). Both the use of the board and context of its use clearly reflect past practice on the estate, and make a small but significant contribution to local distinctiveness.

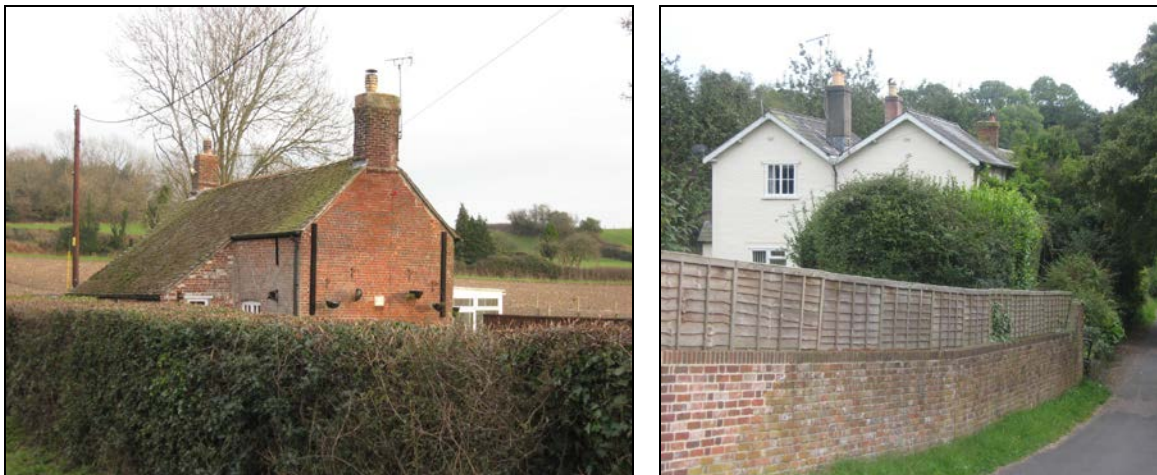
**FIG. 30:** Varied roof forms. Top right: Pitched roof with rear catslide at No. 165. Top right: 'M' shaped roof at No. 69 Higher Street. Bottom: half hipped thatch roof of No. 76 Higher Street. The slate roof of No. 74 adjacent appears to have replaced a roof similar to that at No. 76.

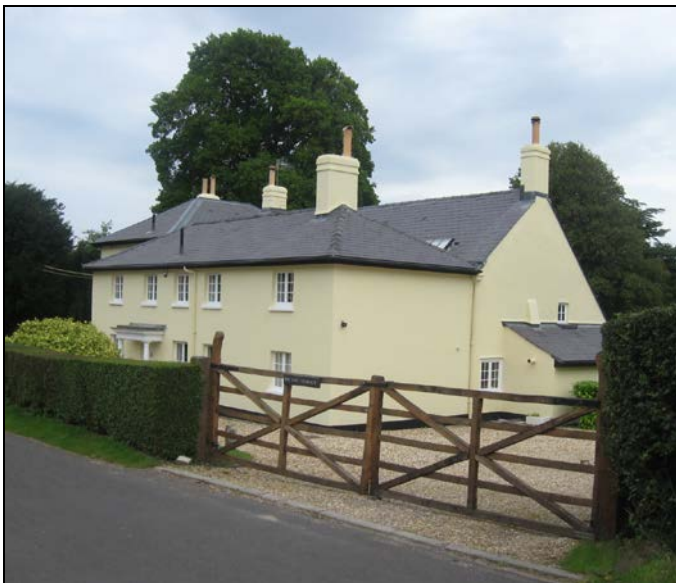
**FIG. 31:** *The Old Vicarage, Higher Street. The roof of this building has recently been re-covered with Welsh slate. The original part of the property is to the rear and can be identified by the steeply pitched roof with catslide – similar to others within the conservation area. Clay tiles are more likely to have covered the original part of the building, though slate would have suited the lower pitches used when remodelled during the nineteenth century.*

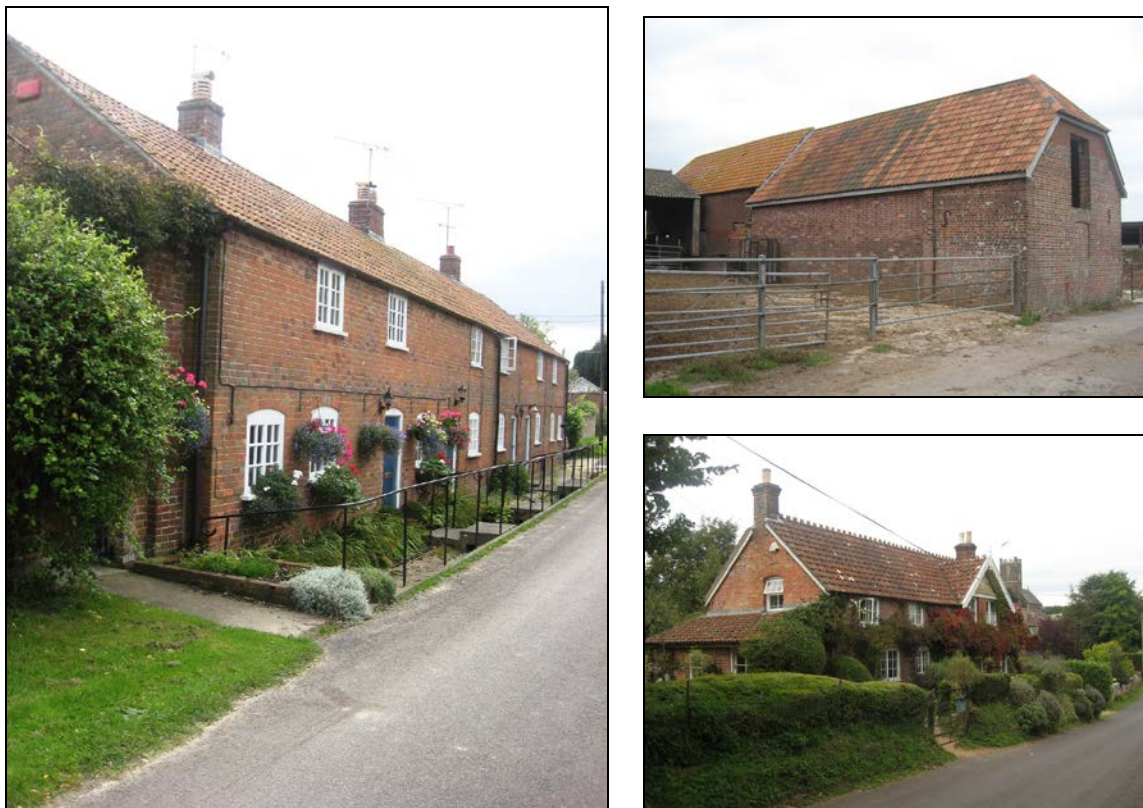
**FIG. 32:** Double Roman tiles. As seen on the roofs of Nos. 64-67 Higher Street (left), a building at Hill Farm (top right) and the Old Post Office Higher Street (bottom right).

104. Around the District generally double Roman tiles are typically found on agricultural and other functional structures, and use in this context is also seen in the conservation area. Notable examples include the old forge (see FIG. 7) and fire station in East Morden, each of which carries specially shaped ridge tiles. Single storey former agricultural structures on Higher Street are also of note for the clear glazed tiles they incorporate to admit light, and larger agricultural structures including those at Sellar's Farm, (FIG. 8), West Morden Farm, Hill Farm and to the rear of No. 60 Higher Street also carry double Roman tiles.

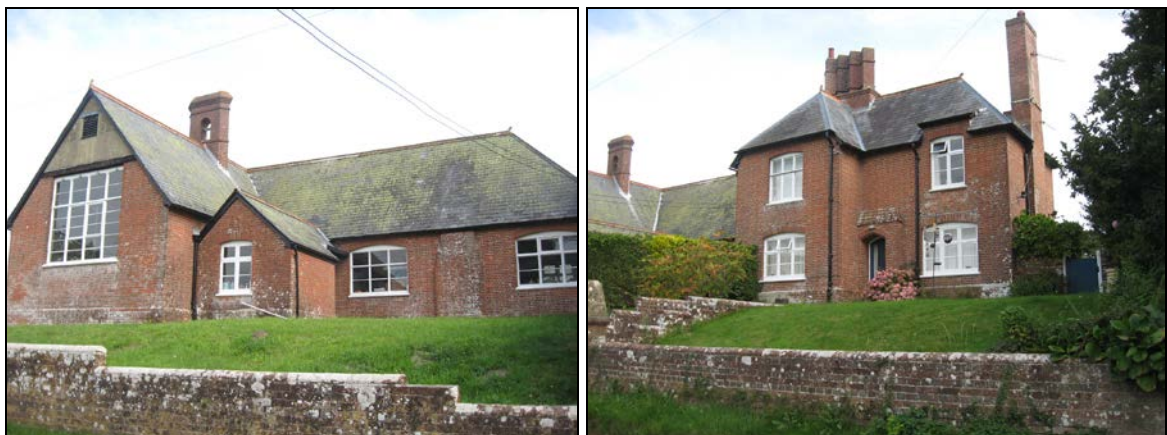
**FIG. 33:** *The old school and school house. Note the chimney stacks which in the case of the school itself were designed to also hang the school bell.*

- *The old school and school house.* (FIG. 33 above) These are prominent roadside buildings, particularly viewed entering East Morden from the north. The school itself has not undergone conversion, though is in use for general storage, and remains a good example of its type.

100. Slate is most typically a feature of nineteenth century buildings within the conservation area, reflecting in part the period in which distribution from North Wales was facilitated by growth of the railways. The best examples of slate roofed buildings are the parish church (FIG. 1) and old school (FIG. 33). In some cases slate may have replaced earlier roof coverings or superseded them when modifications were undertaken. This was the case for example at Home Farm in Higher Street, and is likely to have also been the case at the Old Vicarage and No. 74 Higher Street. The Old Vicarage has recently had its covering renewed with heather blue Penryhn slate (see FIG. 31 below), which makes a strong visual contribution to this part of the conservation area.

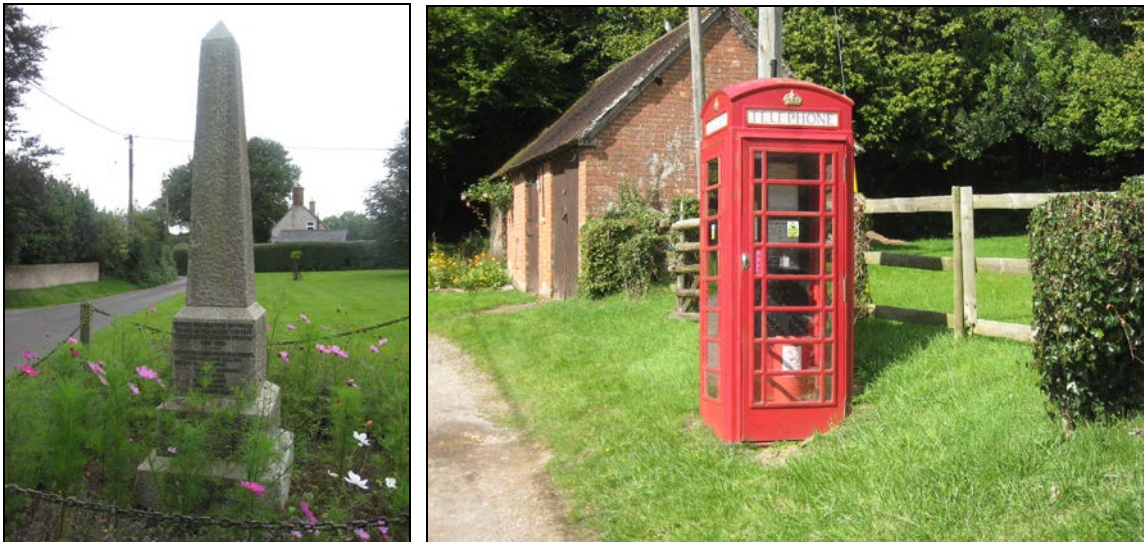
**FIG. 34.** *War memorial in Higher Street, and telephone kiosk at Whitefield.*

- *War memorial, Higher Street.* (see FIG. 34 above). The war memorial is a modest structure of great local importance. Not currently listed, it is likely to qualify for designation under the current Historic England programme.
- *Gravestones in the parish churchyard.* The churchyard contains an interesting collection of gravestones some of which are inevitably older than the church itself. A few good carved designs are present, though the inscriptions are often difficult to read. Ivy growth is affecting some monuments (see for example FIG. 36) and is causing damage.

use of the Tudor crown, which were typically installed 1935-52. None of these kiosks are listed or likely to be eligible for listing, leaving them vulnerable to future removal. Unusually the kiosk at Whitefield is under CCTV surveillance. The kiosks at Firestation Corner and Higher Street are associated with posting boxes.

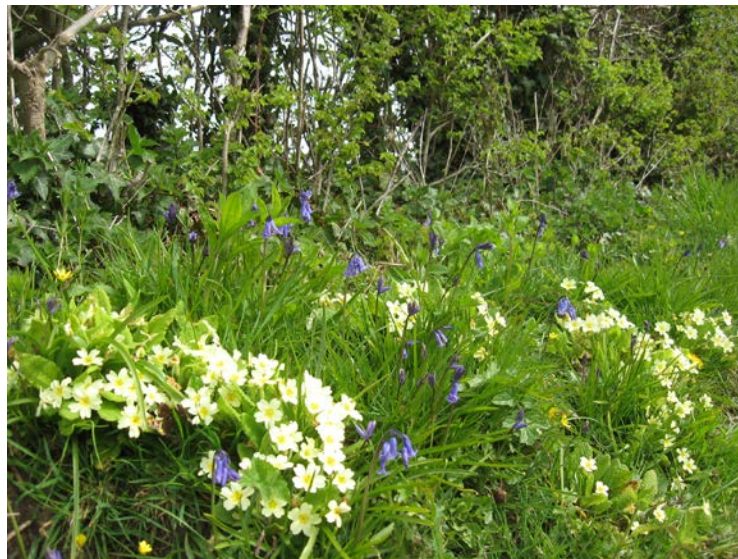
**FIG. 35:** *The importance of verges. Here spring flowers including primroses and bluebells are seen in a verge along Goodwin's Lane.*

115. Verges are an important resource for wild flowers, and during spring bluebells and primroses are seen along many of the lanes in the conservation area (see FIG. 35 below).

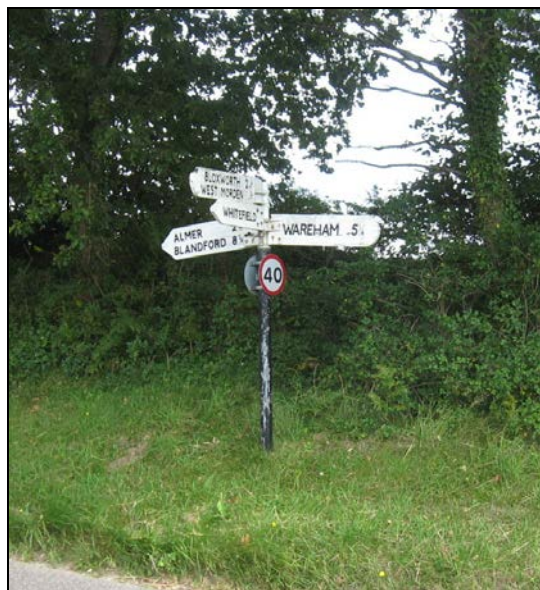
**FIG. 37:** Areas for possible improvement. Left: finger post in poor condition adjacent to the old school. Right: the footpaths with which this sign in the plantation south of Frogmore is associated seem to have disappeared.
