## **Policy Group – 21 June 2017**

### **Purbeck District Conservation Areas review**

# **Morden Conservation Area Appraisal document**

## **Appraisal document**

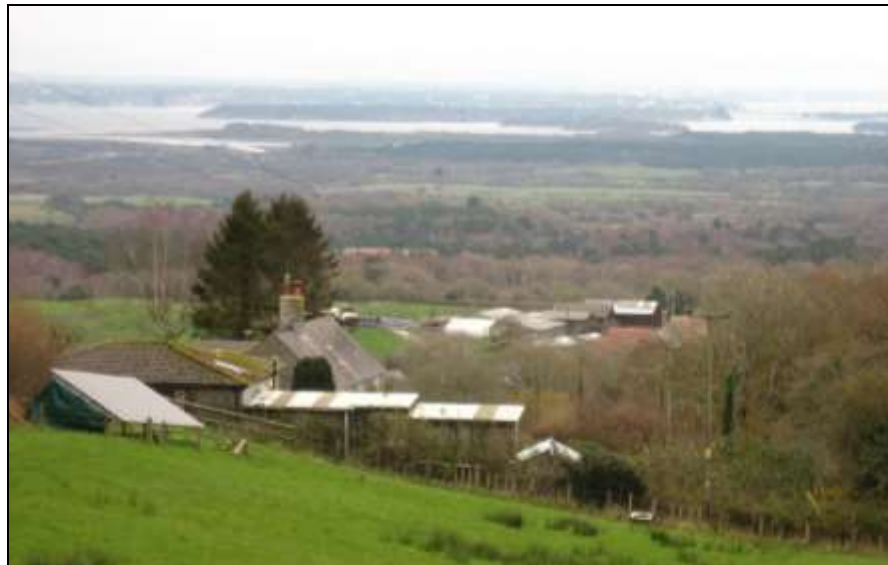
**FIG. 1:** *View to the east. As the land rises, Poole harbour dominates the view. The scene is compromised by modern structures at East Creech Farm and Creech Barrow Cottage. Sheet roofing materials are conspicuous.*

39. Views out of the conservation area towards Poole Harbour and Creech Barrow Hill are notable, particularly on a clear day (see FIG. 1 and 7).

40. Views into the conservation area from higher ground to the north west, west and south west are however not wholly positive (see FIG. 1). These are dominated by the bulky modern agricultural buildings to the rear of East Creech Farm and flat roofed structures at Creech barrow Cottage. These compromise rather than lend interest to the broader landscape panorama.
41. The duck pond (see FIG. 16) has a picturesque quality, though views around it are currently compromised by derelict structures, signage and poor quality surfaces.

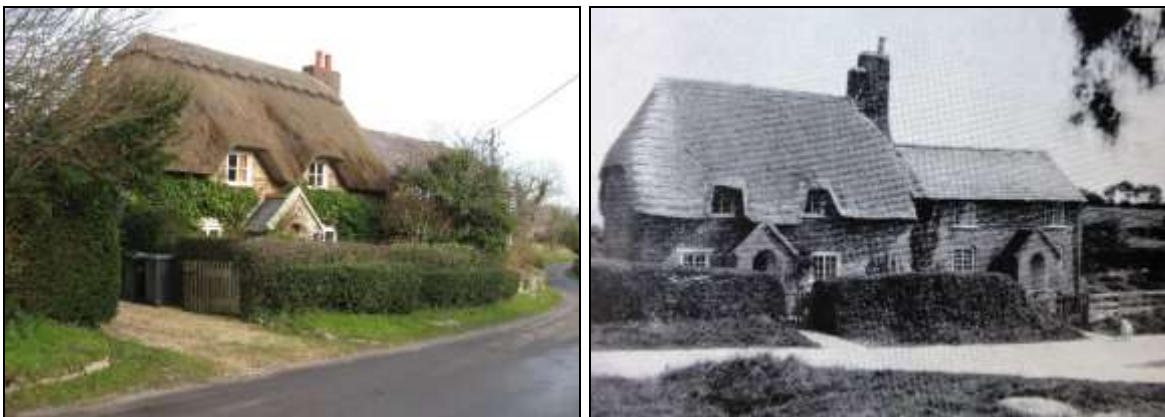
**FIG. 2:** *Rockley Cottage. This is one of the oldest cottages in the hamlet and retains a thatched roof. Dramatic changes in the appearance of the roof have however arisen from replacement of the historic covering as seen by comparing a modern view with one included in the RCHM survey of 1970. The block ridge is a modern feature not typical of the local tradition.*

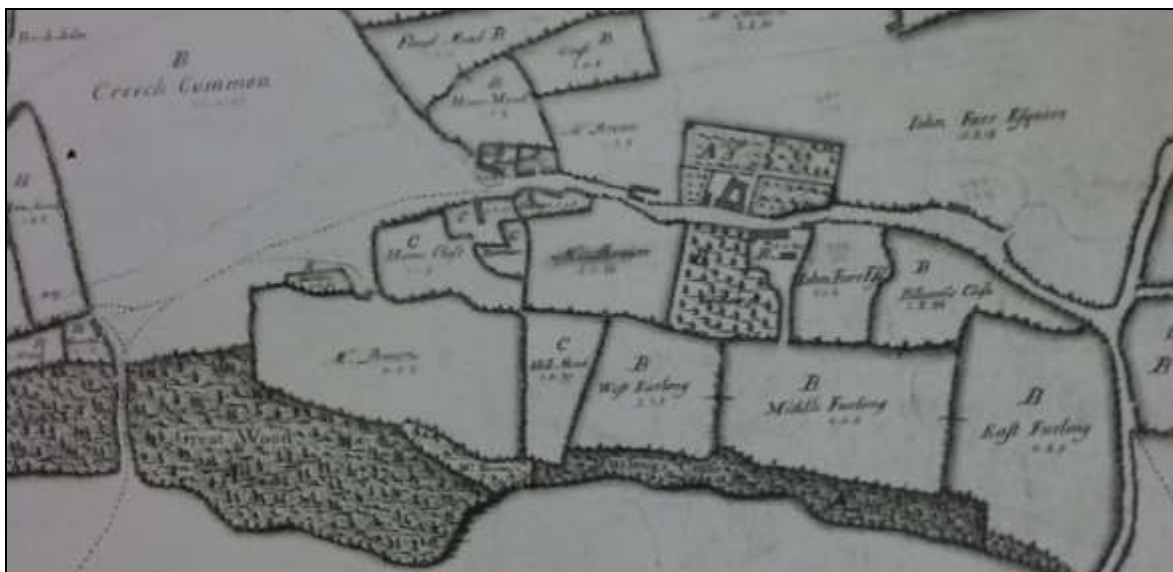
**FIG. 3:** Excerpt from John Sparrow's 1768 Map. Note the plan form and enclosed gardens of East Creech Farm. Other buildings shown include Rockley and Keeper's Cottage. The 'brick kiln' is labelled in the top left hand corner on the edge of Creech Common. Courtesy of Dorset History Centre (Photocopy 16).

19. Most interesting on the 1768 plan is the depiction of East Creech Farm, which at that time could have been considered the 'manor house'. It is indeed labelled 'manshun' (sic) on the plan. This is shown as a large building arranged around a central courtyard, enclosed within a large walled garden/orchard, with a further walled orchard opposite. Fragments of the orchard wall survive on the road frontage opposite the house, and the boundary of that which enclosed the house still appears distinct on post-war maps, though they appear to have been subsequently erased by modern agricultural buildings and access tracks. The house underwent significant remodelling at some point during the eighteenth century, as is clearly seen comparing the east and west ranges (see cover and FIG. 10), however it is unclear whether this was before or after 1768. Either way, reference to the 1768 map indicates that the current property occupies a different footprint and that three of the four ranges of buildings enclosing the central courtyard shown at that time were subsequently demolished.

20. The 1768 map (see FIG. 3 above) provides evidence of early industrialisation with a brick kiln shown to the north of Keepers Cottage at the edge of what was then common land. FIG. 10 shows the brickworks as it existed in 1888.
21. The route across the common between Rockley and Keeper's Cottage is shown as no more than a track on old maps. The current road indeed only appears to have been formalised during the early twentieth century, helping to explain its lack of enclosure with hedging and the 'open' character of the setting (see FIG. 8). A second, now apparently disused route ran across the common via the brickworks. An enclosed remnant of this route survives opposite Creech Barrow Cottage. This may have fallen out of use with closure of the brickworks, though the 1926 Ordnance Survey map (see FIG. 4) seems to suggest it was also partially blocked

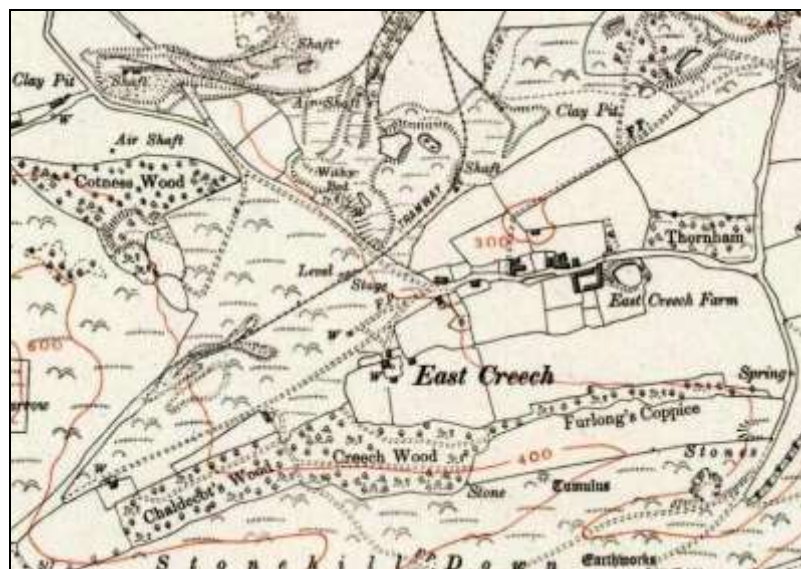
**FIG. 4:** 1926 Ordnance Survey map. The map shows the tramway running across the common and industrialised setting at this time. The brickworks had ceased operation some time after 1900. Contrast with FIG. 10 showing the scene in 1888. A number of the footpaths shown on this map are no longer in use. Reproduced with the permission of the National Library of Scotland.

24. The immediate context of the hamlet saw extensive industrialisation during the nineteenth and early twentieth centuries. Whilst the brickworks remained in operation until the early 1900s, clay mining radically altered the landscape. Whilst 'clay pits' are recorded at Thornhams in 1843, by 1926 pits had been opened immediately to the north and north west of the hamlet, and a tramway had been run across the common (see FIG. 4 below). The latter was part of an extensive network of narrow gauge railway lines serving the mines and here seems to have been used to tip excavated material. The line appears to have been short lived as it is not shown on the 1936 Ordnance Survey map. The route of the former line is today occupied by scrubby woodland.

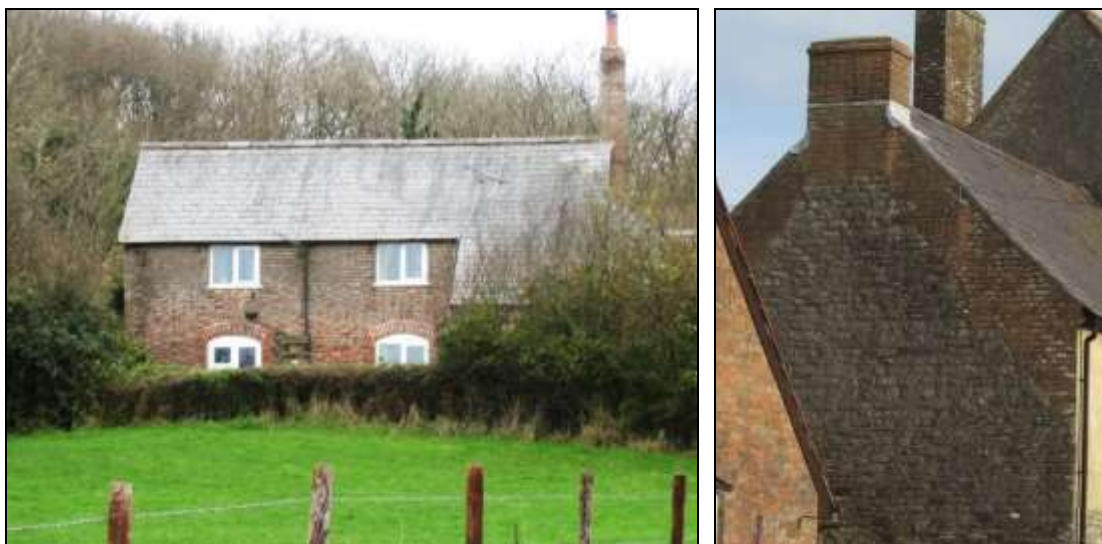
**FIG. 5:** *Increases in height. Both Keeper's Cottage (left) and the west side of East Creech Farm (right) show signs of a historic increase in height. At Keeper's Cottage the band of brickwork at first floor level is a different colour to that below, whilst brick has similarly been added above stone at the farmhouse. Each carries a slate roof though given the age of the buildings the original coverings would have been different. Keeper's Cottage may have originally been a single storey thatched dwelling.*

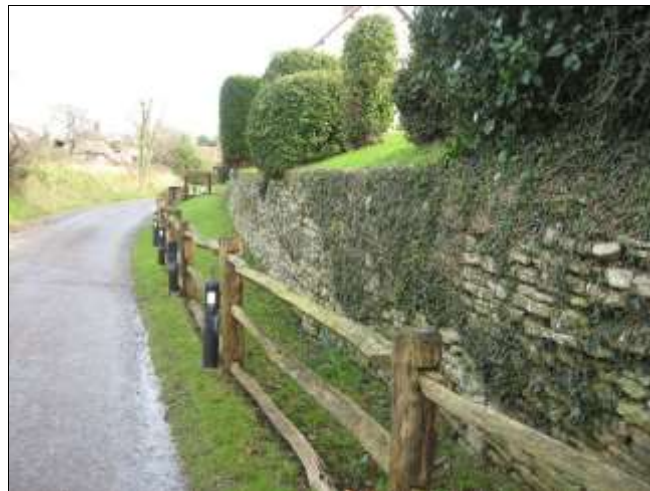
**FIG. 6:** Means of enclosure. Split post and rail fencing is a feature of the west half of the hamlet. Where used in conjunction with other boundary treatments it can sometimes create clutter. The view above shows the stone retaining wall and verge at the front of Fuchsia Cottage.

38. Split post and rail fencing is popular, though its use in the west half of the settlement appears to be more a modern ornamental than traditional feature. Where this has been introduced forward of, or on top of a pre-existing boundary treatment this introduces an element of clutter to the view.

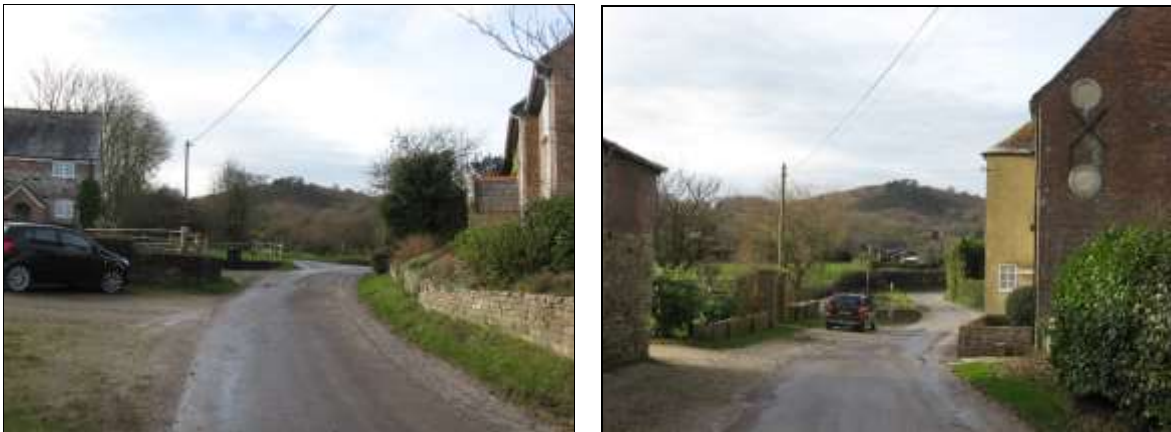
**FIG. 7:** Creech Barrow Hill. The hill is a prominent feature travelling east through the hamlet, and takes centre view at a number of points.

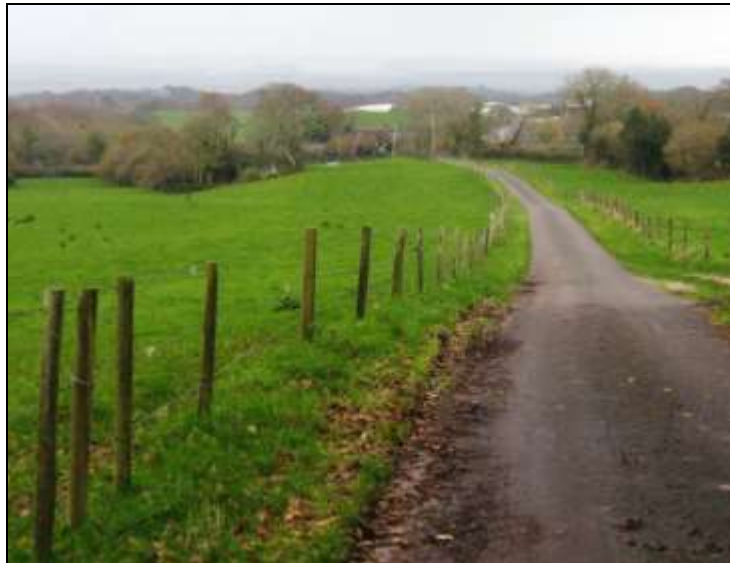
**FIG. 8:** *The old common. A sense of openness remains despite the fencing. The road here was only formalised during the twentieth century, and was previously a track which meandered across the common. Woodland helps to define and shape the space either side of this view.*

45. Agricultural land around the hamlet provides the principal open space, whose openness is further accentuated by transparent boundary treatments (e.g. post and wire fencing). This is most noticeable travelling towards the hamlet from Creech Barrow Hill across the old common given that the road stands at the same level and appears to merge with the fields on either side (see FIG. 8 below).

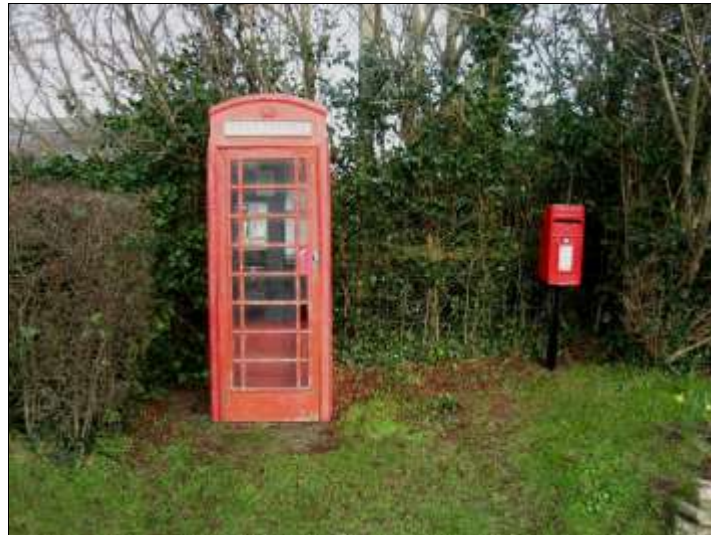
**FIG. 9:** *Street furniture. The telephone kiosk would benefit from repainting.*

47. The conservation area contains a red K6 telephone kiosk adjacent to which is positioned a square topped Royal Mail post box (FIG. 9 below). The telephone kiosk is a 'jubilee' model (date range 1935-52), identified by use of the Tudor crown. It appears little used, the interior filled with cobwebs. Externally the paintwork is in poor condition. The post box is post-1952 date.
48. A traditional finger post stands at the Furzebrook Road junction at the east end of the hamlet. This retains its distinctive roundel. The finger post has clearly been refurbished, and whilst in good condition, has lost its original cast lettering.

- *K6 telephone kiosk*: (FIG. 9) a ‘jubilee’ model K6 telephone kiosk (installed 1935-1952).
- *East Creech finger post*: a distinctive piece of street furniture, particularly given retention of its unique roundel. It is a shame that the original cast lettering on the fingers has been lost in refurbishment.
- *Little Cottage*: (FIG. 15) despite being almost encircled by extensions the external form and character of this diminutive historic vernacular cottage remains appreciable.

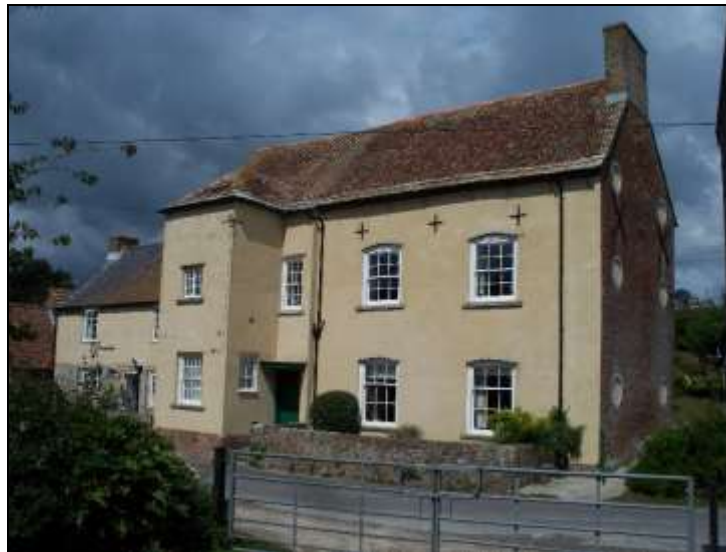
**FIG. 10:** *East Creech Farmhouse. The west half of the building (also see cover photo) is dated to the seventeenth century and has clearly been increased in height, whilst the east range appears to have been more substantially remodelled at some point during the eighteenth century. The two storey porch is an interesting feature. An imposing building generally, the house has a mixed style*

52. The conservation area contains a number of cottages which demonstrate traditional, pre-industrial local vernacular style (see FIG. 2, 13 and 15). These vary in the extent to which they have been subsequently altered or embellished, but are typically characterised by their use of basic and immediately available building materials (cob and thatch), employing details but within formats lacking any standardisation in composition. Later cottages and contemporary remodelling of earlier buildings show greater formality in composition though again lack consistent or discernible style. A lack of formal style is again evident at East Creech Farm which is surprising for a building of its status and age. The eccentric arrangement of the eighteenth century wing in particular recalls seventeenth century and earlier designs found elsewhere in the District (see FIG. 10 below and cover photo).

61. East Creech Farm sees combination of plain clay tiles with an easing course of stone tiles at the eaves (see FIG. 10 and cover). This style of roofing appears to have been a popular around the District during the late eighteenth century, most typically for larger houses. The use of stone tiles at the eaves helped to shed rainwater clear of the eaves in the absence of gutters. Prior to its unsympathetic conversion, a more unusual combination of Welsh slate with stone tiles was a feature of the small agricultural building east of the barn (see FIG. 14 below). As this building is shown in the map of 1768 it seems probable that slate itself was not the original covering.

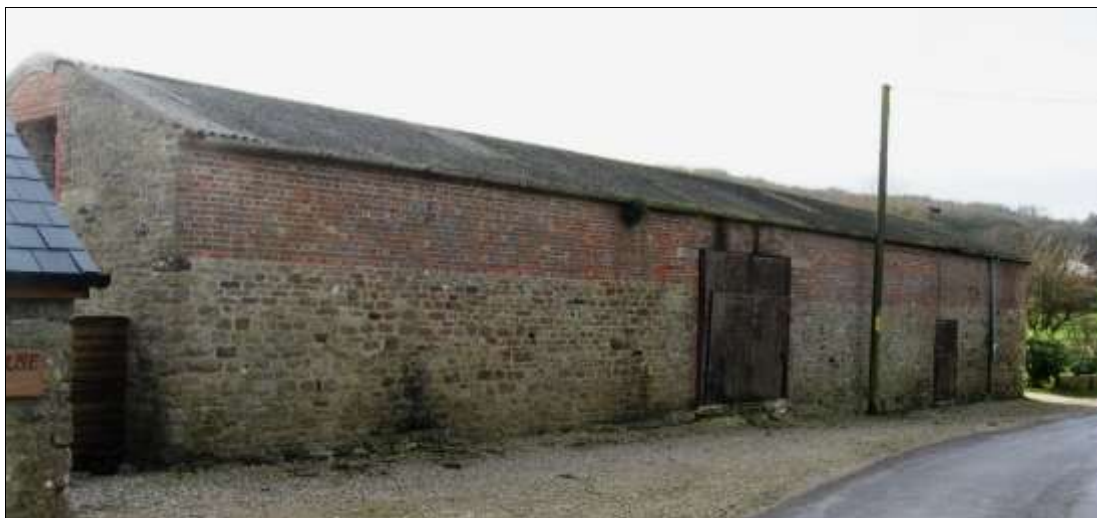
**FIG. 11: Stonework.** *The barn opposite East Creech Farm features a mixture of limestone and heathstone rubble. The walls have been raised in brick. The building was heavily altered during the twentieth century and is compromised by the sheet roof and poorly formed entrance.*

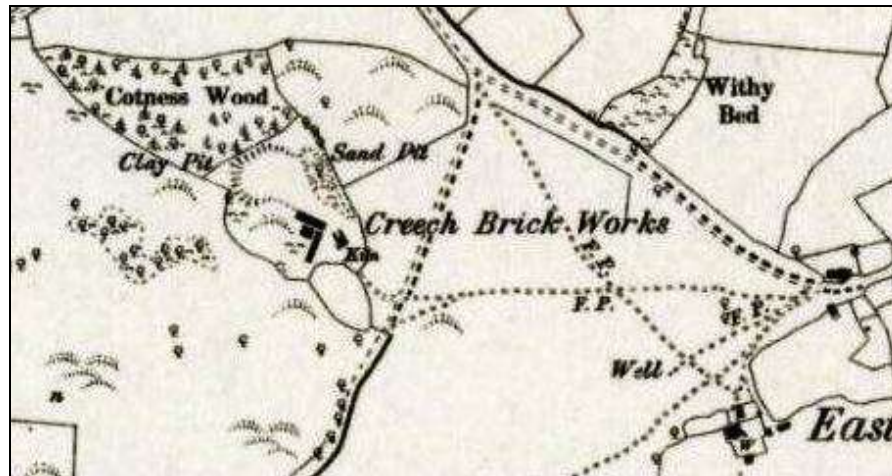
**FIG. 12:** Creech Brickworks. As shown on the 1888 Ordnance Survey map. Reproduced with the permission of the National Library of Scotland.

55. A range of different clays suitable for brick making (and indeed historically used for this purpose in the broader region) are available within the immediate vicinity of the hamlet. Creech Brickworks (see FIG. 12 below) operated adjacent to the common from at least the mid-eighteenth century into the early twentieth, using clay dug on-site. This was from a localised source known as the Creech Brick Clay Member, a deposit which occurs within the Branksome Sand Formation. It is reasonable to assume that at least some of the brick within the hamlet dated to the period was produced at the works, though the variation seen would suggest that at least some came from outside. The colour of brick around the hamlet ranges between buff and pale red, with some darker reds and decorative use of 'flared' (burned) or glazed brick seen. Far greater and not always complimentary variation is shown in the colour of modern brickwork.

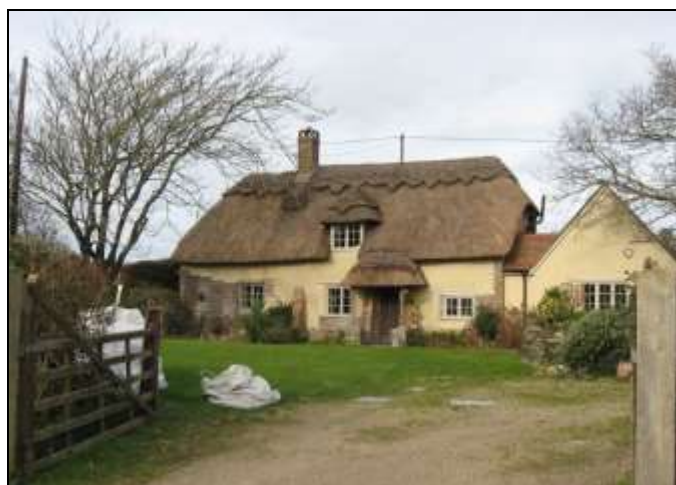
**FIG. 13:** *Wren Cottage. The original part of the structure stands at the centre. The elaborate block ridge is not a traditional feature.*

32. Several buildings show clear external signs of having been raised in height historically (see FIG. 5). These include the west side of East Creech Farmhouse, Keeper's Cottage, Jubilee Cottage, the older western half of Fuchsia Cottage and perhaps also the barn opposite East Creech Farm (which was otherwise heavily altered during the twentieth century). Buildings which appear to remain at their original height include the diminutive Little Cottage, whose low one and a half storey form remains discernible despite being encircled by modern extensions, and the core of Wren Cottage (see FIG. 13 and 15).

60. Use of thatch is characteristic of vernacular construction, and survives on a number of cottages. It is likely that the frequency of thatched buildings was greater historically, but that this was replaced as buildings were enlarged during the nineteenth century, typically by slate. Rockley and Wren Cottage carry ornamental block ridges on their roofs (see Fig. 2 and 13). Raised ridges are not typical of traditional thatching style in Dorset, and undermine local distinctiveness. Fortunately they can simply be eliminated during the regular cycle of maintenance. Little Cottage retains a traditional flush ridge (see FIG. 15).

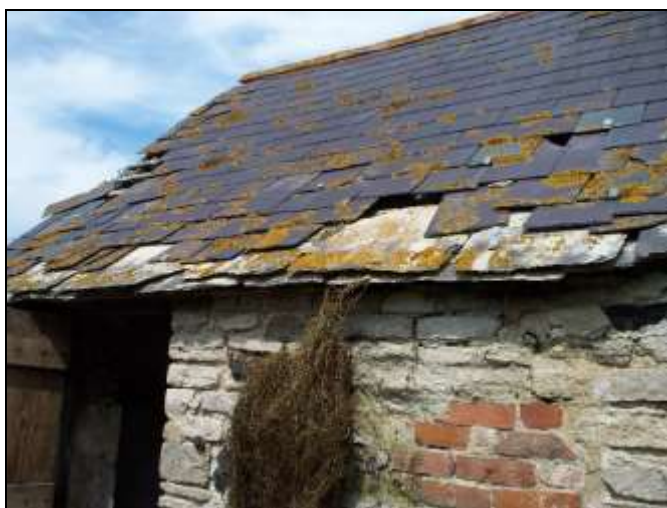
**FIG. 14:** *Stone eaves course. This photo captures a detail recently lost in the poorly handled conversion of an agricultural building opposite East Creech Farm. The detail can still be viewed in combination with clay tiles on the farmhouse itself.*

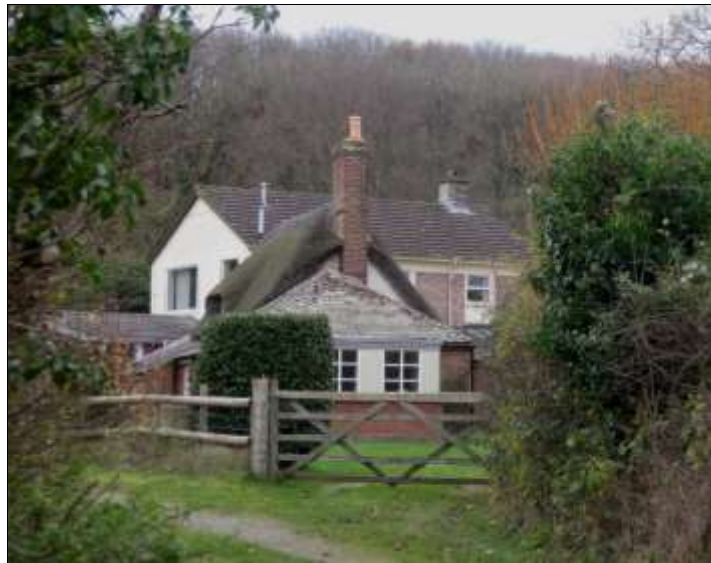
**FIG. 15:** *Little Cottage. The cottage is viewed with Squire’s farmhouse in the background. The form remains distinct though much extended. Squire’s farmhouse has clearly undergone extensive modification.*

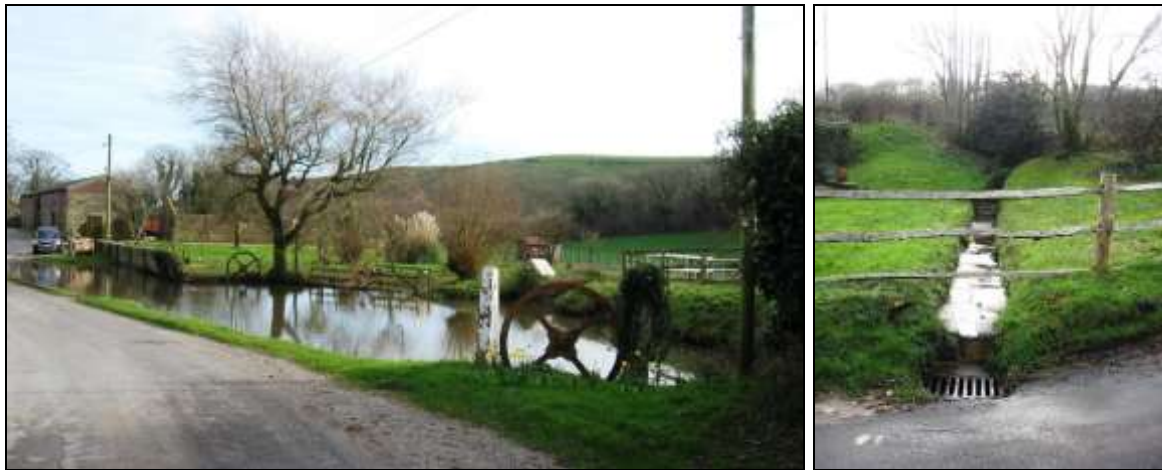
**FIG. 16:** *Duck Pond and stream. The pond (left) forms an attractive roadside feature passing through the hamlet, though its position makes it vulnerable to pollution from vehicles. The watercourse (right) is visible adjacent to Jubilee Cottage.*

71. The watercourse and ponds within the hamlet add to this diversity as well as contributing to the attractiveness and interest of the street scene (FIG. 16 below).

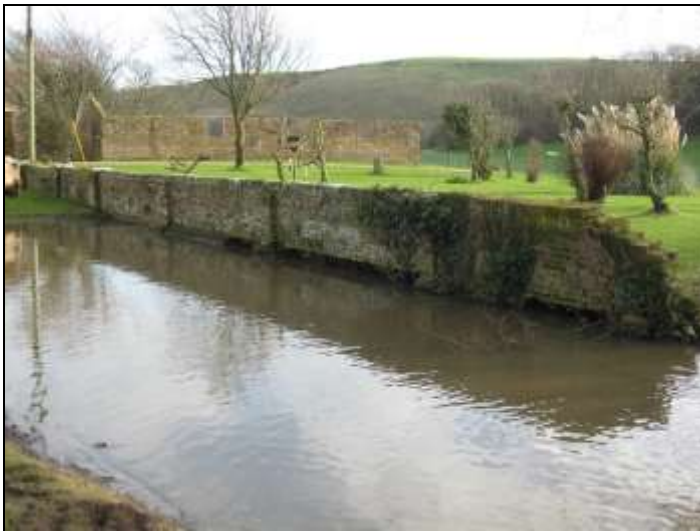
**FIG. 17:** Garden wall opposite East Creech Farm. The brickwork is in poor condition, being damaged by ivy and leaning in places.
