## **Policy Group – 22 November 2017**

### **East Creech Conservation Area review**

**3 - Draft East Creech Conservation Area Appraisal**

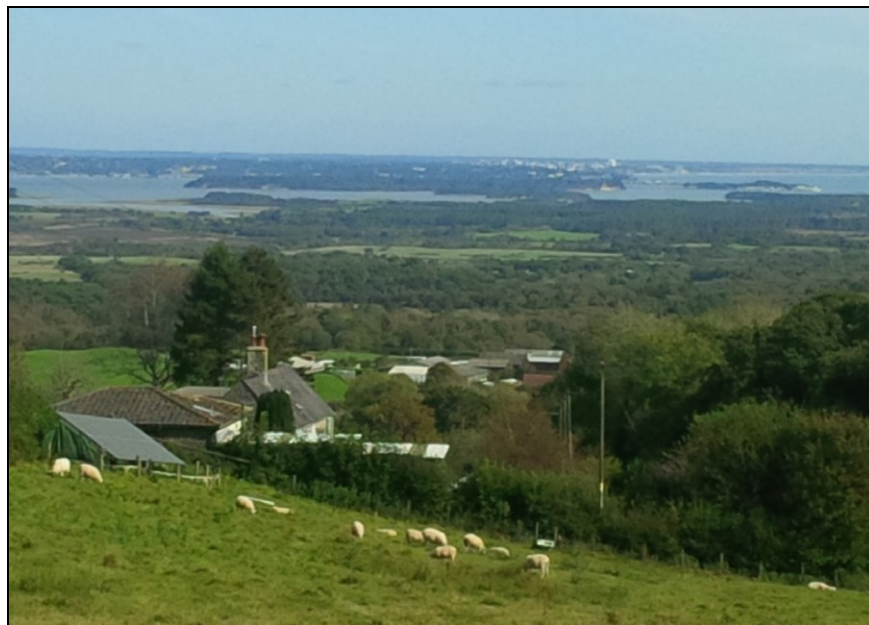
**FIG. 1:** *View to the east. As the land rises, Poole Harbour, Brownsea Island and the settlements beyond dominate the view. The foreground is compromised by modern structures at East Creech Farm and Creech Barrow Cottage where sheet roofing materials are conspicuous. It is surprising that no past attempt has been made at camouflage.*

35. Cottages of one and a half or two storeys make up the majority of dwellings in the conservation area. These generally appear 'modest' in terms of mass.
36. The eastern range of East Creech Farmhouse consists of two full storeys with attic rooms, and is, relative to other domestic buildings in the conservation area, exceptional in terms of its height (see FIG. 7). This chiefly reflects the historic status of the building, which though slightly archaic in style, has the considerable floor to ceiling heights typical of higher class houses of the eighteenth century. Bulky modern agricultural buildings to the rear of the farm house reach the greatest size given the large area they cover, and these are clearly visible and somewhat obtrusive components of the view over a long distance (see FIG. 1).

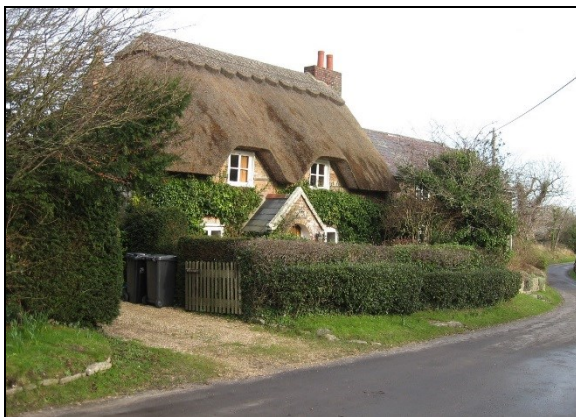
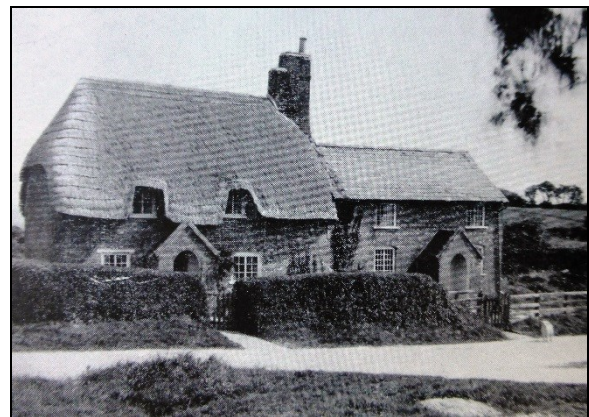
**FIG. 2:** *Rockley Cottage. One of the oldest cottages in the hamlet. Dramatic changes in the appearance of the roof have arisen from replacement of the historic covering as seen by comparing a modern view with one included in the RCHM survey of 1970. The block ridge is a modern feature not typical of the local tradition.*

20. Rockley Cottage (FIG. 2 below) and the western range of East Creech Farmhouse (see cover) have been dated to the seventeenth century. A further cottage of seventeenth century origin (described by the 1970 RCHM survey) stood to the front of Wren Cottage as late as the 1960s, though had been demolished by the 1980s.

45. Some of the cottages within the conservation area were originally constructed using cob. Use shows a clear differentiation in the status of construction relative to the contemporary western range of East Creech Farm, which was constructed in stone (see cover photo). The clay content of the surrounding soils combined with the ready availability of chalk is particularly favourable for cob construction. Rendered cob remains visible at Wren Cottage (see FIG. 10), where use apparently post-dates the brickworks, though at Rockley (see FIG. 2) the walls have been faced in brick.

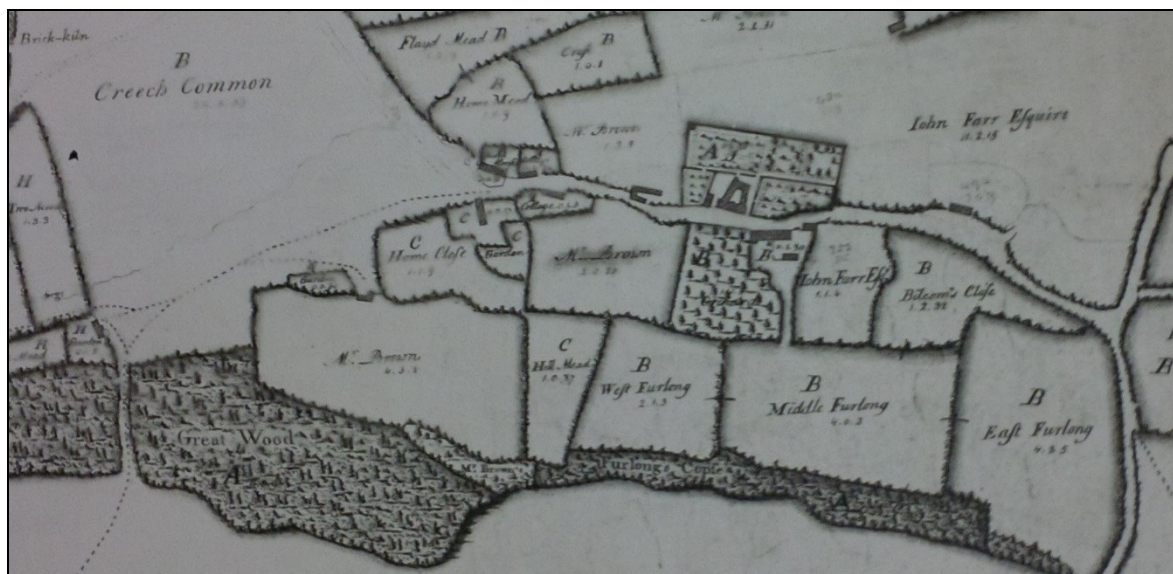
**FIG. 3:** Excerpt from John Sparrow's 1768 Map. Note the plan form and enclosed gardens of East Creech Farm. Other buildings shown include Rockley and Keeper's Cottage. The 'brick kiln' is labelled in the top left hand corner on the edge of Creech Common. Courtesy of Dorset History Centre (Photocopy 16).

23. The 1768 map (see FIG. 3 above) provides evidence of early industrialisation with a brick kiln shown to the north of Keepers Cottage at the edge of what was then common land. FIG. 9 shows the brickworks as it existed in 1888.

65. The 1768 map of the manor (see FIG. 3) shows a large orchard opposite East Creech Farmhouse and further orchards in the walled gardens enclosing it. These orchards do not appear to have survived the nineteenth century, though the semi-domestic character of the open space opposite the farmhouse seems to reflect its former presence. More recently a small orchard has been established adjacent to Rockley.
66. Agricultural land around the hamlet provides a largely open setting for the buildings within it. Openness is accentuated in places by transparent boundary treatments (e.g. post and wire or post and rail fencing). This is most noticeable travelling towards the hamlet from Creech Barrow Hill across the old common (see FIG. 13 below), and is also a feature south of the duck pond (see FIG. 14 below).

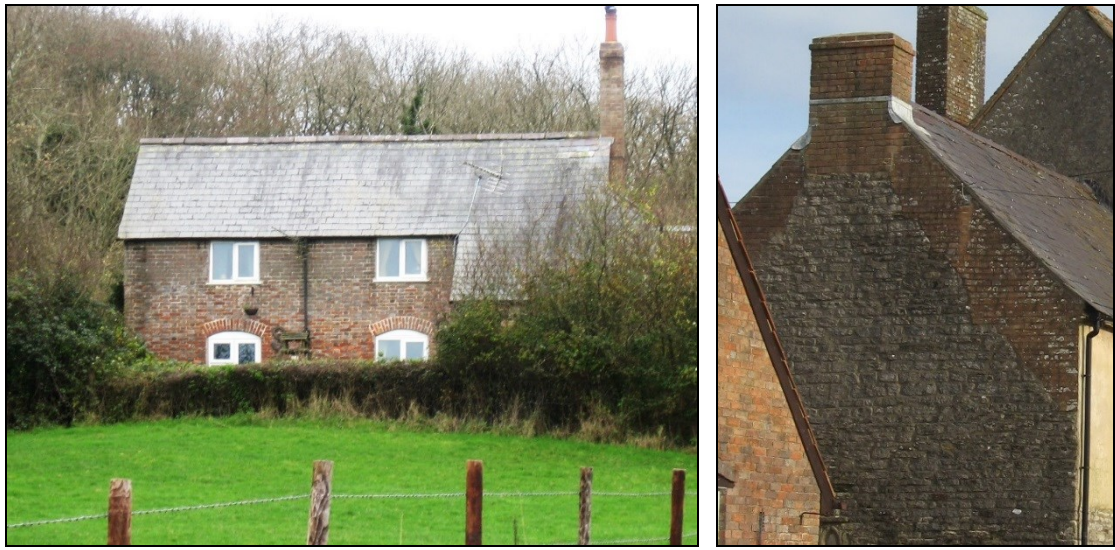
**FIG. 5:** *Increases in height. Both Keeper's Cottage (left) and the west side of East Creech Farm (right) show signs of a historic increase in height. At Keeper's Cottage the band of brickwork at first floor level is a different colour to that below, whilst brick has similarly been added above stone at the farmhouse. Each carries a slate roof though given the age of the buildings the original coverings would have been different. Keeper's Cottage may have originally been a single storey thatched dwelling.*

37. Several buildings show external evidence for historic increases in height. In residential buildings this is typically associated with historic addition or enlargement of upper storeys (see FIG. 5). This is suggested by changes in construction visible on the west gable of East Creech Farmhouse, front elevations of Keeper's Cottage and Jubilee Cottage and in the western half of Fuchsia Cottage. Buildings which appear to remain at their original height include the diminutive Little Cottage, whose low one and a half storey form remains discernible despite being encircled by modern extensions, and the core of Wren Cottage (see FIGs. 10 and 16).

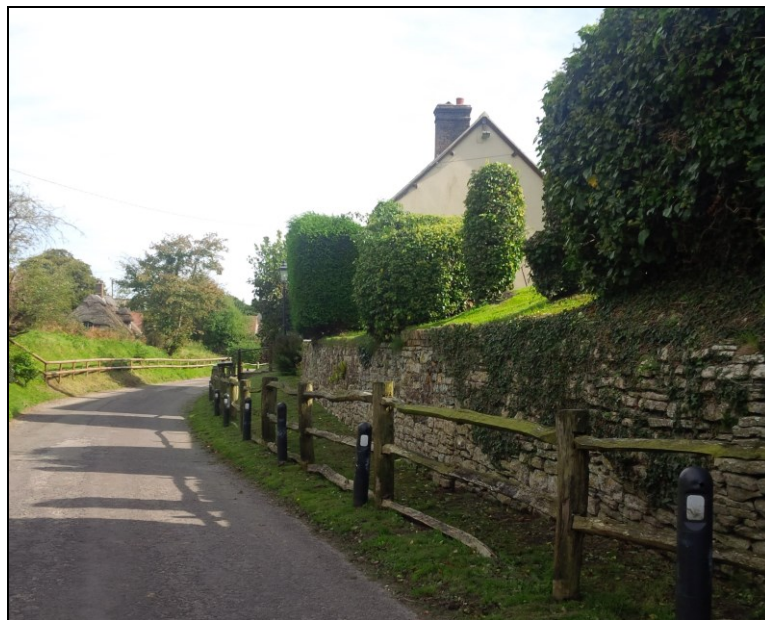
**FIG. 6:** Means of enclosure. Split post and rail fencing is a feature of the west half of the hamlet. Where used in conjunction with other boundary treatments it can sometimes create clutter. The view above shows the stone retaining wall and verge at the front of Fuchsia Cottage along which reflective bollards are also positioned.

42. Split post and rail fencing frequent, though its current use in the west half of the settlement often appears ornamental. Where this has been introduced forward of, or on top of a pre-existing boundary treatment this introduces an element of clutter to the view.

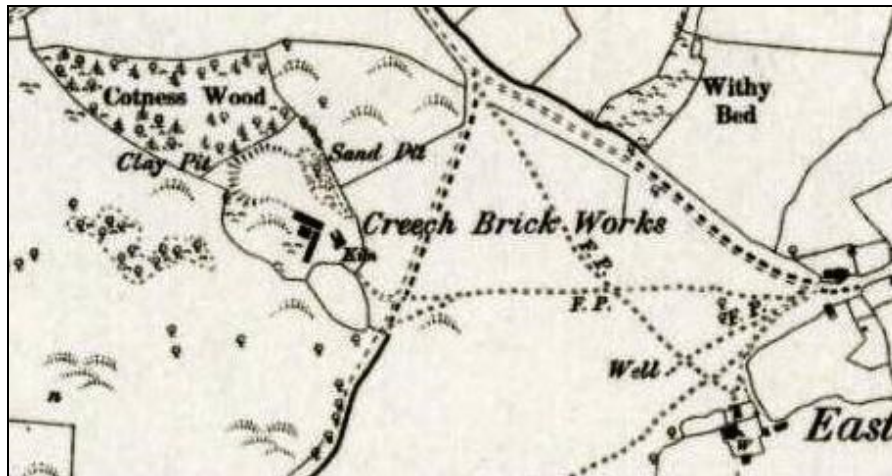
**FIG. 9:** Creech Brickworks. As shown on the 1888 Ordnance Survey map. Reproduced with the permission of the National Library of Scotland. Note old footpaths which appear to have been distinguished when a tramway was later built across the common, and the informal character of the roads.

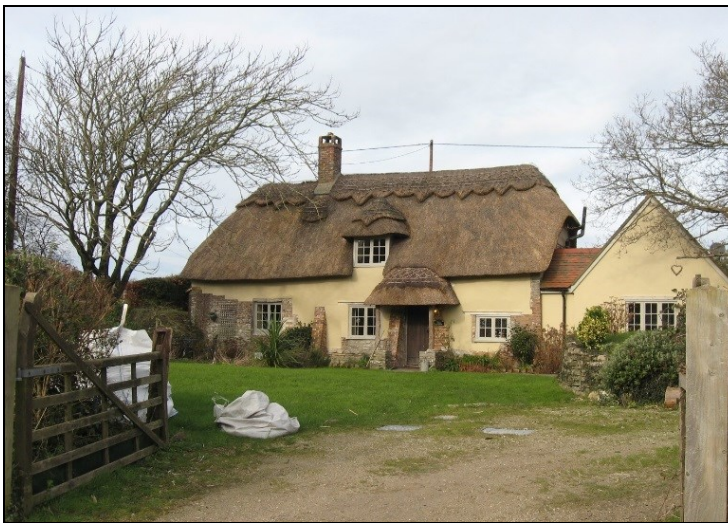
**FIG. 10:** *Wren Cottage. The original part of the structure stands at the centre. The elaborate block ridge is not a traditional feature.*

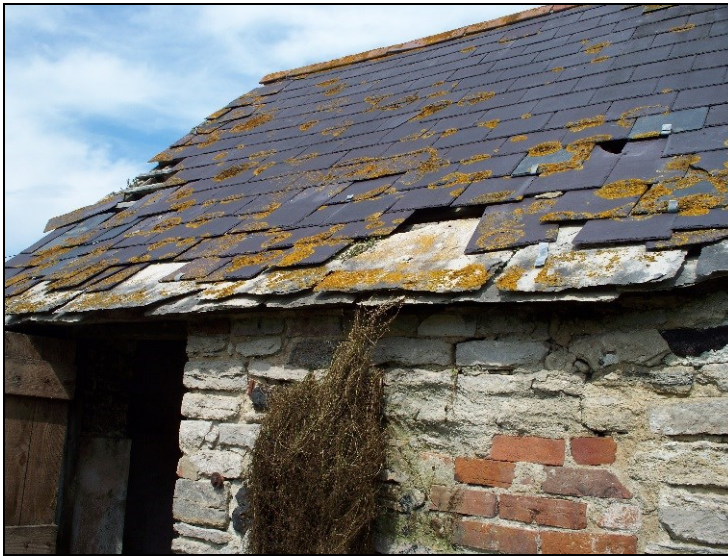
**FIG. 11:** *Welsh slate and stone eaves course. This photo captures roofing materials and details recently lost in the poorly handled conversion of the small agricultural building opposite East Creech Farm. The detail can still be viewed in combination with clay tiles on the farmhouse itself. Note the wall shown here has also been insensitively rebuilt.*

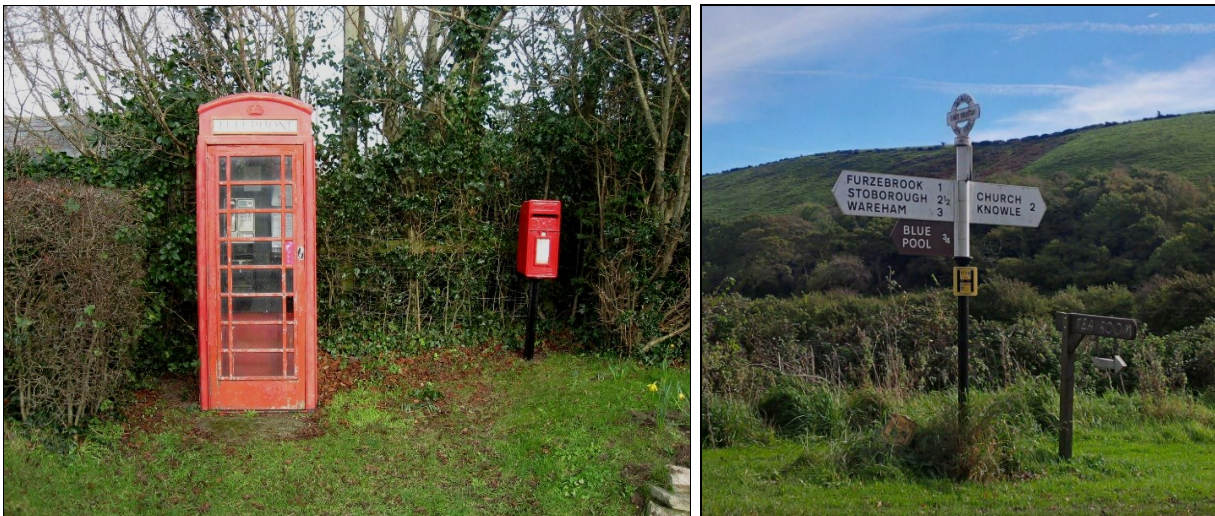
**FIG. 12:** Street furniture. Left: red telephone kiosk adjacent to Rockley. Right: finger post at the east end of the hamlet.

60. The conservation area contains a red K6 telephone kiosk adjacent to which is positioned a square topped Royal Mail post box (FIG. 12 below). The telephone kiosk is a 'jubilee' model (date range 1935-52), identified by use of the Tudor crown. It appears little used, the interior filled with cobwebs. Externally the paintwork is in poor condition. The post box is post-1952 date.
61. A traditional finger post stands at the Furzebrook Road junction at the east end of the hamlet (FIG. 12 below). This retains its distinctive roundel. The finger post has clearly been refurbished, and whilst in good condition, has lost its original cast lettering.

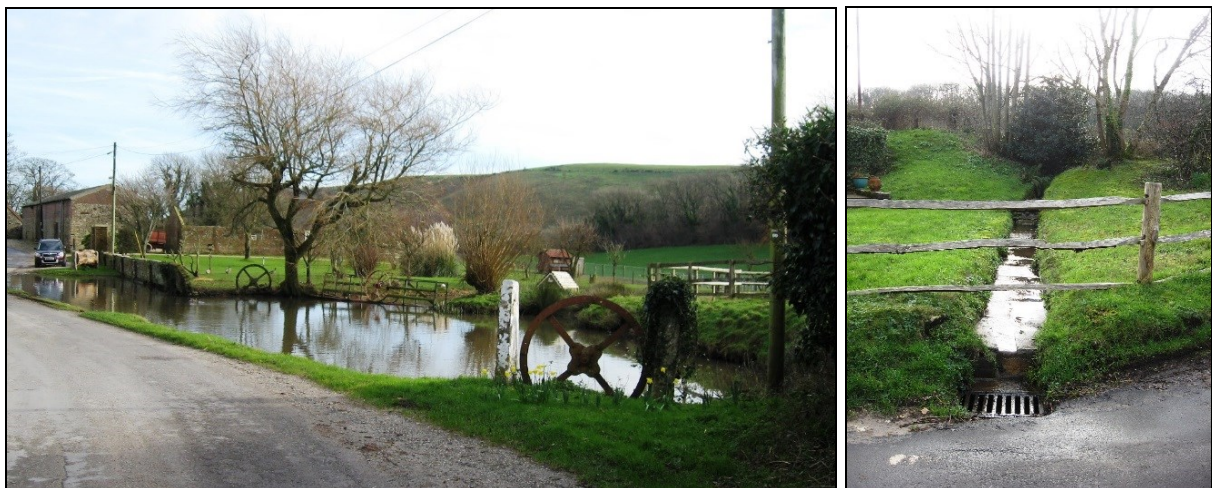
**FIG. 14:** *Duck Pond and stream. The pond (left) forms an attractive roadside feature passing through the hamlet, though its position makes it vulnerable to pollution from vehicles. The watercourse (right) is visible adjacent to Jubilee Cottage.*

76. The duck pond (see FIG. 14 above) has a picturesque quality, though views around it are currently compromised by derelict structures, signage and poor quality surfaces. All provide opportunities for both improvement and enhancement.

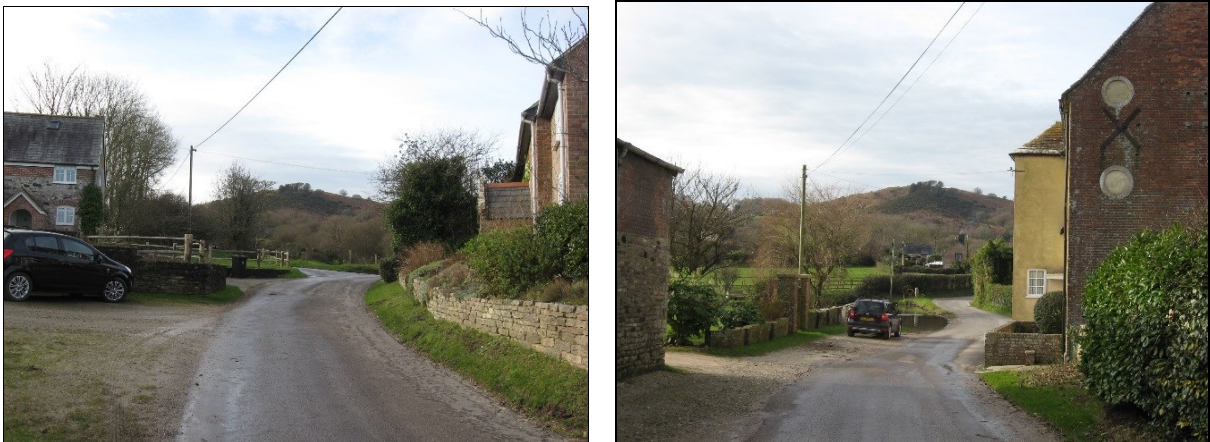
**FIG. 15:** *Creech Barrow Hill. The hill is a prominent feature travelling east through the hamlet, and takes centre view at a number of points.*

67. Creech Barrow Hill is itself clearly an important open space, albeit some trees have become established in places.
68. Woodland plays an important role in providing a southern backdrop to the settlement and southern edge to the conservation area. Chaldecot's Wood, Creech Wood and Furlong's Coppice are each classified as 'ancient' given that they have been continuously wooded since at least 1600. The 1768 estate map (see FIG. 2) shows the boundaries of these woods have remained reasonably consistent up to the present day. Names reflect past management. Most of this woodland is now a nature reserve, reflecting the rich ecological value of ancient woodland.

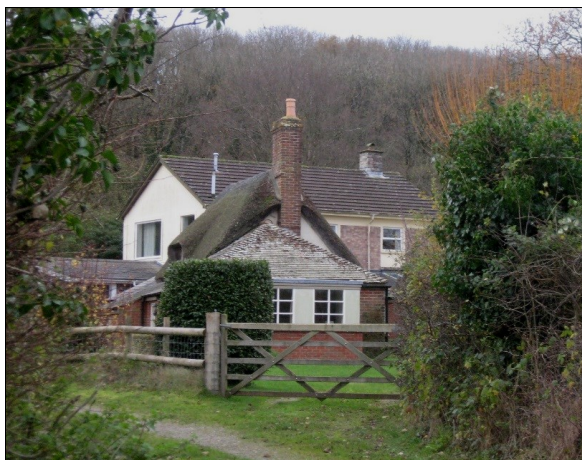
**FIG. 16:** *Little Cottage. The cottage is viewed with Squire's farmhouse in the background. The form remains distinct though much extended. Squire's farmhouse has clearly undergone extensive modification.*
