Morden Conservation Area review

Morden Conservation Area Appraisal

Edition for adoption November 2017

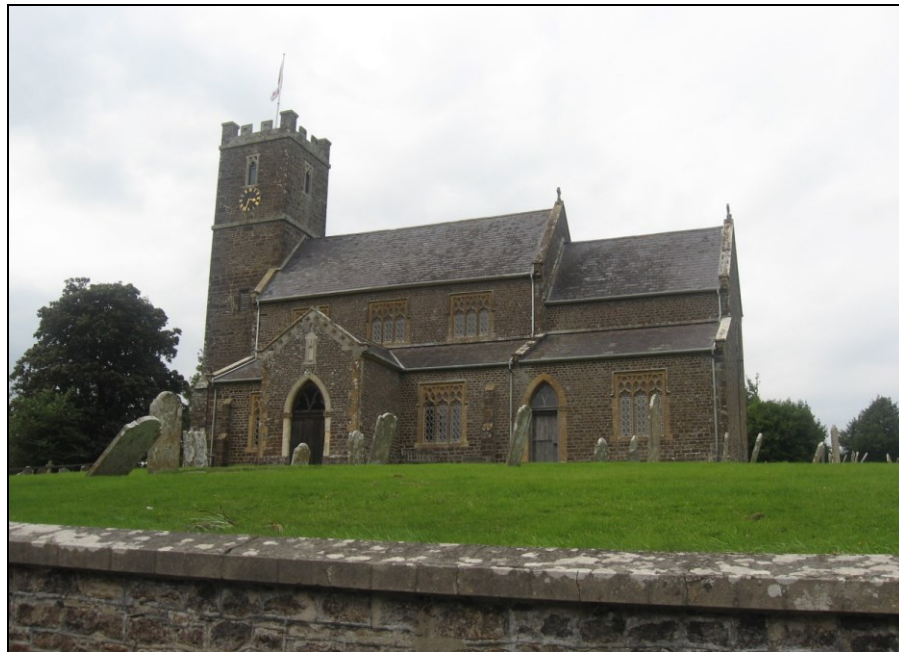
FIG. 1: *St. Mary's Church, Higher Street. A picturesque and well positioned building, the church is of particular interest as for being almost entirely constructed from heathstone. Little remains of the medieval church it replaced.*

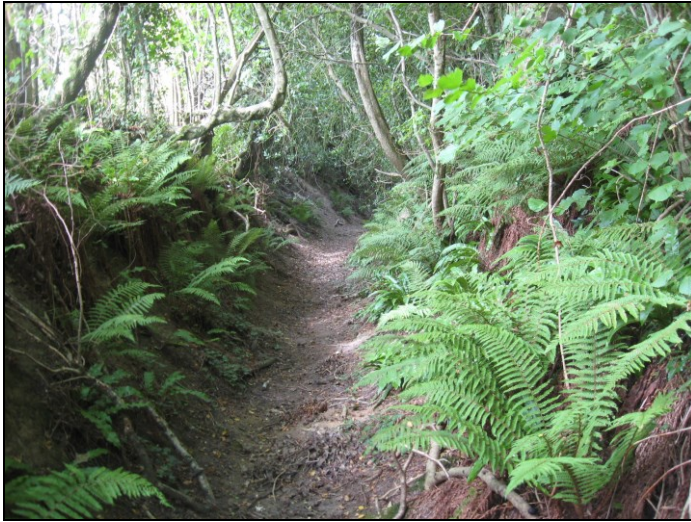
FIG. 2: *Collins's Lane. The lane is a sunken track which remains a right of way. It connects Goodwin's Lane with Lower Street.*

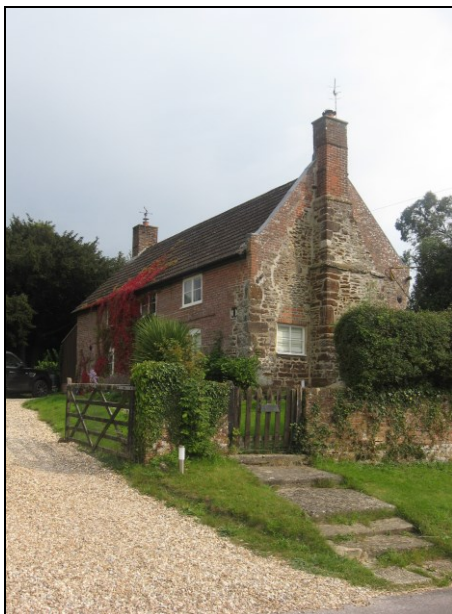
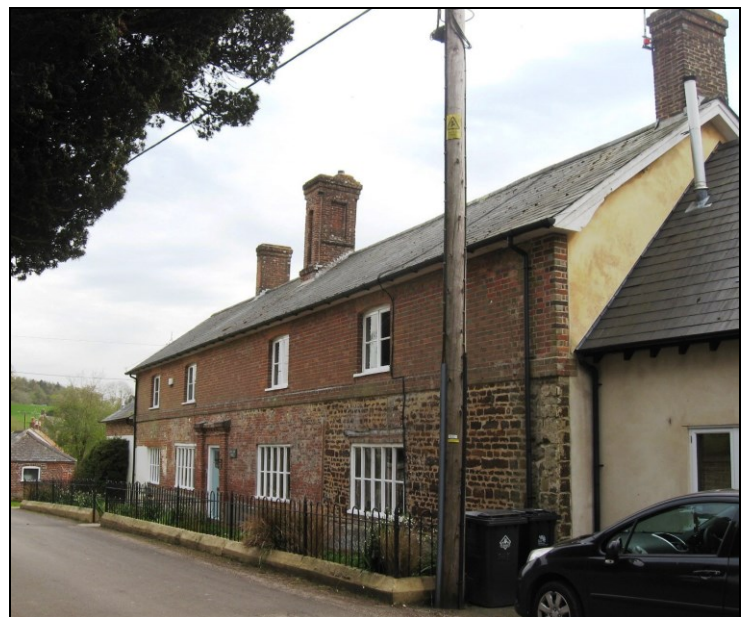
FIG. 3: *Buildings of the sixteenth and seventeenth centuries. Left: 60 Higher Street, the heathstone end gable of which is seventeenth century. Right: Home Farm a building of sixteenth century origin likewise rebuilt in the eighteenth century.*

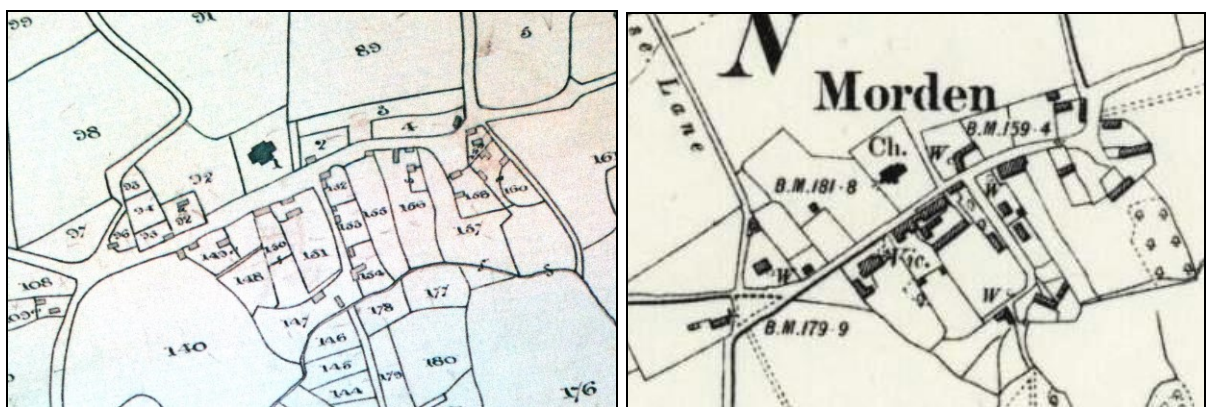
FIG. 5: Morden. Left: 1847 tithe map showing little change since the 1770s. Right: 1900 OS. Reproduced with the permission of the National Library of Scotland.

31. As referenced on old OS maps (see FIG. 5 below) 'Morden' is the principal part of the settlement centred on Higher Street.
32. As noted above, the eighteenth and nineteenth centuries saw some earlier buildings rebuilt and altered. In the cases of 60 Higher Street and Home Farmhouse (FIG. 3 above) the work is evidenced in the contrasting materials used, whilst rebuilding of the parish church employed materials to match, and substantial extension of the Old Vicarage (see FIG. 30) masked the original building. No. 76 Higher Street (FIG. 29) was an addition of the eighteenth century, and Church Villa a stylistically notable contribution of the early nineteenth century.

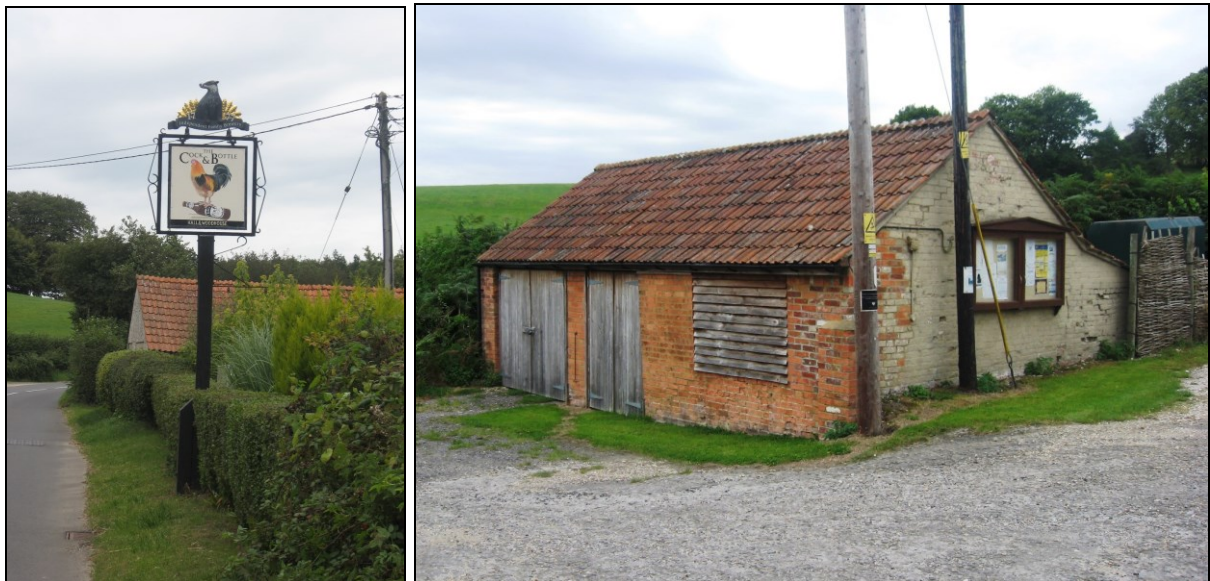
FIG. 7: *Features of interest in East Morden. Left: Cock and Bottle Inn sign. Whilst the sign itself is not particularly old, both the unusual name and image have a long history which adds interest. Right: Old smithy opposite Fire Station Cottage, now used as a store. A pound was formerly attached to the gable on which the parish notice board is now located – see FIG. 6 above for map location.*

95. Around the District generally double Roman tiles are typically found on agricultural and other functional structures, and use in this context is also seen in the conservation area. Notable examples include the old forge (see FIG. 7) and fire station in East Morden, each of which carries specially shaped ridge tiles. Single storey former agricultural structures on Higher Street are also of note for the clear glazed tiles they incorporate to admit light, and larger agricultural structures including those at Sellar's Farm, (FIG. 8), West Morden Farm, Hill Farm and to the rear of No. 60 Higher Street also carry double Roman tiles.

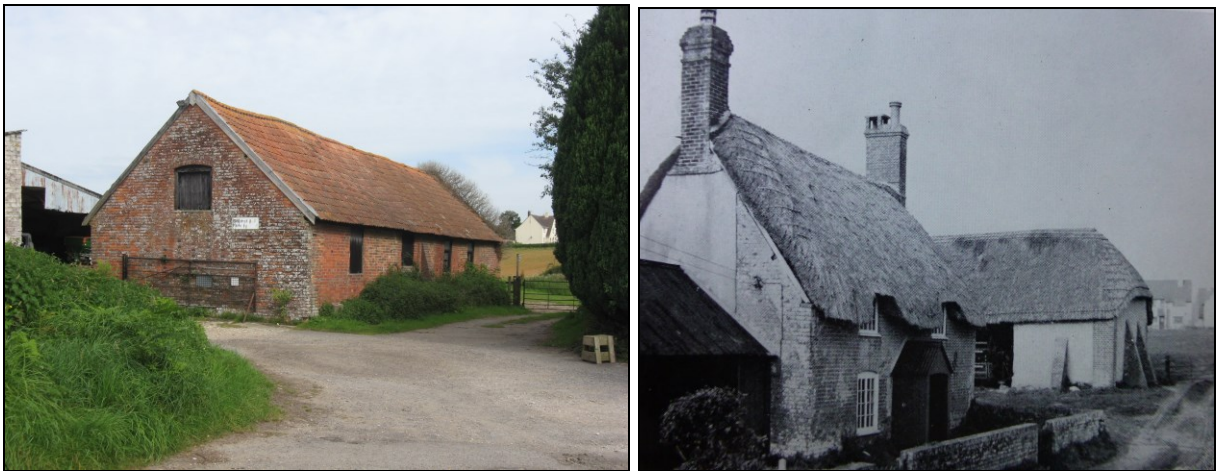
FIG. 8: *Eighteenth century farmhouse and barn. Photo (right) taken from the 1970 RCHM survey – see FIG. 6 for position shown on a map. Note modern Council houses on New Road in the background. The thatched buildings were subsequently demolished though a few related buildings (left) remain in use by Sellar's Farm.*

39. Housing development since the 1960s has seen addition of clusters of generic modern houses and bungalows. Sellar's Farmhouse is also a relatively modern addition showing greater resemblance to Sticklands than the thatched cottage which previously stood on the site (FIG. 8 above). Just off the maps shown in FIG. 6, the character and setting of Brooks Farm has been significantly gentrified.

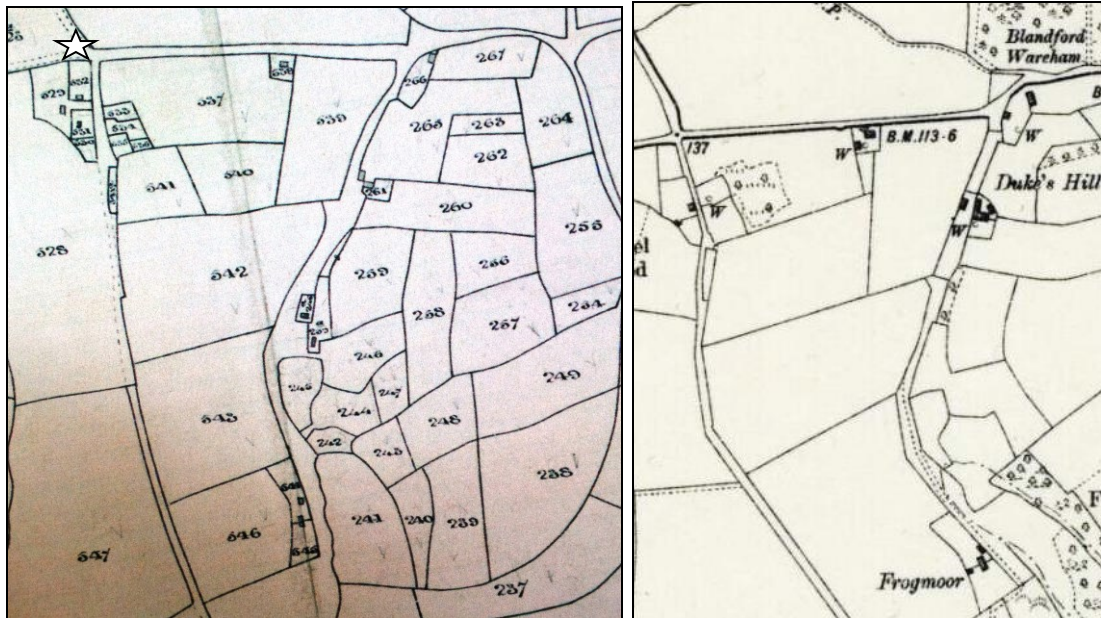
FIG. 10: *Frogmoor and Hector's Corner. Note, Hector's Corner is the junction marked with a star. Left: 1847 tithe map. Right: 1900 OS. Only three of the dwellings shown in 1847 survive. The lane running to Frogmore remains a right of way but lacks enclosure south of Frogmore Farm. Maps reproduced with the permission of the National Library of Scotland.*

41. Frogmore Farm, a building of eighteenth century date, today stands at the end of a short lane running south from Lousey Wood. Several dwellings historically stood on this lane which extended south to a pair of cottages labelled 'Frogmoor' on the 1900 OS (see FIG. 10 below). To the south of Frogmoor lay former common land, now a plantation of conifers. Two cottages located on the centre section of the lane disappeared during the second half of the nineteenth century, though the pair of eighteenth century cottages at Frogmoor, and another seventeenth century dwelling at the top of the lane survived long enough to be identified by the RCHM survey.

42. The cottages at Frogmoor and the top of the lane recorded in the 1970 survey were each subsequently demolished. The lane itself remains a right of way though is no longer fully enclosed south of Frogmore Farm. Most of the field boundaries shown in FIG. 10 no longer exist. The site of the two dwellings at Frogmore is currently a pheasant pen.

43. A cluster of three dwellings was shown at Hector's Corner in 1847 (see FIG. 10). Maps of 1760 show the cottages standing amidst common land, parts of which had only recently been enclosed at the time of the 1847 tithe. It is possible that the historic group at Hector's Corner may originally have been encroachments on the common (i.e. houses built on common land – a traditional form of squatting). Two of these cottages had vanished by 1900, but the third still survives. Other dwellings now present here are of post-war date. The green lane running south survives as an enclosed route despite extensive loss of field boundaries elsewhere, and is a historic landscape feature of particular interest.

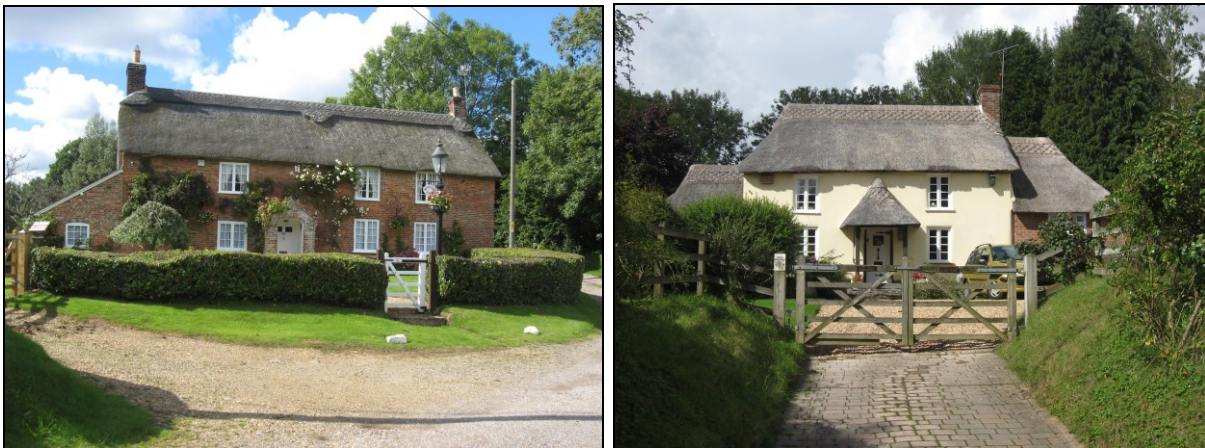
FIG. 11: *Thatched buildings at Whitefield. No 153 and Whitefield Farmhouse. Note the contrast in ridge styles – a flush ridge is the local traditional finish.*

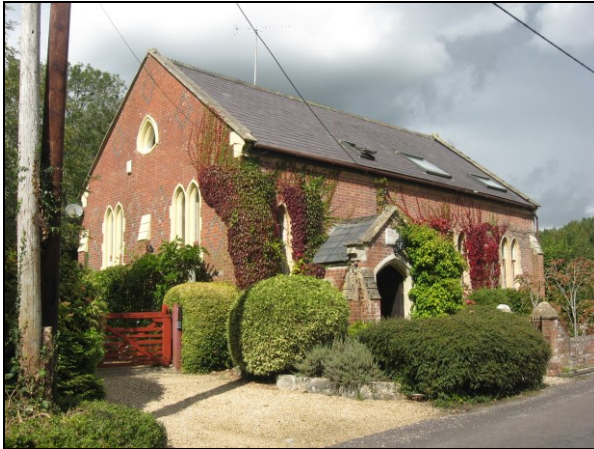
FIG. 12: *The old Methodist chapel at Whitefield. Note decorative brickwork.*

46. A number of nineteenth century additions include No. 155 and No. 49 which date between early and mid-century, and the Methodist Chapel (see FIG. 12 below). The latter was constructed in 1873 and is now a residential property.

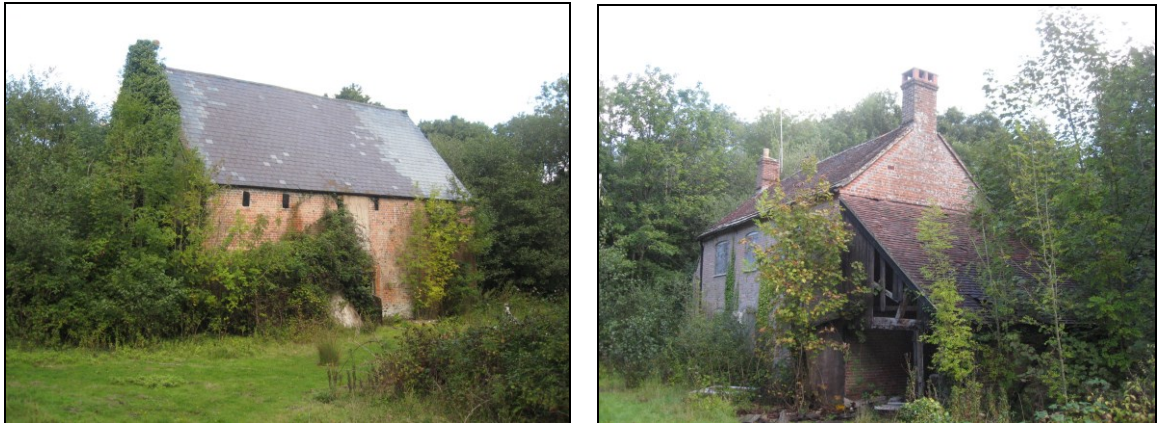
FIG. 14: *Morden Mill and Farmhouse. Derelict listed buildings, albeit the farmhouse was inhabited until recently. Note the attached timber framed and clad outbuilding – a common feature of Morden Estate properties around the conservation area. Maps reproduced with the permission of the National Library of Scotland.*

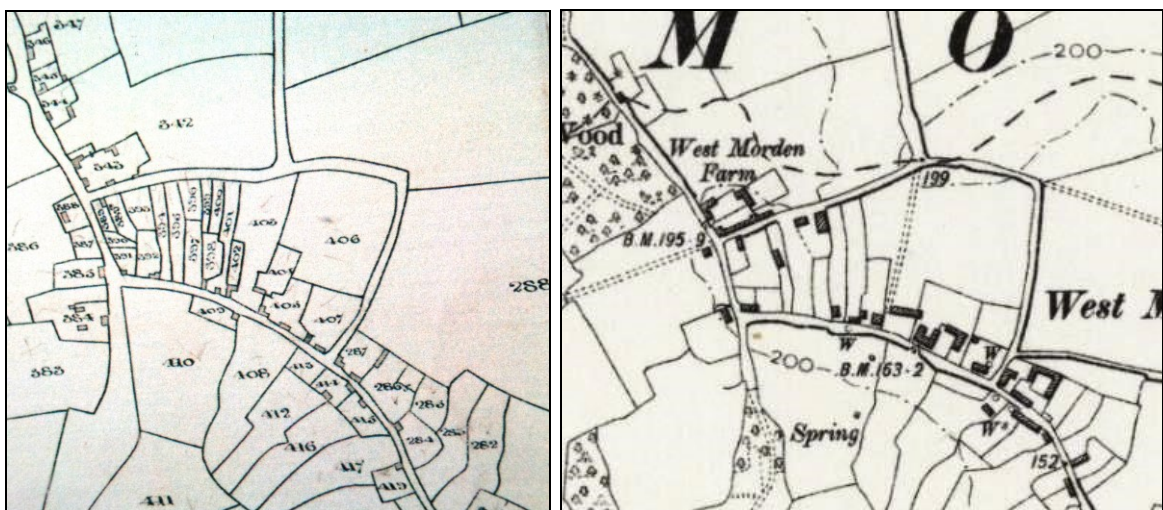
FIG. 15: *West Morden. Left: 1847 tithe map showing little change since 1760s. Right: 1900 OS. Maps reproduced with the permission of the National Library of Scotland.*

49. Buildings in West Morden which originated during the eighteenth century include No. 36 ('Wayside' – FIG. 21), the large outbuilding at West Morden Farmhouse, No. 45, and King's Corner Farmhouse, though most of the latter is of nineteenth century date.
50. Comparing maps of the area between 1847 and 1900 (FIG. 15 below) there was some contraction in the number of dwellings, four cottages disappearing from the west side of the hamlet: one south of No. 43, one west of No. 36 and a couple north of West Morden Farm. Other notable changes included the construction of farm buildings at King's Corner Farm and opposite West Morden Farm.

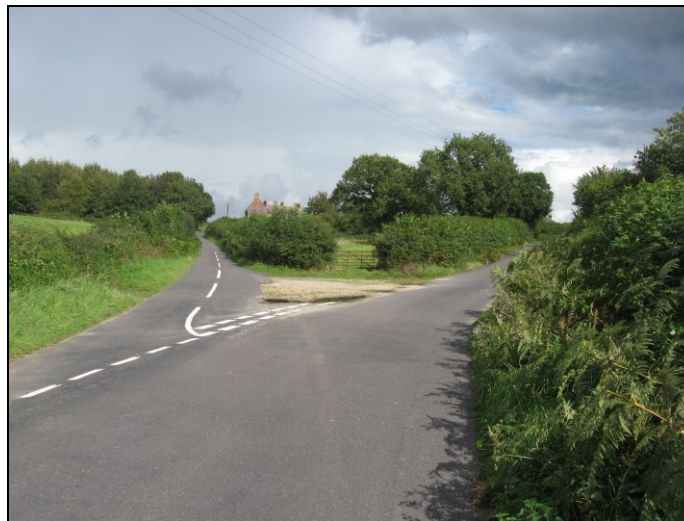
FIG. 16. *Junction. Heading away from Whitefield the road splits left to West Morden, right to East Morden, the routes forming two sides of a triangular piece of former common land. Continuing right, Hector's Corner is located at the crossroad whose northern branch forms the third side of the triangle.*

56. Within the network of lanes junctions are necessarily frequent features. Some of these, such as Hector's Corner and Firestation Corner, are specifically named. The broad junction at the north end of Whitefield is shown in FIG. 16 below.

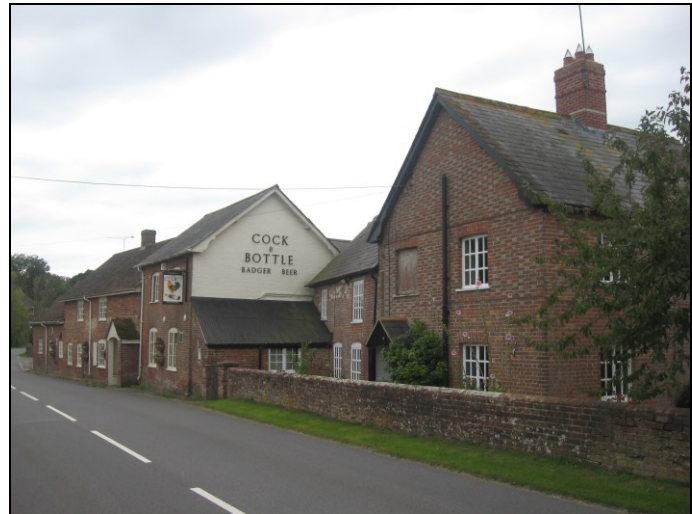
FIG. 17: *East Morden building frontage. This is one of only two continuously developed frontages in the conservation area. Variation in building form, orientation and height here provides visual interest.*

59. A continuous developed frontage of attached buildings currently occurs only opposite the parish church in Morden, and at the Cock and Bottle in East Morden (see FIG. 17 below). Further development of this type historically existed at the Lower Street entry to Collins’s Lane (see FIG. 6). Elsewhere buildings are generally separated from their neighbours by appreciable spaces of various size and form.

64. The orientation of buildings relative to the street again varies, adding visual interest and variety where differences occur in close proximity (for examples see FIGs. 17 and 22). Historic dwellings standing in isolation or scattered amongst the fields typically adopt an independent orientation, though it is noted that a south facing aspect is favoured by a number of such dwellings in the central part of the conservation area. Elsewhere, though it is most common for buildings to be positioned parallel to and facing the street, many exceptions occur. These include No. 48 West Morden and a number of buildings adjacent to the Cock and Bottle where a perpendicular orientation occurs, and King's Corner Farm where the house backs directly onto the road.

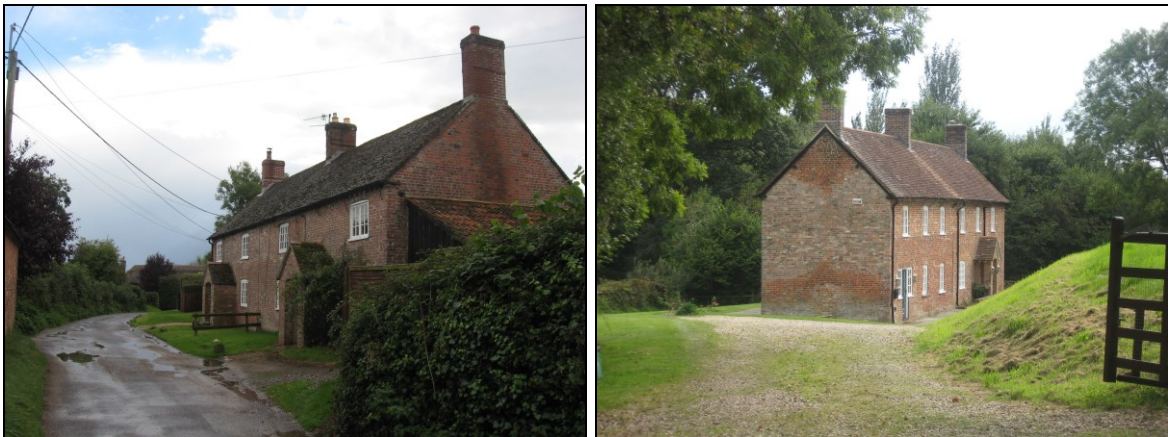
FIG. 18: *Simple rows. Typical two storey rows of brick cottages; simple in form, appearance and detailing. Left: Nos. 46 and 47 West Morden. Right: Nos. 103-105 (Cherry Cottage) Cockett Hill.*

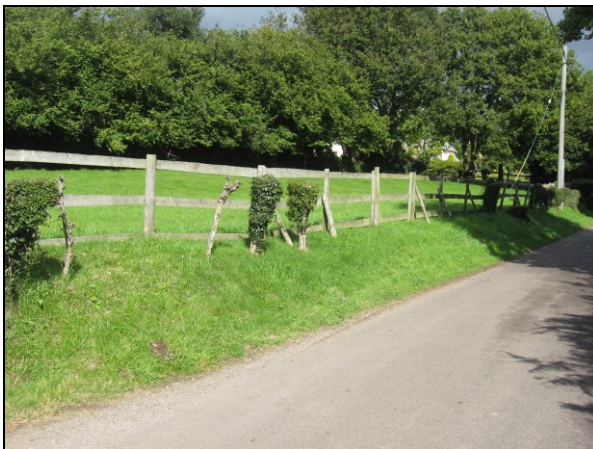
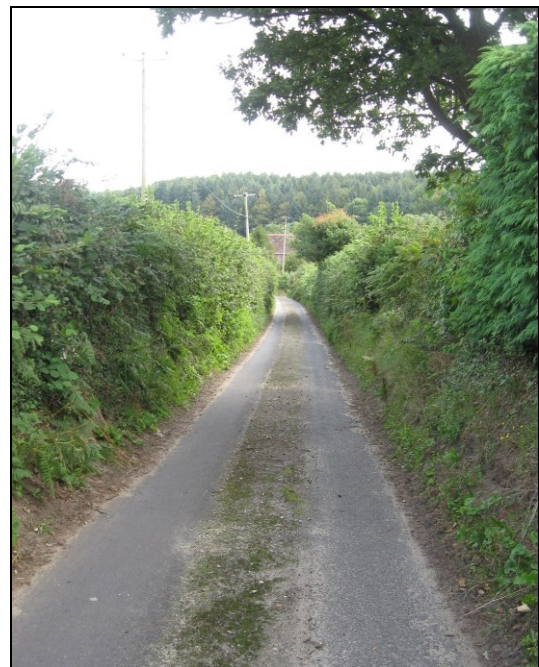
FIG. 19: *Hedges. Below: fragments of a hedge at Whitefield. Some field boundaries are in a similar condition. Right: hedges contribute to the heavily enclosed feel of Gallop's Lane.*

68. Within fields themselves a few notable hedges exist, such as that running between Shrubbetts and New Lane. Compared to the boundaries shown on old maps however the number of hedges appears to have been substantially reduced, and there are surprisingly few hedgerow trees. There is no evidence of traditional hedgerow management anywhere in the conservation area, and this has resulted in progressive thinning and generally poor condition particularly where also heavily flailed (see FIG. 19 below). Continuing to treat hedges this way may lead to their eventual loss.

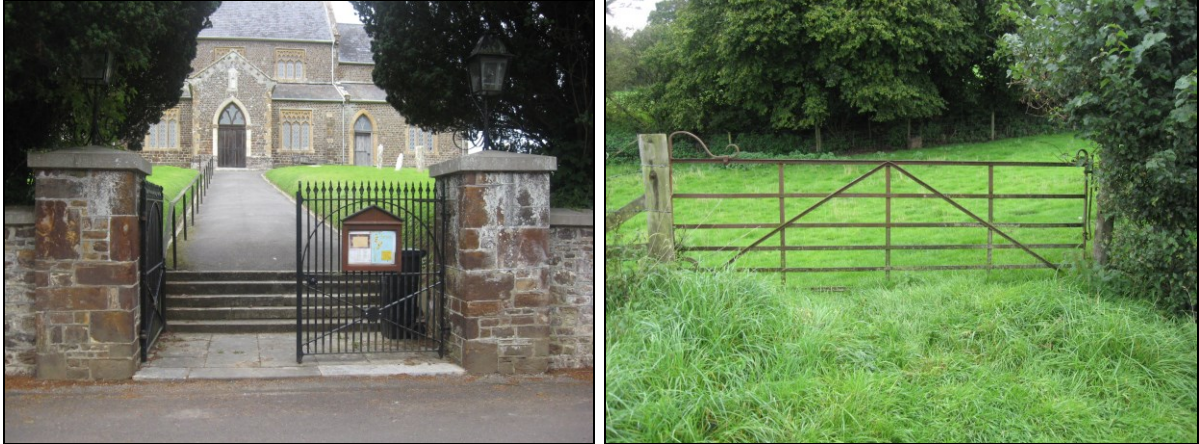
FIG. 20: *Gates. Left: the entrance gateway to the parish church. Note the lanterns either side. Right: a typical estate gate. Numerous examples of this design can be seen around the conservation area.*

69. Gates are typically used to close field accesses. The use of particular design of iron estate gate, numerous examples of which can be seen around the conservation area (see FIG. 20 below), is a distinctive local feature. The condition of these gates varies, many remaining in use, others overgrown. Most would benefit from a protective coat of paint.

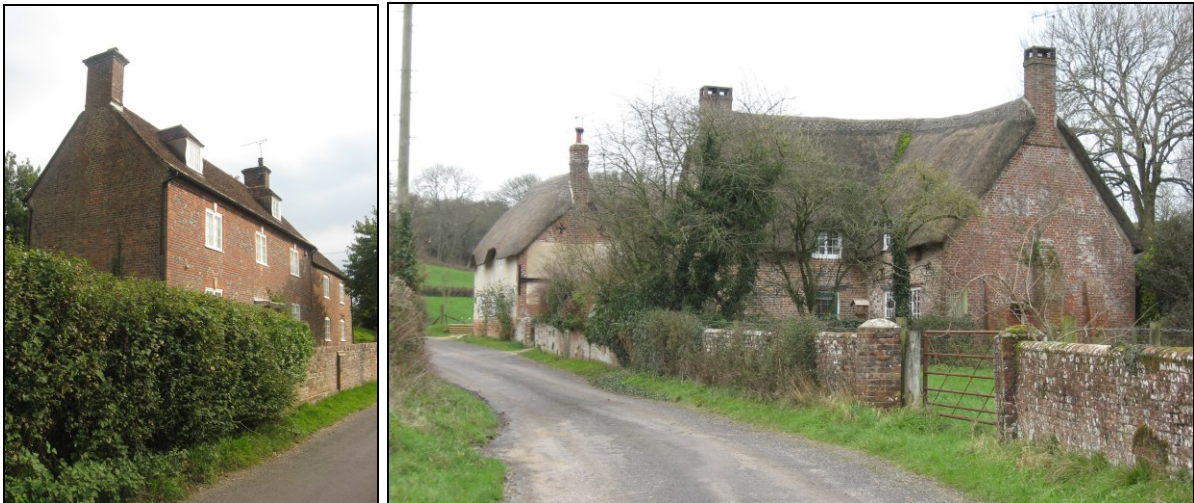
FIG. 21: *Architectural variation. Left: Stickland’s Farmhouse, the original part of which features a bold symmetrical frontage with high quality brickwork and detailing. Right: Paddock Cottage and No. 36 West Morden (‘Wayside’), two vernacular structures showing possible variation in historic status.*

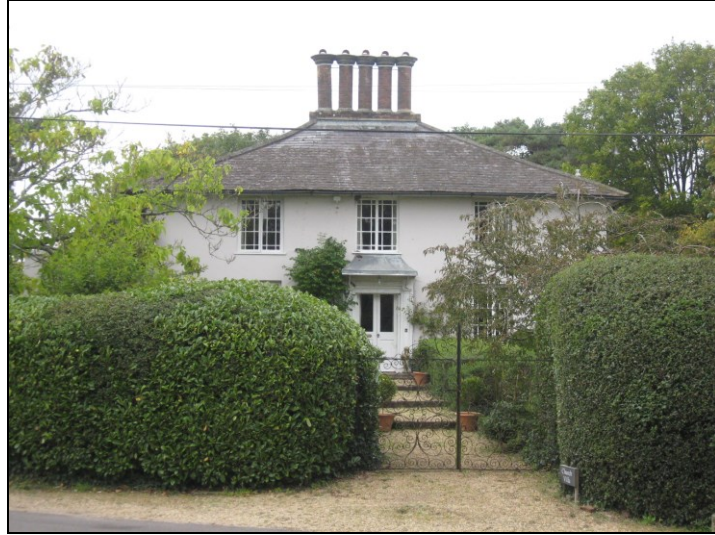
FIG. 22: *Church Villa. This early nineteenth century building has an ornate Regency design. The chimney stacks are a particularly notable feature.*

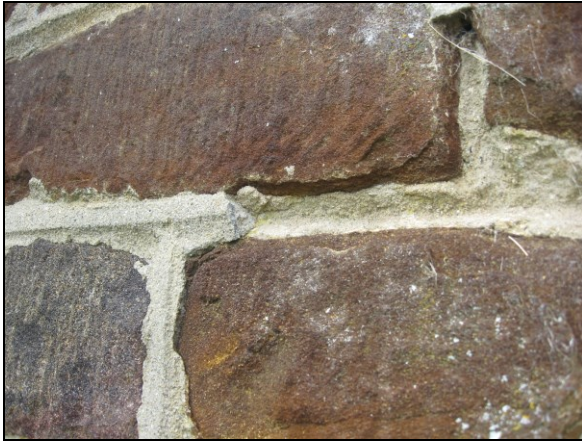
FIG. 23: *Heathstone. Blocks of heathstone seen at the parish church. This detail shows failure of poor quality pointing, the raised and smeared appearance of which has greatly disfigured the appearance of the building and may have accelerated decay of the stonework.*

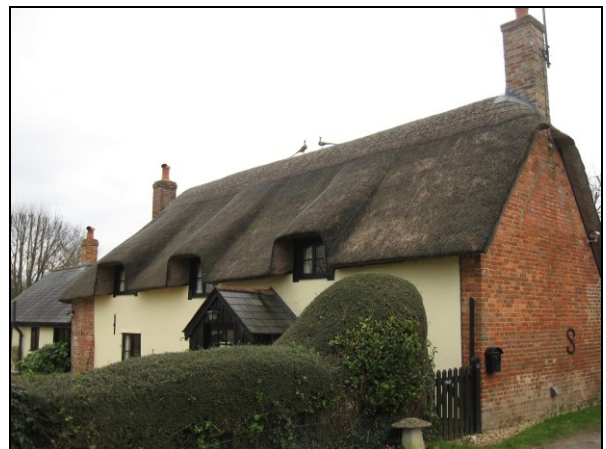
FIG. 24: *No. 48 West Morden. Over time brick patching or facing was often added to cob structures, as seen in the example. The thatch on this property has been renewed, the relatively thin coat accentuating the dormers. With successive recoating using wheat straw dormers in roofs like this traditionally gained a flush appearance.*

76. The local availability of clay rich soils and chalk provided favourable conditions for construction in cob (earth). As such cob forms an important component of the historic vernacular, and as is common in the broader context, it is used in conjunction with thatch. The frequency of cob buildings within the conservation area was much reduced by demolitions of the 1960s and 70s. Cob buildings retaining their original rendered appearance are now scarce within the conservation area, though include No. 76 Higher Street (see FIG. 29) and Nos. 153 and 154 Whitefield (see FIG. 11). Brick patching, and sometimes encasement of cob was common historically. Several of the demolished buildings recorded in the RCHM survey were described as patched. Cob with brick is still seen at Nos. 36 and 48 West Morden (FIG. 24 below).

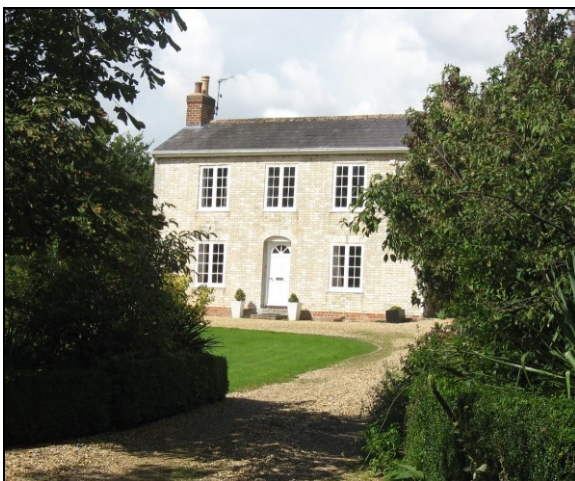
FIG. 26: No. 149 Whitefield. Use of white brick in this small house of formal design is entirely exceptional, though in terms of general design the frontage is similar to that No. 155 Whitefield.

78. Clay extracted at East Morden and Whitefield was of two types – Reading Clay at Whitefield and London Clay at East Morden. Old bricks within the area are typically shades of orange, except where burned for decorative effect (discussed below). Use of white brick at No. 149 Whitefield is wholly exceptional (see FIG. 26 below).

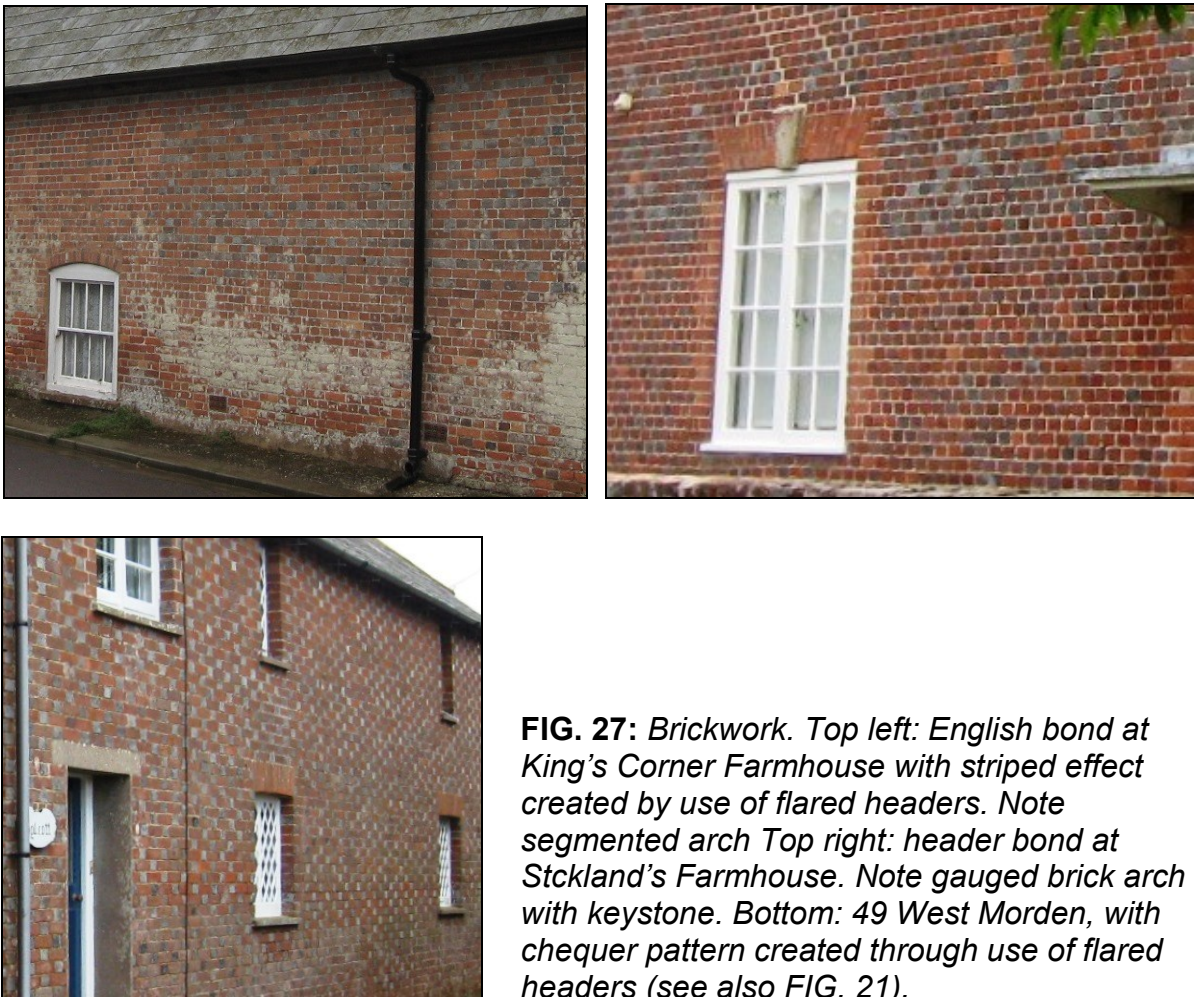
FIG. 27: Brickwork. Top left: English bond at King's Corner Farmhouse with striped effect created by use of flared headers. Note segmented arch Top right: header bond at Stckland's Farmhouse. Note gauged brick arch with keystone. Bottom: 49 West Morden, with chequer pattern created through use of flared headers (see also FIG. 21).

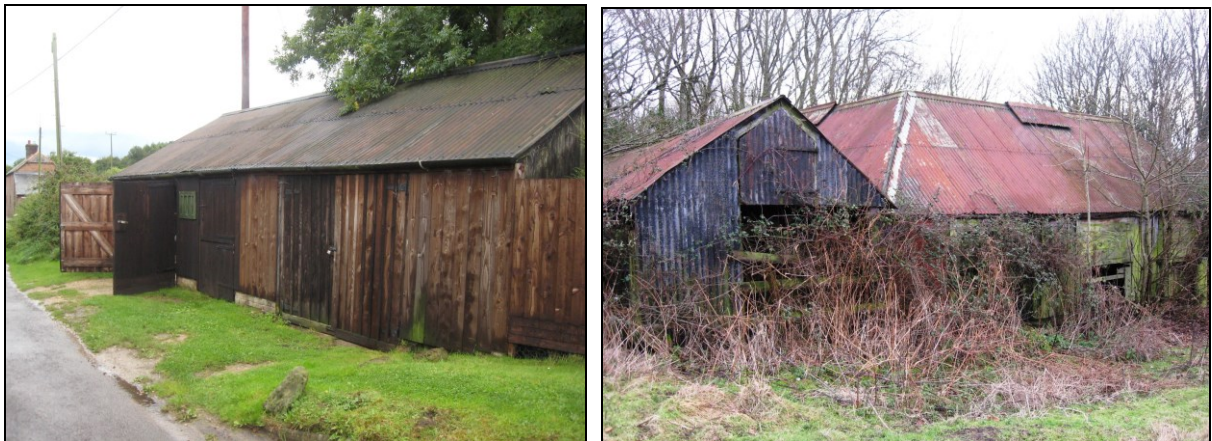
FIG. 28: *Timber boarding and corrugated iron. Left: shed at 47 West Morden featuring the distinctive use of vertical timber boarding. Corrugated iron covers the roof. The latter is frequently seen around the conservation area as a partial or full cladding as in the semi-derelict structure located at Shrubets (right).*

83. Vertical timber board incorporating battens laid over the joints is frequently seen used as a cladding material for attached timber framed outbuildings or sheds (see FIG. 28 below). The board is typically black in finish, reflecting the traditional use of pitch as timber preservative. In recent years some of these outbuildings have been replaced by more permanent extensions which have been clad in the same manner (see for example No. 43 West Morden). Both the use of the board and context of its use clearly reflect past practice on the estate, and make a small but significant contribution to local distinctiveness.

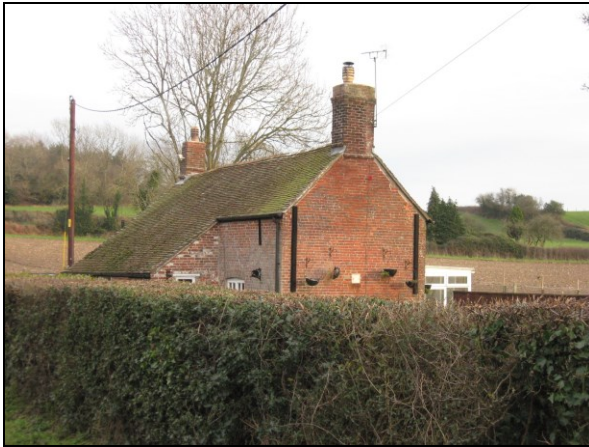
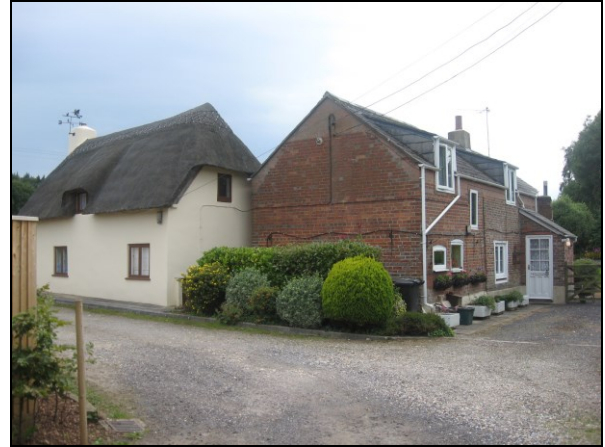
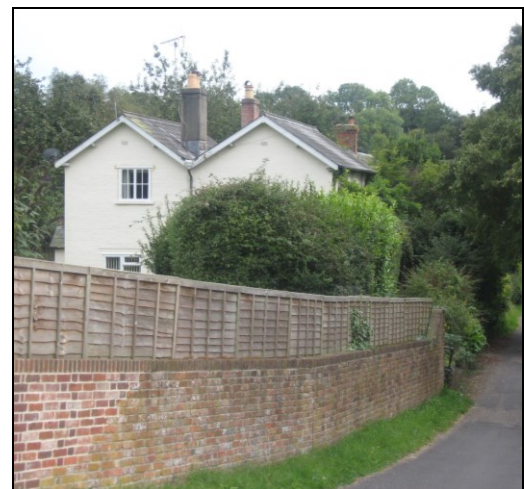
FIG. 29: Varied roof forms. Top left: Pitched roof with rear catslide at No. 165. Top right: half hipped thatch roof of No. 76 Higher Street. The slate roof of No. 74 adjacent appears to have replaced a roof similar to that at No. 76. Right: 'M' shaped roof at No. 69 Higher Street.

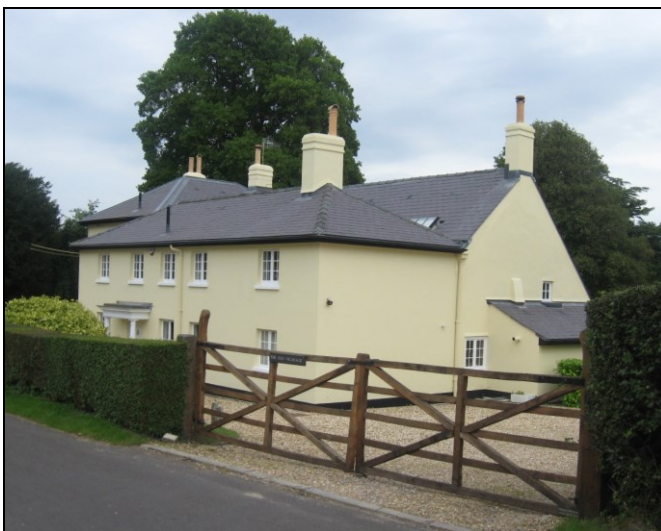
FIG. 30: *The Old Vicarage, Higher Street. The roof of this building has recently been re-covered with Welsh slate. The original part of the property is to the rear and can be identified by the steeply pitched roof with catslide – similar to others within the conservation area. Clay tiles are likely to have covered the oldest part of the building originally, though slate would have suited the lower pitches used when enlarged during the nineteenth century.*

91. Slate is most typically a feature of nineteenth century buildings within the conservation area, reflecting in part the period in which distribution from North Wales was facilitated by growth of the railways. The best examples of slate roofed buildings are the parish church (FIG. 1) and old school (FIG. 35). In some cases slate may have replaced earlier roof coverings or superseded them when modifications were undertaken. This was the case for example at Home Farm in Higher Street, and is likely to have also been the case at the Old Vicarage (FIG. 30 below) and No. 74 Higher Street (FIG. 29 above). The Old Vicarage has recently had its attractive covering of distinctively coloured heather blue Penryhn slate renewed.

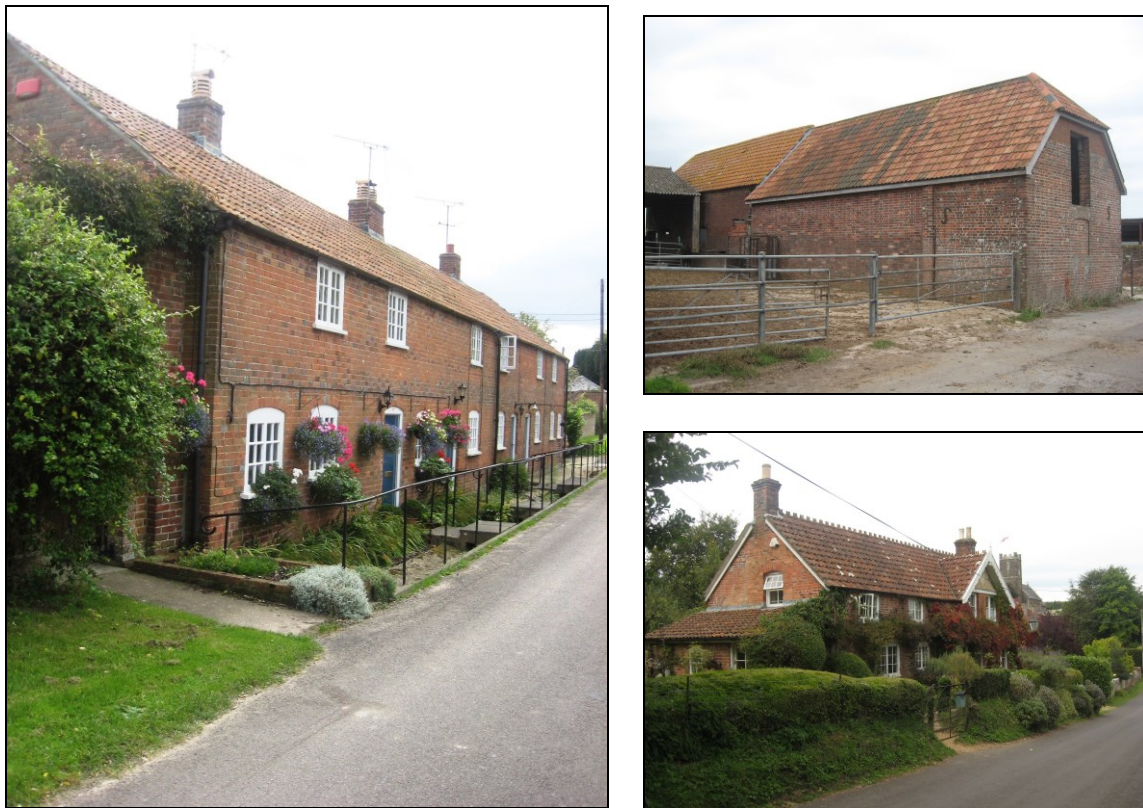
FIG. 31: *Double Roman tiles. As seen on the roofs of Nos. 64-67 Higher Street (left), a building at Hill Farm (top right) and the Old Post Office Higher Street (bottom right).*

93. Large format clay double Roman tiles are a frequent feature around the conservation area, and most particularly its eastern half around Morden and East Morden. The tiles appear to have found common use on the estate generally during the past, and frequency of use is indeed greater than seen elsewhere in the District. As such the tiles make an important contribution to local character and distinctiveness. The same is not true of concrete interlocking tiles seen in some late twentieth century development.

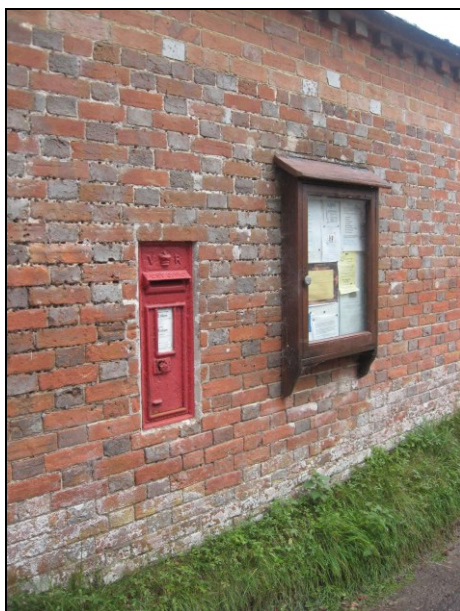
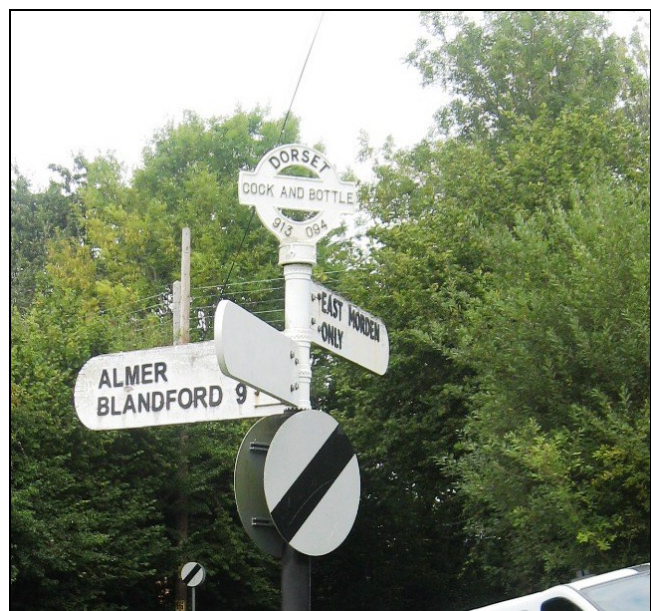
FIG. 32: Street furniture. Left: Pillar box in West Morden. The Victorian box is fitted into the wall of an agricultural building at King's Corner Farm. Note the chequered Flemish bond brickwork using red stretchers and blue headers. Right: Finger post at the Cock and Bottle. Two fingers have clearly been replaced, but it retains its original roundel which records the location. The appearance of the post is spoiled by the speed sign attached below. Surprisingly the speed limit here is 60 mph.

104. Three finger posts are located in the conservation area. That adjacent to the Cock and Bottle (FIG. 32 below) is in good condition and retains its distinctive roundel. That adjacent to the old school (see FIG. 37) is in poor condition and has lost its roundel, though retains its historic cast lettering. Old maps record presence of a milestone on the site, though this appears to have been removed. A third finger post at the junction of the B3075 with the roads to East Morden and West Morden is in reasonable condition though lacks a roundel and appears to have lost some of its pointers. The roundel from a fourth finger post at Morden park Corner is now awkwardly mounted on top of a modern highways sign adjacent to the junction.

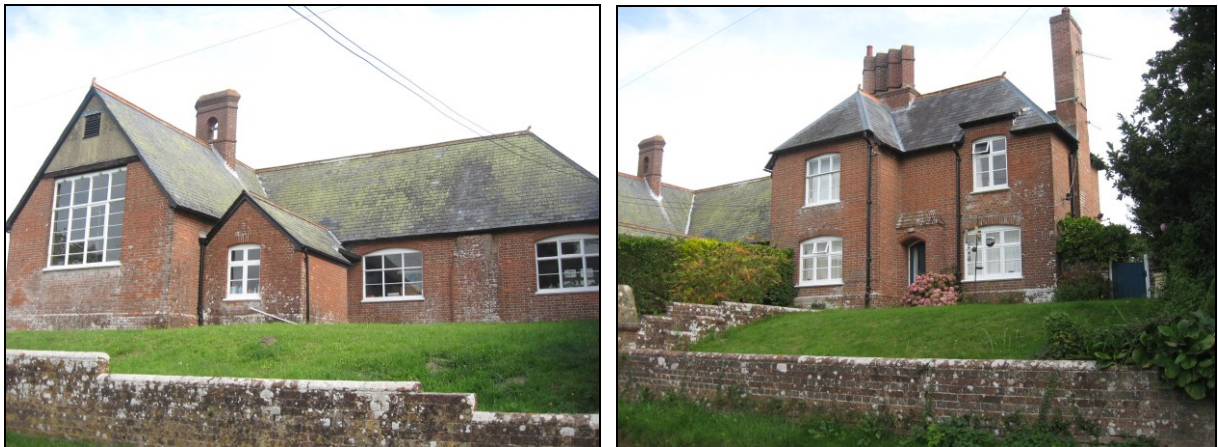
FIG. 35: *The old school and school house. Note the chimney stacks which in the case of the school itself were designed to also hang the school bell.*

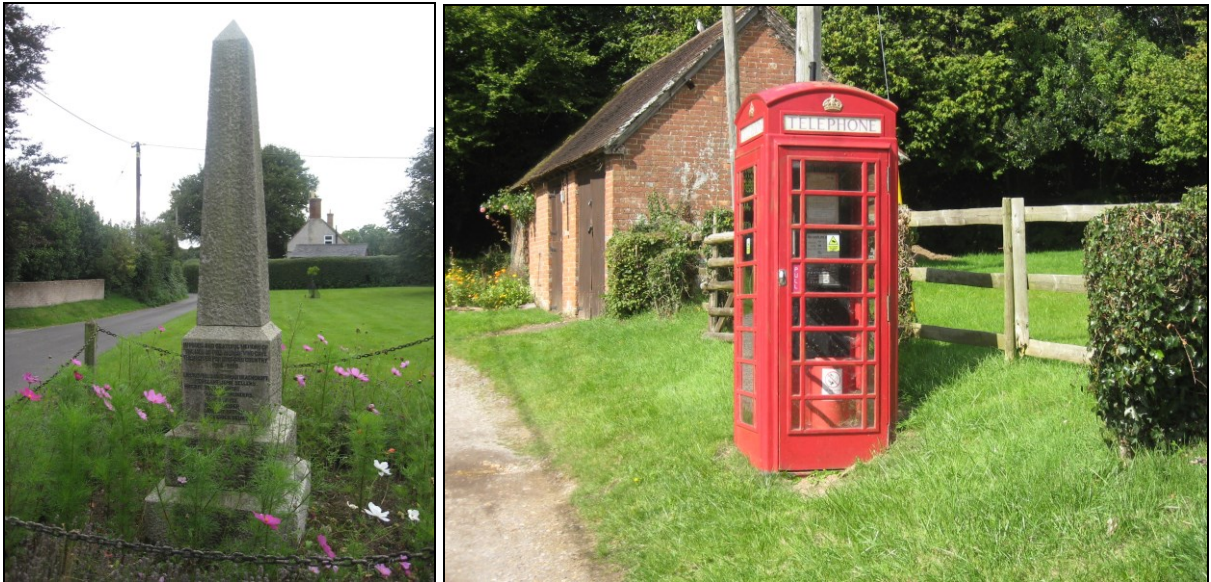
FIG. 36. War memorial in Higher Street, and telephone kiosk at Whitefield.

- *K6 phone boxes at Fire Station Corner, Higher Street and Whitefield.* (see FIG. 36 below). These are classic townscape features. As noted above, all are 'jubilee' models typically installed 1935-52.

- *War memorial, Higher Street.* (see FIG. 36 above). The war memorial is a modest structure of great local importance. Not currently listed.
- *64-67 Higher Street.* (see FIG. 31). An attractive row of nineteenth century brick cottages.

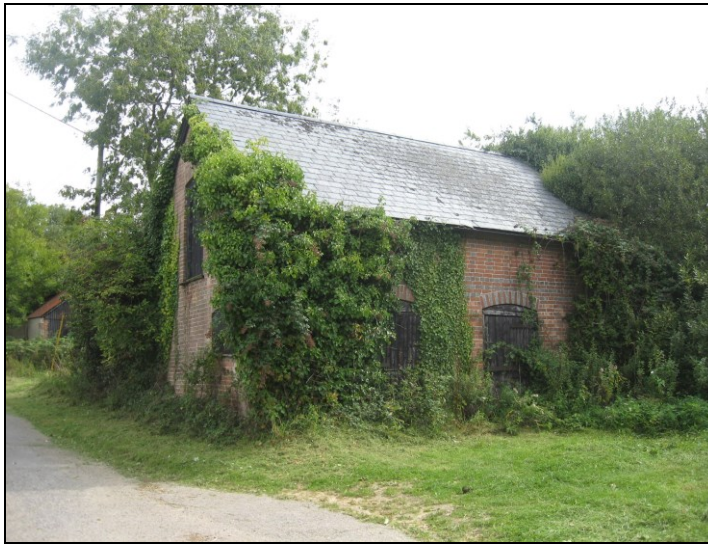
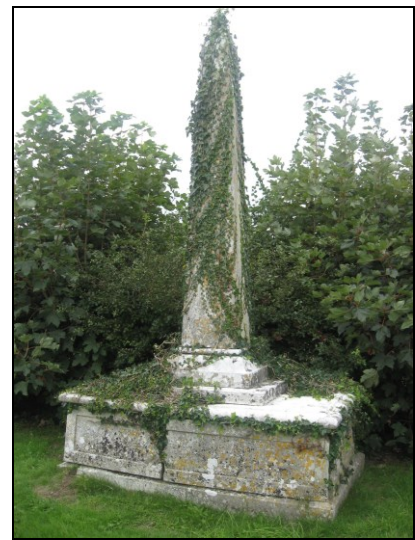
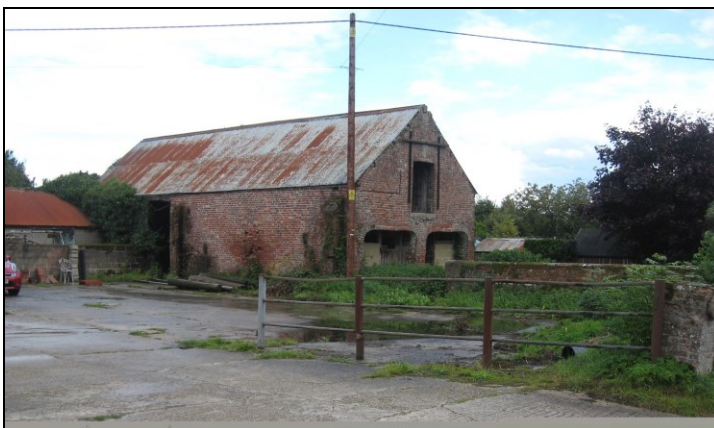
FIG. 37: *General neglect. A range of structures within the conservation area show signs of general neglect. Top left: overgrown building opposite Orchard Cottage. Top right: ivy clad obelisk in the parish churchyard. Bottom: barn at West Morden Dairy.*

124. A range of unlisted 'positive' structures within the conservation area are observed to be in poor condition. This appears to be principally a result of neglect, often arising from disuse. Some of these structures, such as the derelict tin sheds north of the village hall, are of limited interest, whilst others such make a contribution to local character and interest that could be enhanced by their renovation. Examples are provided in FIG. 37 below.

127. Former agricultural buildings at West Morden Dairy (see FIG. 37) are in poor condition though a scheme for their conversion has been approved in the recent past.

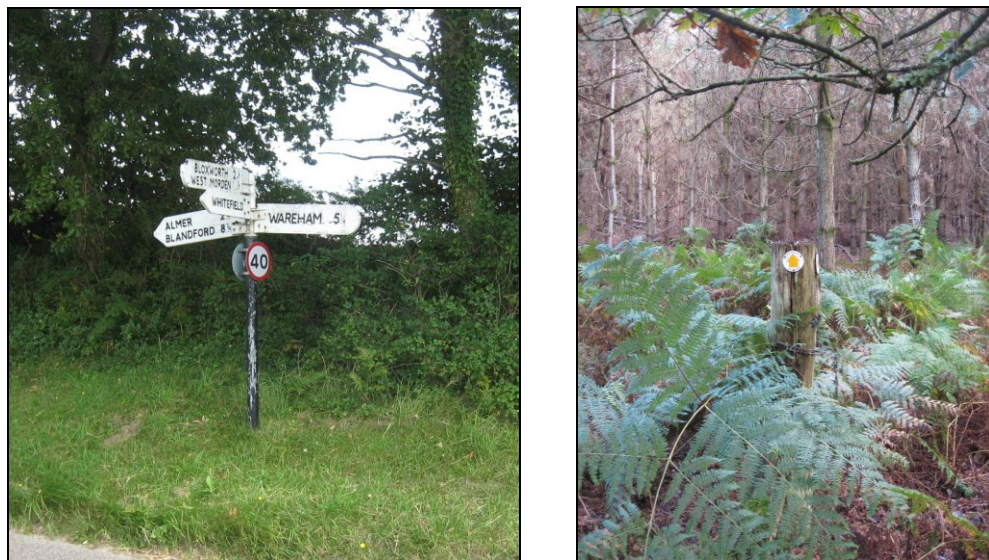
FIG. 38: Areas for possible improvement. Left: finger post in poor condition adjacent to the old school. Right: the footpaths with which this sign in the plantation south of Frogmore is associated seem to have disappeared.
