## Policy Group – 22 November 2017

### Piddle Valley Conservation Area review

# **Piddle Valley Conservation Area Appraisal**

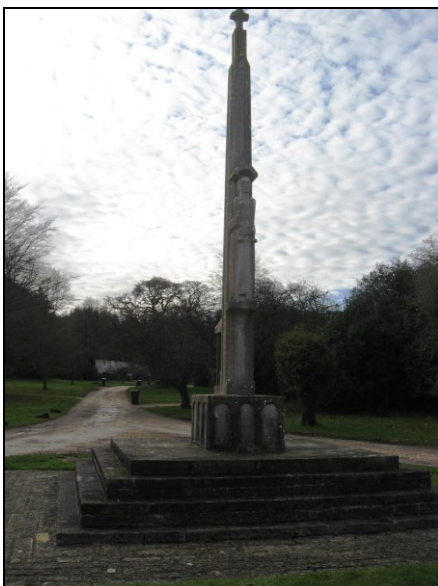
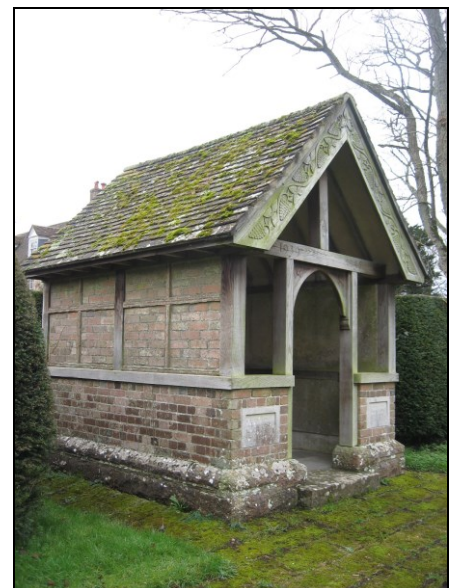
**FIG. 1:** *War memorials. The conservation area contains two listed war memorials commissioned by Ernest Debenham. Left: Eric Gill's Bladen Valley Great War memorial. Right: The Second World War memorial in Affpuddle church yard designed by Laugham Pendred.*

14. The conservation area contains a large and distinctive collection of vernacular buildings, a remarkably large number of which find origin within, or are substantially dated to the sixteenth and seventeenth centuries. This contrasts with the range of architect designed Arts and Crafts buildings of both domestic and agricultural type, which form an important legacy of the Bladen Estate. Many of these buildings are listed, providing the conservation area with an exceptionally high number of protected twentieth century buildings. Artistic interest is added by sculptural works by Laugham Pendred and Eric Gill (see FIG. 1 below).

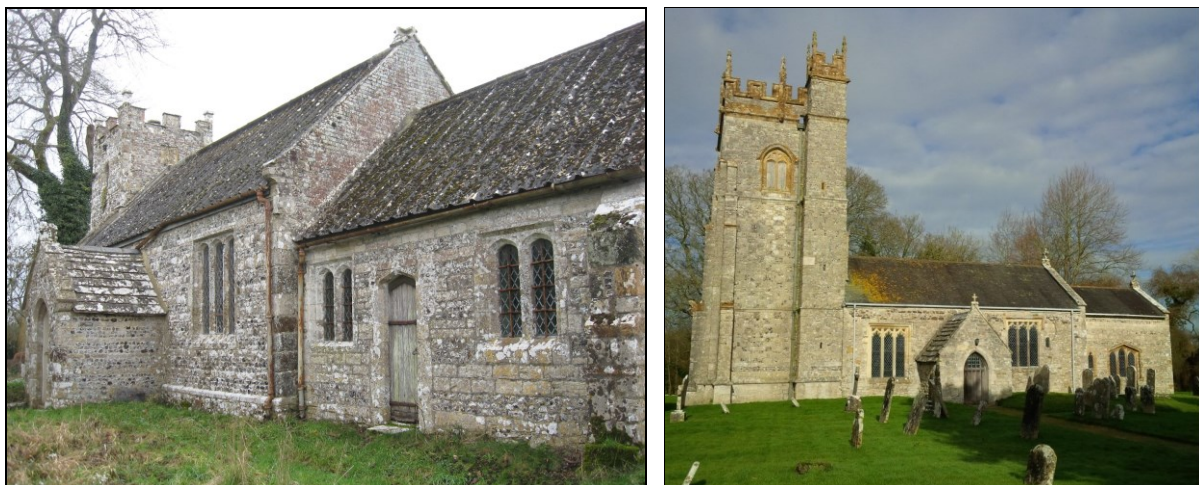
**FIG. 3:** Parish churches. Left: former Church of the Holy Trinity in Turnerspuddle. Right: Church of St. Lawrence in Affpuddle.

22. Until recently the parishes of Affpuddle and Turnerspuddle were separate entities, each holding a parish church. The Church of St. Laurence at Affpuddle (FIG. 3 below) contains fabric substantially dated to the fourteenth and fifteenth centuries, whilst the Church of Holy Trinity at Turnerspuddle (FIG. 3 below) is largely dated c.1500. Hutchins records the latter as originally a chapel of ease to the church at Bere Regis.

77. Amongst historic buildings construction in stone is reserved for the parish churches in Affpuddle and Turnerspuddle, and is an exceptional feature in both the original and remodelled sections of East Farm in Affpuddle. This generally reflects the historic status and importance of these buildings (see FIG. 3). The quality of materials used for construction of the churches appears to differ between the two, being higher for the Church of St. Laurence. Ornamental use of knapped flint is a feature of particular interest at all three buildings, employed in chequered panels and as banding within limestone masonry (see FIG. 19 below). Similar decorative effects are employed at the parish church in Bere Regis. Flint is otherwise seen in the much later churchyard wall in Affpuddle (see FIG. 18) and the boundary walls at Briantspuddle Dairy (see FIG. 25) where its use forms an element of the distinctive though not wholly contextual design of the site.

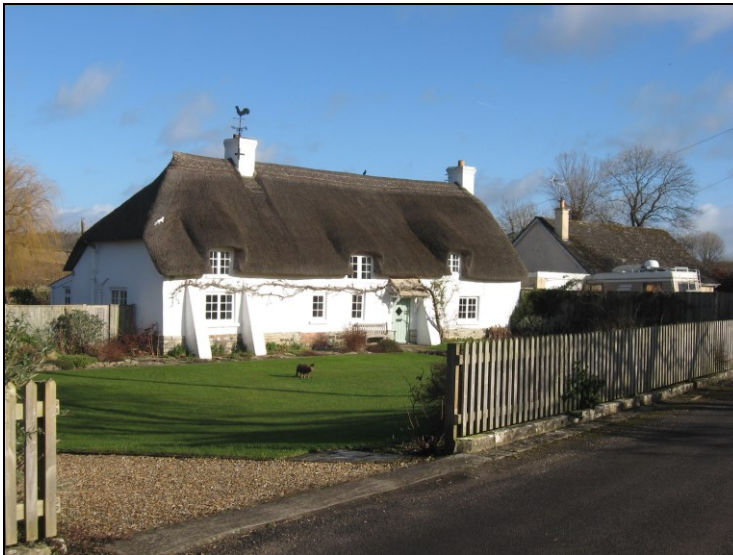
**FIG. 4:** *Cruck Cottage, Briantspuddle. The oldest domestic property in the conservation area, elements of which date to the late fifteenth century.*

23. Cruck Cottage (see FIG. 4 below) is the oldest domestic property in the conservation area. This finds origin as a late fifteenth century hall house, to which a first floor was added in the sixteenth century. The building was subsequently extended in the seventeenth century and has been modified in various ways since.

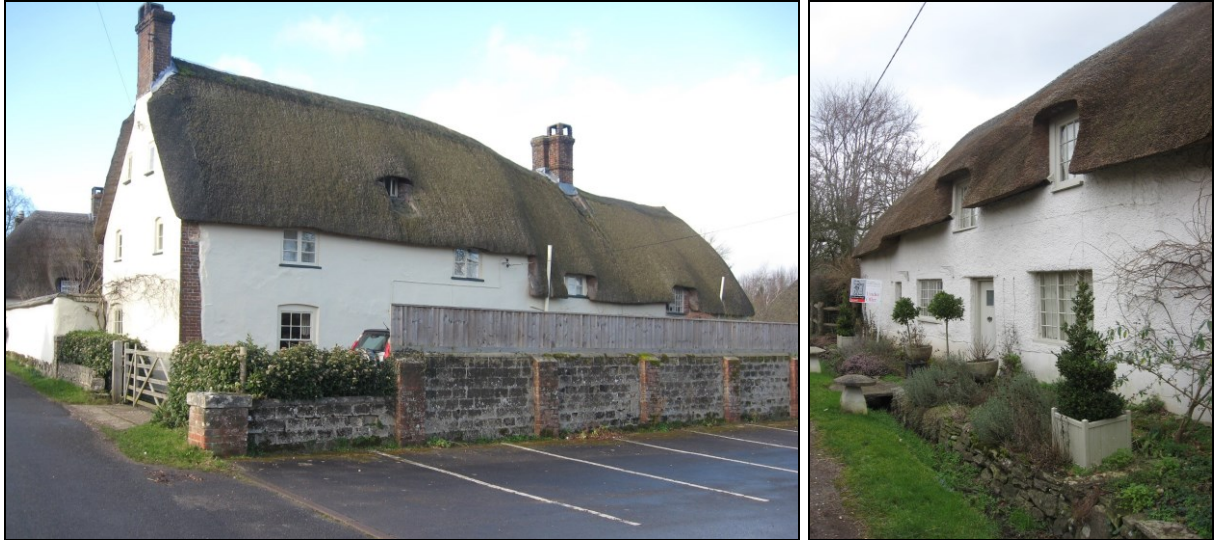
**FIG. 5:** *Seventeenth century. Left: No. 26 Briantspuddle. The oldest section of the former farmhouse stands at 1.5 storeys. Note the deep thatch and exceptional height of the later section of the dwelling. Right: Piper's Cottage, Throop.*

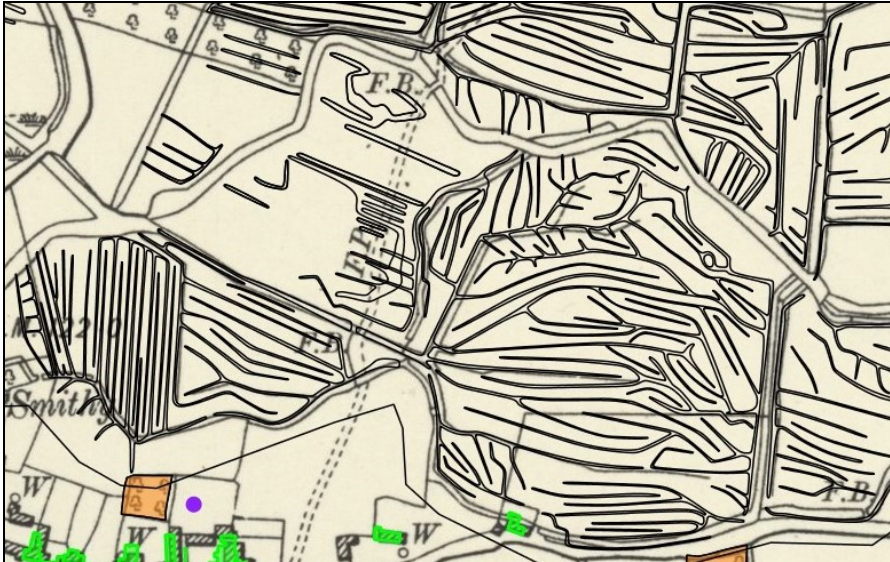
**FIG. 6:** Mapping of water meadows in the HER. The survey is shown overlaying the 2nd Edition OS map which fills some of the gaps. The segment shown is located immediately north of Briantspuddle.

analysis to clearly identify and attempt to date systems historically in use, and are best viewed in conjunction with map bases showing extant and historic carrier channels as these fill the gaps in the data. With reference to RCHM typology layouts appear to differ between regular ‘right angled’ or ‘herringbone’ sequences of channels, and more irregular variations on the latter. According to Historic England, irregular layouts may be considered generally earlier in date to regular layouts. Survey evidence is however patchy in places, and unfortunately so in Affpuddle.

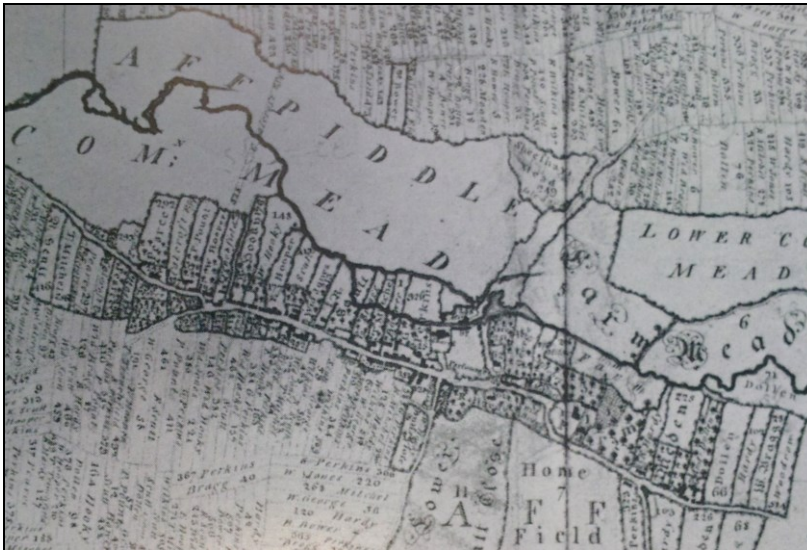
**FIG. 7:** *Affpuddle as shown in an excerpt from the Moreton Estate Map. Note the heavily developed street frontage, common land and strip fields and water meadows. Courtesy of Dorset History Centre.*

32. The Affpuddle estate map (FIG. 7 below) shows that village was reasonably well developed by the 1760s, with buildings and adjoining gardens laid out along both sides of Southover Road. The almost continuously developed frontage shown on the plan is unrecognisable today, though the street edge position of the few historic cottages that survive recalls the historic layout (and reflects that which survives in the historic core of Briantspuddle). The modern pattern of development is clearly inconsistent with that which existed in the past. Traces of lost cottages and related enclosures remain in evidence along the north side of the street, evidenced by many undulations and depressions on the field surface.

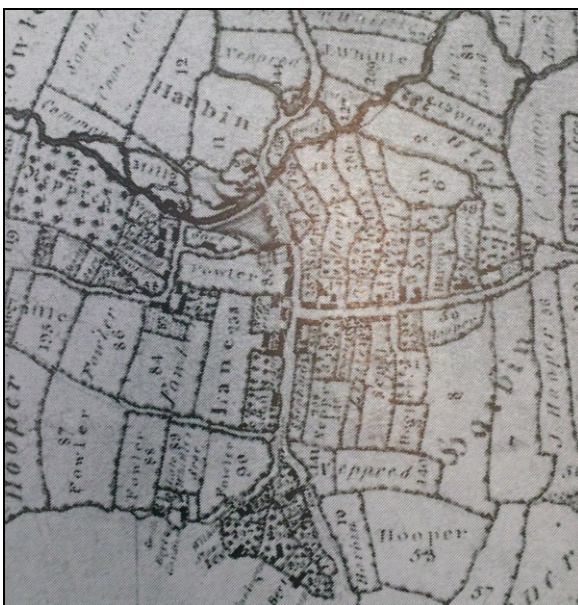
**FIG. 8:** *Briantspuddle as shown in an excerpt from the Moreton Estate Map. The map shows the original dog legged entry into the village from Affpuddle, and The Hollow perched on the edge of heathland. The survival of many of the buildings shown on the map clearly contrasts with the situation in Affpuddle. Courtesy of Dorset History Centre.*

51. Prior to the twentieth century the western entry into Briantspuddle from Affpuddle took a deviating course, running north at the Old School along the current lane, then east to the bridge and south past Hanthorpe Cottage (see FIG. 8). Construction of a link road by-passing the loop, and adopting the pre-existing line of a footpath caused the old route to become defunct. This provided the origin of the detached group of housing around the Old School, whose cul-de-sac arrangement is not historic in character but a vestige of the historic route.

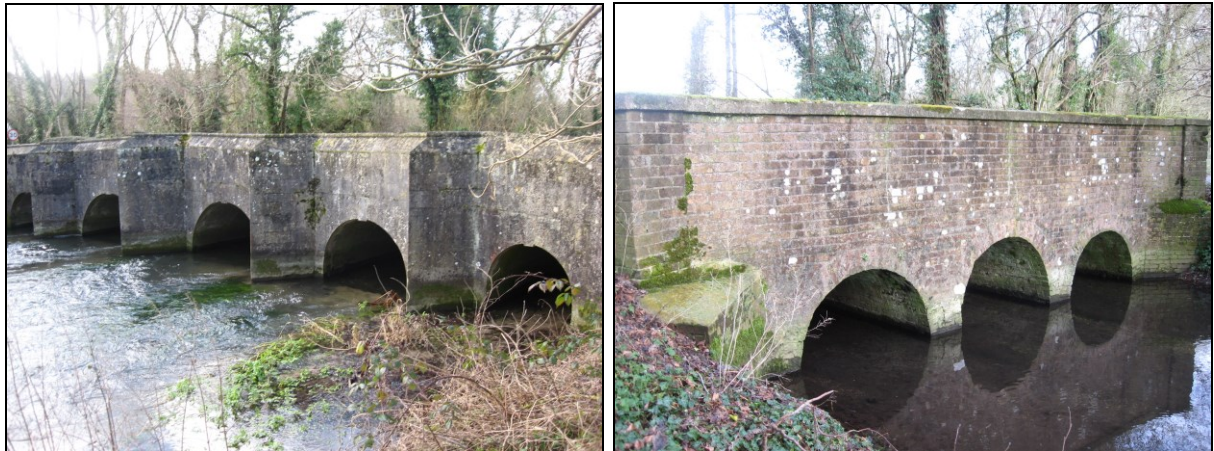
**FIG. 9:** *Bridges over the Piddle at Briantspudde.*

35. Other buildings and structures dated to or originating during the period include: barns at Tonerspudde Farm, Nos. 2 and 3 Turnerspudde, No. 24 Affpudde, No. 5 Brintspudde (though mostly rebuilt subsequently), Nos. 14, 18, 21, 22, 24 and 35 Briantspudde, Nos 2 and 3 The Hollow, Throop House and the principal bridge over the Piddle at Briantspudde (see FIG. 9 below).

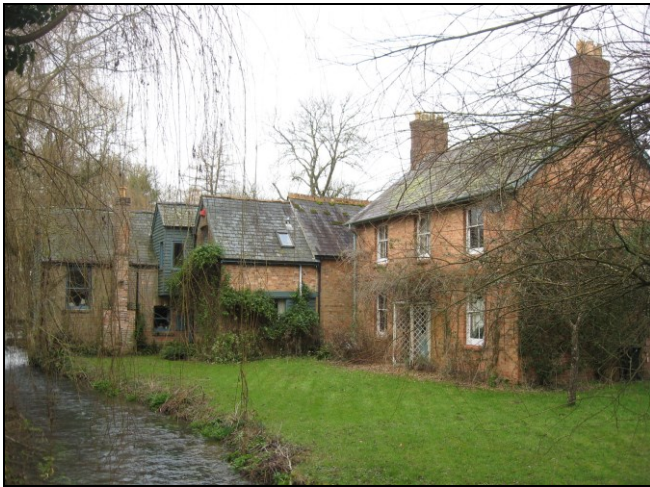
**FIG. 10:** *Affpuddle Mill. The mill and mill house were rebuilt during the nineteenth century, replacing earlier structures. The mill has been altered since, and originally straddled the mill race.*

37. A number of buildings have been dated to the period, some of which replaced earlier structures on the same sites. These include: the three bridges over the Piddle in Affpudde dated 1848; the former barn and granary of Briantspudde Farm (No. 26), built in 1803 and 1814 respectively; the similarly dated barn and granary opposite the Vicarage at Affpudde; the old school in Briantspudde built 1870, the current mill and mill house in Affpudde (see FIG. 10 below); the north end of Chapel Cottage (the central part of which was converted for use as a Wesleyan chapel during the period – see FIG. 16); and Shop Farm. The main barn at East Farm was burned out and partially converted for chaff cutting late in the century, giving one end of the structure an interesting industrial character.

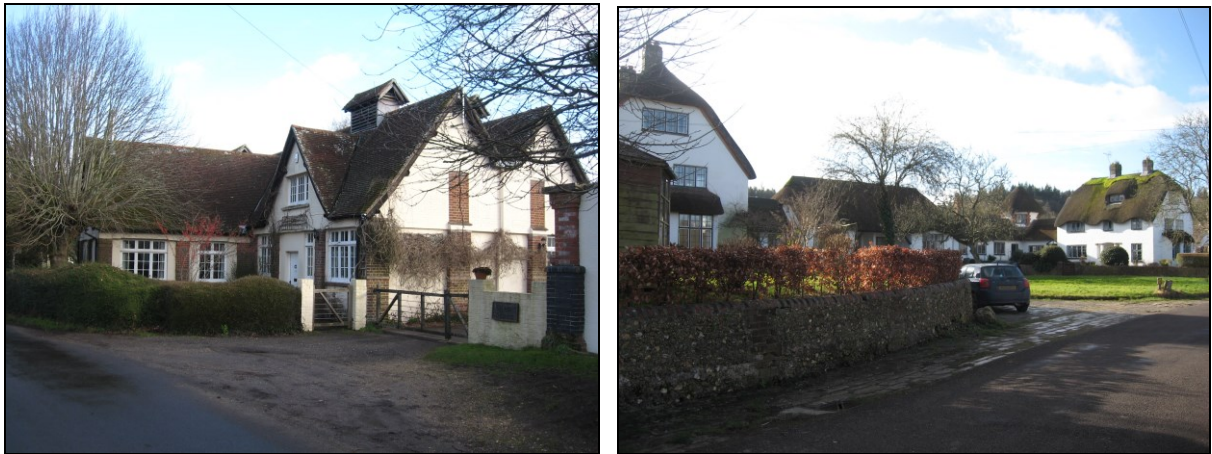
**FIG. 12:** *Bladen Estate buildings. Two elements of the former farms business – left: the former engine house; right: the public face of the former dairy.*

104. The former Briantspuddle Dairy (see FIG. 12) features large expanses of stone paving to the surface the access roads (see FIG. 25 below). This is an important aspect of the historic design character of the dairy and adds distinctiveness to the site. Stone paving is not otherwise a frequent feature within the conservation area.

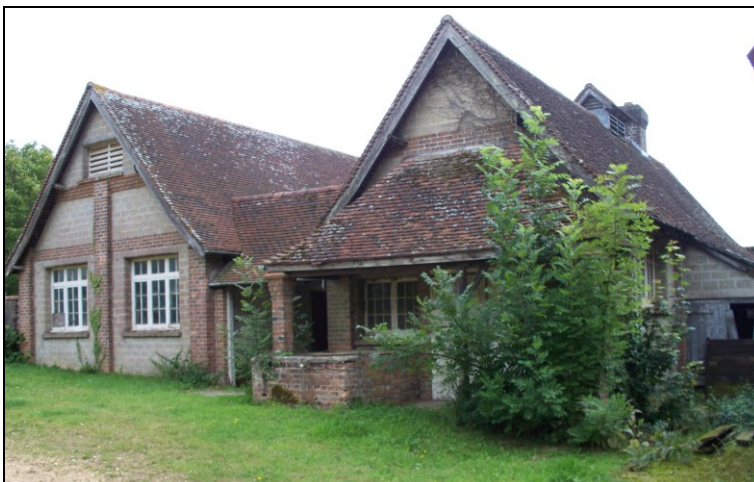
**FIG. 13:** Dairy building at Tonerspudde Farm. Shown prior to conversion. Typical block and brick construction, unusually domestic in character.

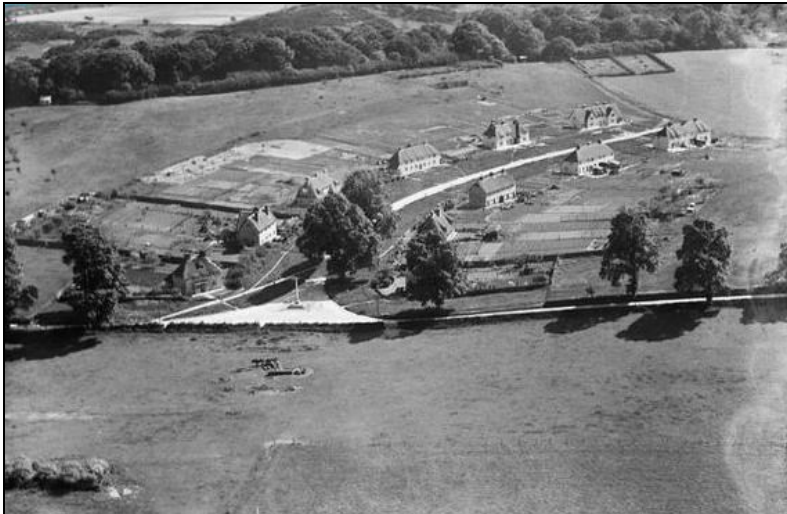
**FIG.15:** *Bladen Valley 1930. (Britain from Above: image EPW032353). The spacing of buildings and subdivision of plots is evident, as too the lack of trees (the plot having been agricultural land previously).*

56. As a planned development, the spacing of buildings in Bladen Valley is a particular and distinctive aspect of its design (see FIG. 15 below). This bears no direct relation to the pattern which exists elsewhere in the conservation area, though formal placement is also seen in the crescent of post-war bungalows in Briantspuddle. Most Bladen Estate dwellings stand within spacious plots (e.g. see FIG. 25).

57. The layout of Bladen Valley is best appreciated on aerial photos taken shortly after its development, and prior to tree planting (see FIG. 15 below). Large garden spaces were originally intended for use as allotments, though most no longer serve this purpose. The spaciousness of Bladen Valley remains clearly appreciable, though character has been eroded by the construction of an assortment of sheds, garages and outbuildings within the gaps between properties.

97. Chimney stacks are generally built of brick. Substantial chimney stacks incorporating decorative details often form important elements of Bladen Estate designs. Here their large size is proportionate to the bulk of the buildings they serve, and often adds significant stature (see FIG. 15 particularly).

120. Whilst reference to FIG. 15 shows that, with the exception of pre-existing specimens, trees were not an original component of the design of Bladen Valley, trees today play an important landscape role (see FIG. 28 below). This is particularly true of large trees standing within or adjacent to the verge, the quality of which is recognised in their specific protection by preservation orders. In some places however vigorous growth of leylandii hedging detracts from the general setting and character of the estate.

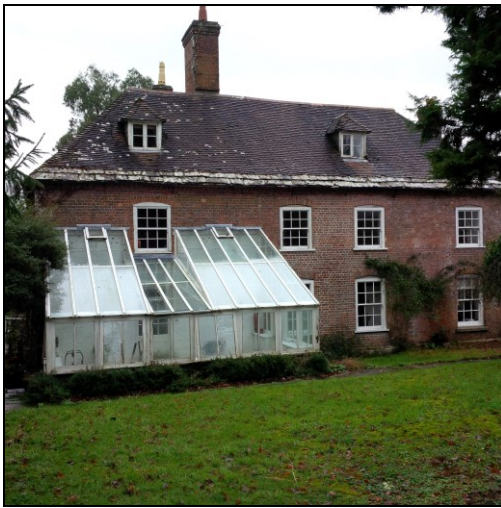
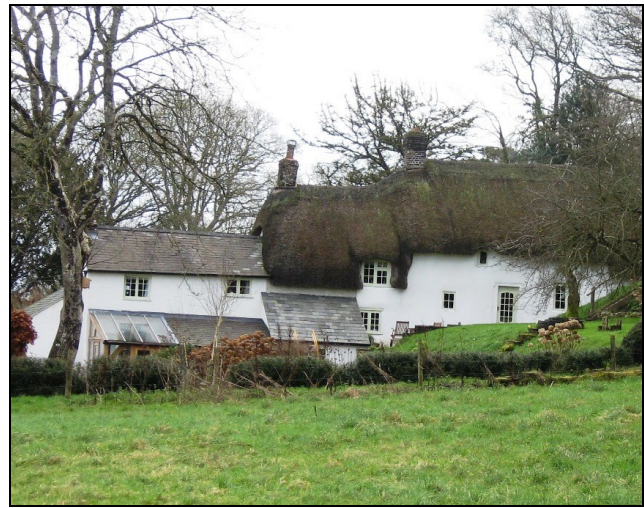
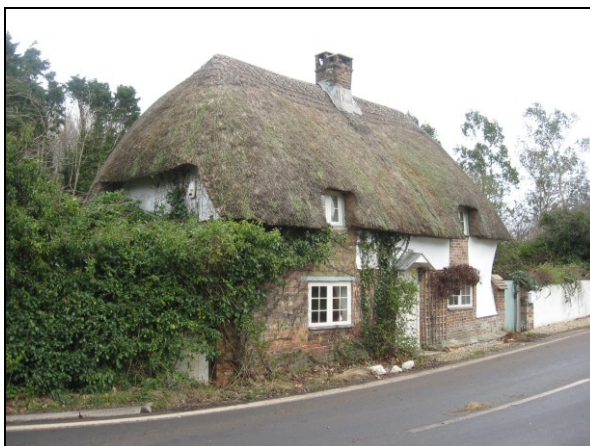
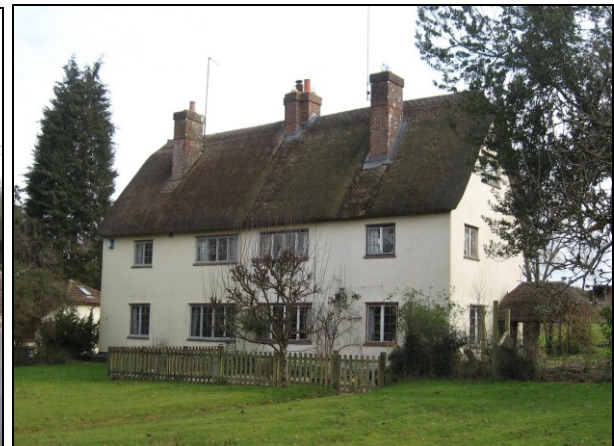
**FIG. 16:** *Height and massing. Above left: East Farm, Affpuddle – one of a number of bulky two-storey eighteenth century dwellings of irregular plan form in the conservation area. Above right: Chapel Cottage. A linear amalgamation of modest vernacular forms which provides great visual interest. Below left, the modest 1.5 storeys of No.21 Affpuddle. Note the deep and well rounded thatch which is typical of historic thatched roofs. Below right: Nos. 5 and 6 Bladen Valley – a formal two storey design whose only vernacular parallel is No. 26 Briantspudde.*

62. Variation in height across the row of buildings forming Chapel Cottage and No. 26 Briantspuddle provides visual interest (shown in FIG. 16 above), and reflects a process of the historic addition of elements over time.
63. Modern bungalow designs don't generally exceed the height of earlier cottages, though their suburban character and appearance otherwise detracts from historic and architectural distinctiveness of the conservation area.

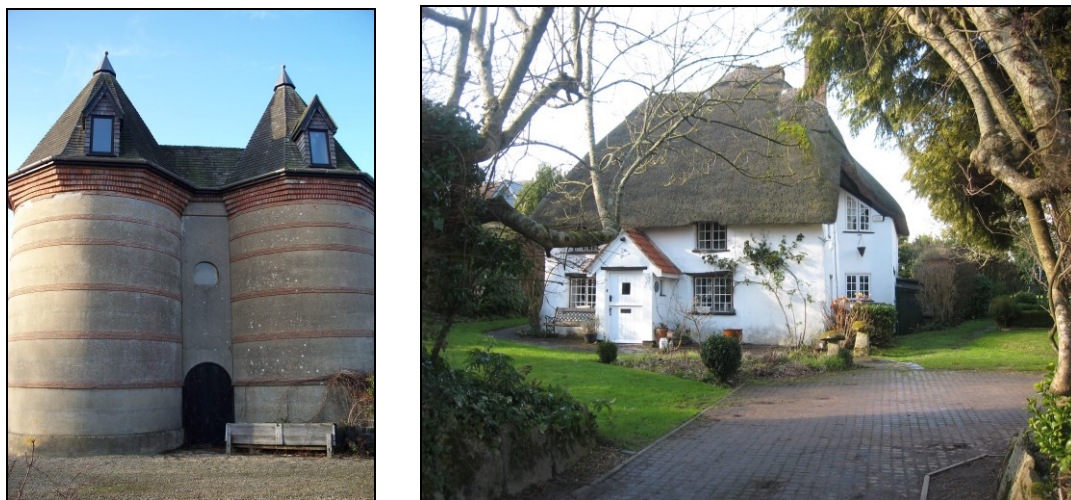
**FIG. 18:** *Architectural character. Left: turreted silos at Briantspuddle Dairy. Right: the local vernacular demonstrated by No. 2 Briantspuddle.*

71. The 'vernacular' is strongly represented by cob and thatch cottages (see FIG. 18 below and 4, 5, 16, and 30) occasionally refaced in brick and invariably modified since construction. Built according to local tradition these show typical inconsistencies in the organisation of details, whilst sharing a range of basic common forms and components. Vernacular character is best appreciated and shows a particular dominance where historic buildings form clusters, most particularly around the core of Briantspuddle, and on a more localised basis in Throop and the west end of Affpuddle (see FIG. 30).

73. Arts and Crafts style was favoured by the Bladen Estate, and as such has a strong presence within the conservation area generally, and a defining presence in Bladen Valley in particular. Designs can be attributed to Halsey Ricardo and Leslie MacDonald Gill, who was architect in residence on the Estate 1914-19. As discussed in the sections above, house designs vary in terms of the elaboration of form and degree of stylisation, contrasting with earlier vernacular buildings in terms of scale and formality whilst reflecting more general aspects of their character. Of particular note was the stylistic treatment of more functional buildings on the Bladen Estate (see for example FIG. 18 below, and 12, 13, 18, 21 and 24).

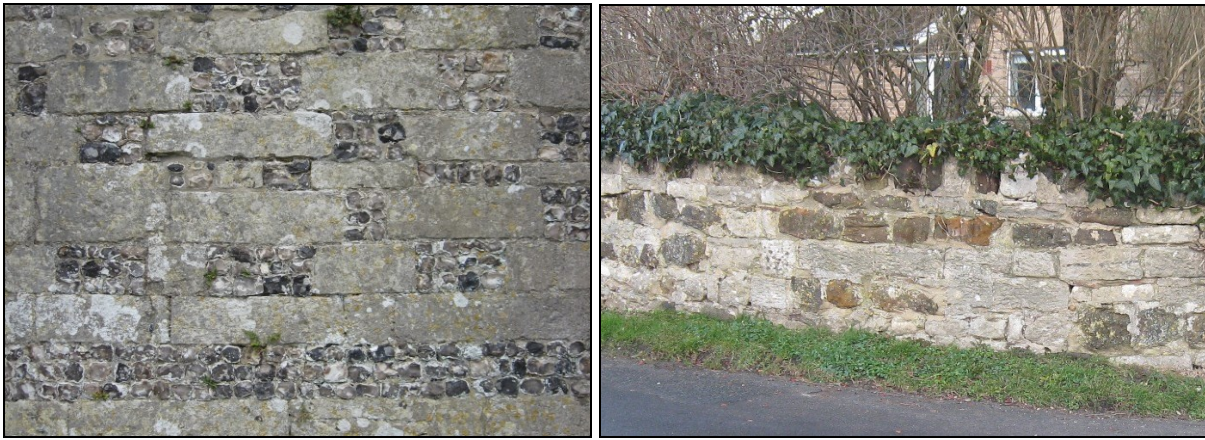
**FIG. 19:** Stone. Left: Panels of knapped flint used to create a chequered pattern with blocks of limestone at the parish church in Affpuddle. Right: heathstone and limestone rubble in the wall now forming a boundary of Barbaru, Briantspuddle.

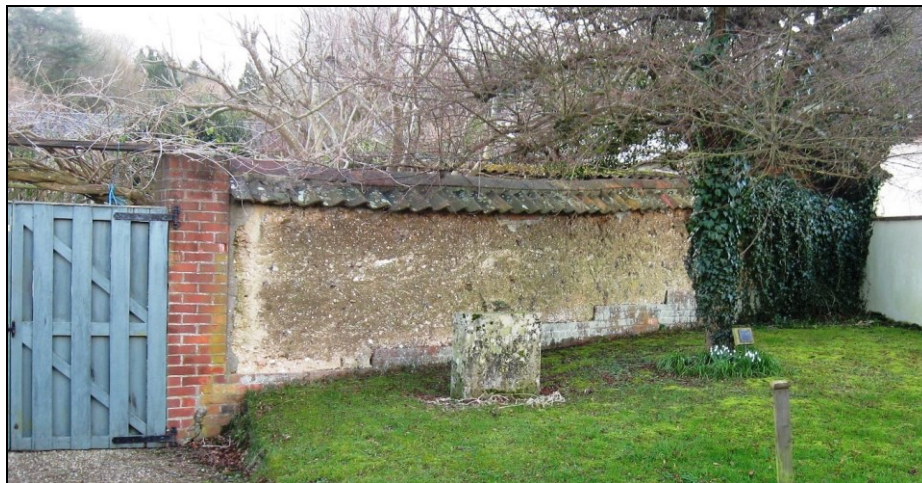
**FIG. 20:** Section of cob boundary wall, Briantspuddle. The protective coat of render appears to have fallen off or been removed. Note the pantile coping and brick plinth.

79. Cob represents the material favoured in vernacular construction of both buildings and boundary walls, and as such is typical of pre-nineteenth century cottage development. Cob structures surviving in the conservation area are generally rendered, though decay of this protective coating has exposed the underlying cob in a number of locations (see FIG. 20 below). Cob construction persisted through the nineteenth century into the Bladen Estate era, though was generally displaced by brick during the former and concrete blocks during the latter.

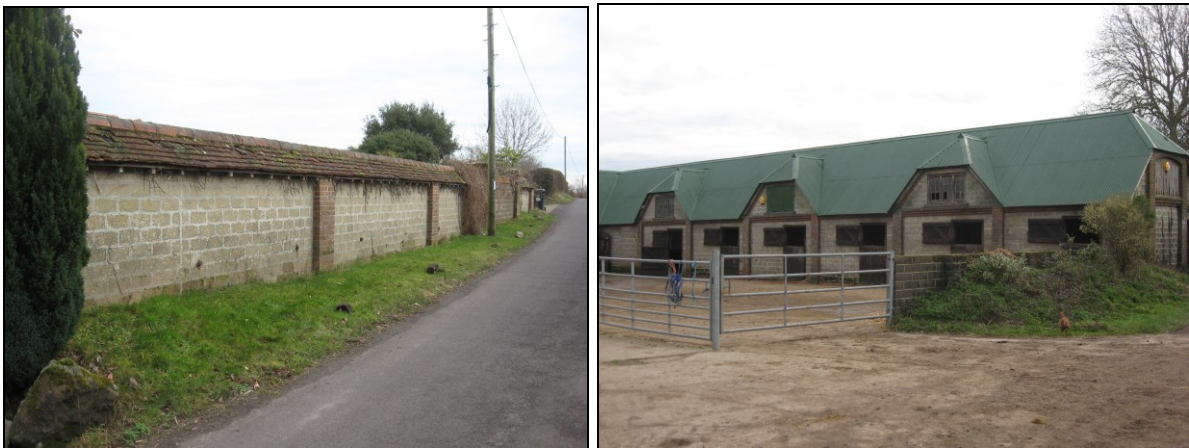
**FIG. 21:** *Bladen Estate blockwork. Estate manufactured block was used in the construction of boundary walls and buildings. Left: boundary wall at Symmond's Barn – note the tiled coping which echoes the weathering provided for cob walls. Modern blockwork is conspicuous where used to fill the former entrance further along. Right: buildings in Affpuddle which again combine block and brick.*

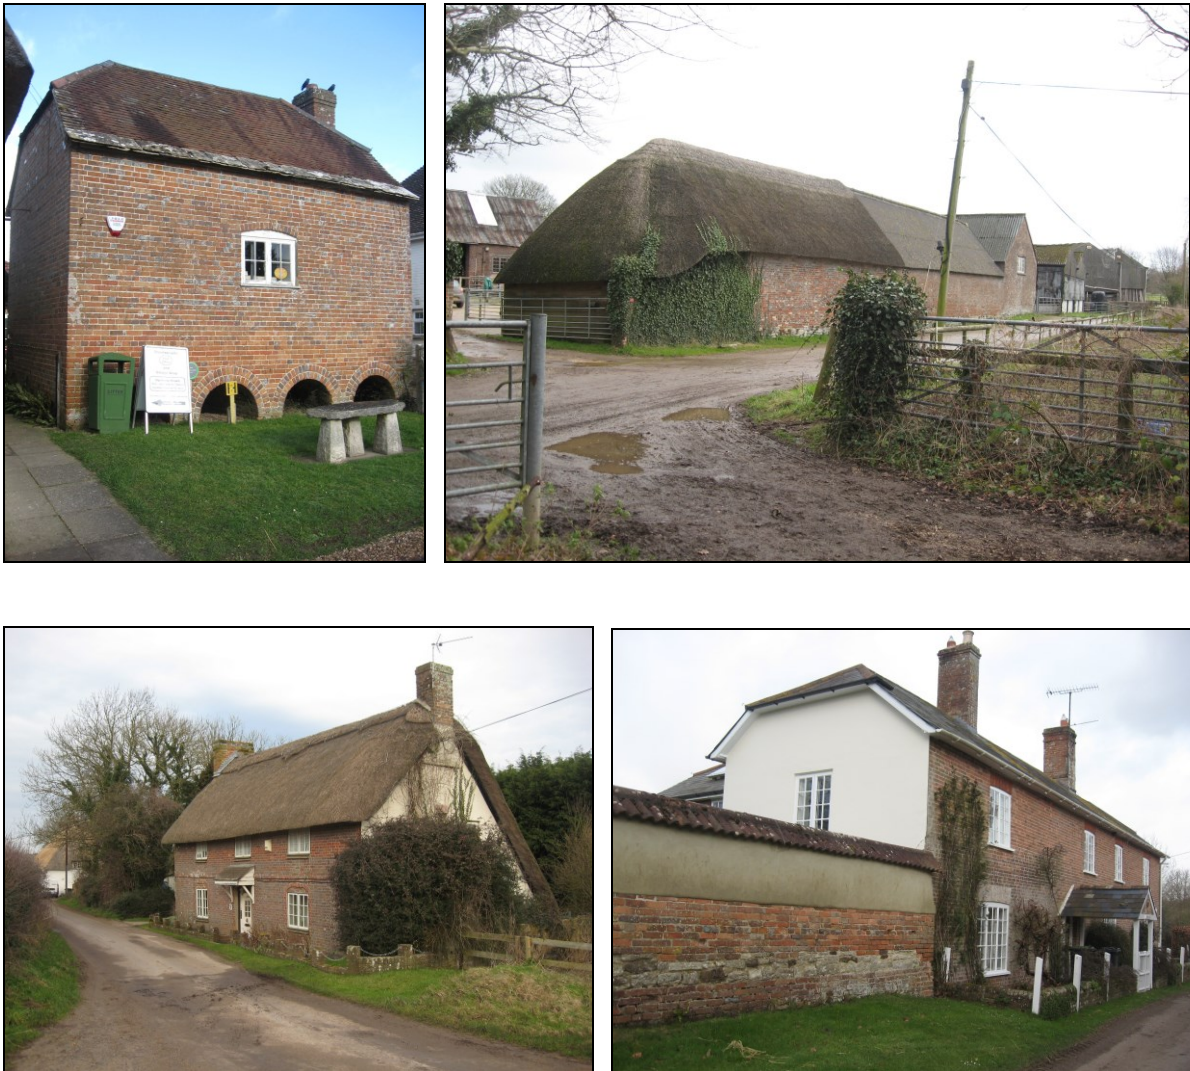
**FIG. 22:** *Brick. The important contribution made by brickwork to the historic character of the conservation area is easily overlooked. Top left: granary, Briantspuddle. Top left: barns at Tonerspuddle Farm. Bottom left: No. 3 Affpuddle. Bottom right: Throop House. Note the range of roof coverings.*

83. As noted above, brickworks were operated in the broader locality by both the Moreton and the later Bladen Estates, providing an important source of building materials. Manufacturing sites included a kiln at Oker's Wood which was in existence during the eighteenth century, another near Briantspuddle which principally functioned during the second half of the nineteenth century, and a third near Blackhill which the 1929 Bladen Estate brochure describes made a 'mottled purple' brick.
84. At least initially the use of brick appears associated with status. At a time when cob was in widespread use, the late eighteenth century saw brick used in elements of East Farm, the Old Vicarage at Affpuddle, Tonerspuddle Farm and the adjacent barns. In Briantspuddle meanwhile, the former granary built in 1814 (see FIG. 22 above), would have appeared exceptional in its context, representing a bold

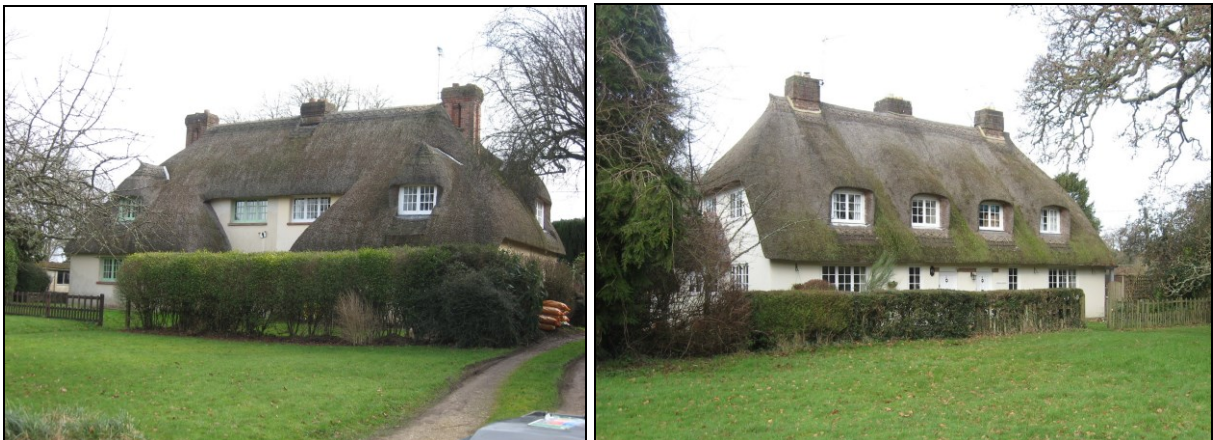
**FIG. 23:** Picturesque roof forms. Left: Nos. 9 -10 Bladen Valley. An identical pair (Nos. 15 and 16) stands in Briantspuddle. Right: Nos. 3 - 4 Bladen Valley.

87. Roof forms are varied and include hipped, half hipped and pitched configurations, the latter sometimes with a cropped gable. Form does not generally appear related to use of material. Bladen Estate designs feature some stylistic elaboration of standard forms (see FIG. 23), whilst the conical arrangements seen at the former Briantspuddle Dairy are unusual.

92. The majority of thatched buildings have flush ridges (e.g. see FIG. 23). This is traditional, local form of finish. Ornamental block ridges, fashionable post-war, are seen less frequently. These detract from the simple form and appearance of the roofs on which they are used and the locally distinctive character of the street scene.

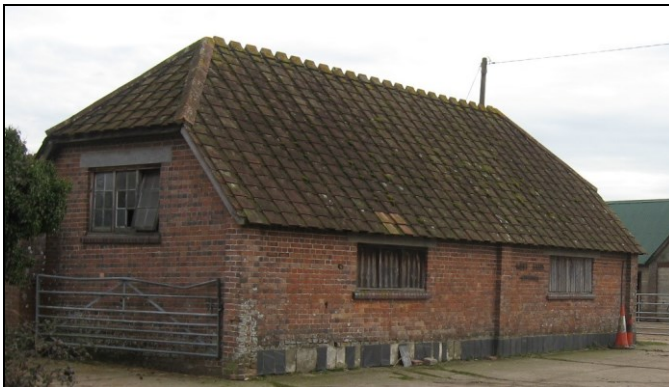
**FIG. 24: Broomhall tiles.** This complex interlocking tile is a 'Taylor's Patent' designed in 1855 by Thomas Taylor Coniam, produced by Broomhall Tile & Brick Co, in Bridgwater. An advert from Laxton's Builder's Price Book 1868 is shown below. The tiles can still be produced by special order.

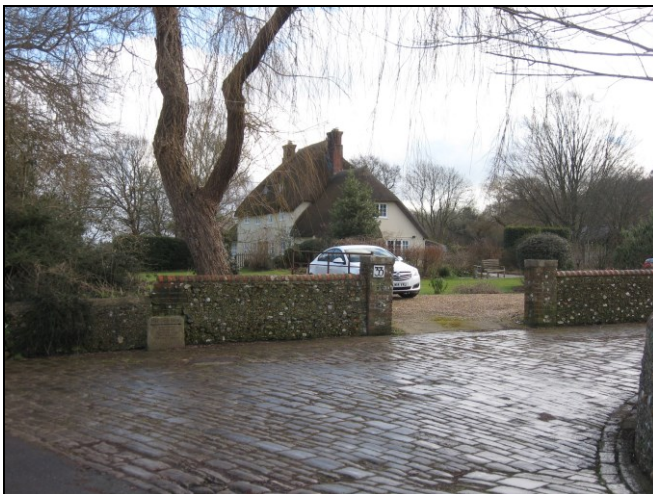
**FIG. 25:** *Paving at the entrance to Briantspuddle Dairy. Note the bulky form and spacious position of contemporary semi-detached pair, Nos. 33 and 34.*

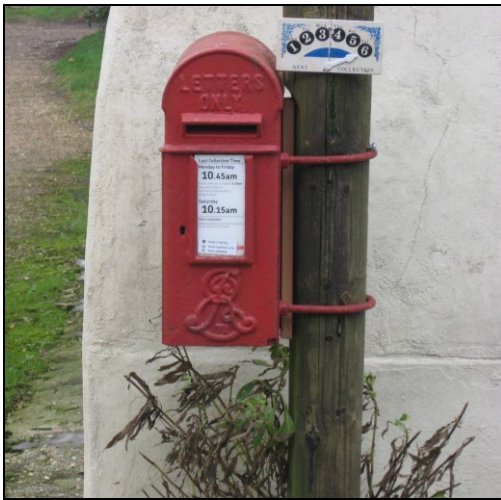
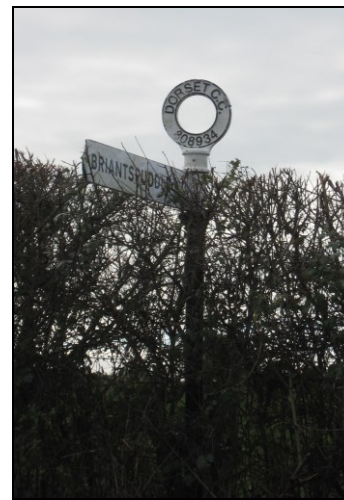
**FIG: 26:** *Street furniture. Left: Edward VII letter box, Throop. Right: finger post, junction of B3390 with Briantspuddle road. The finger is a modern replacement – other fingers are missing.*

105. The conservation area contains four finger posts, generally installed during the 1920-30s. A modified finger post which has lost its roundel but retains its black and white stripes stands opposite No. 21 Affpuddle. A refurbished post with original roundel but modern printed finger (others appear to be missing) stands opposite No.

24 Affpuddle. A third post, again modified and lacking its roundel stands at the cross road in Briantspuddle, whilst a fourth stands on Yearling's Drove pointing the way to Turnerspuddle. This post again lacks its roundel and is in the worst condition.

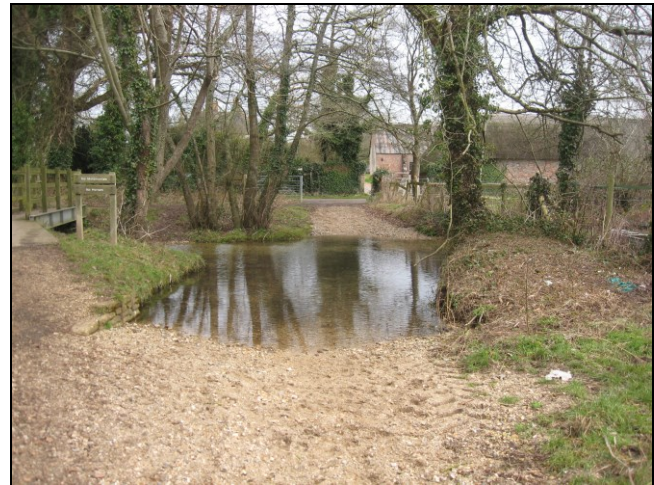
**FIG. 27:** *The River Piddle at Turnerspiddle. Here the unmetalled road from Throop passes through a ford. A pedestrian footbridge has been added for walkers.*

115. Here as elsewhere agricultural intensification has greatly diminished the ecological richness of the meadows, though it remains possible to find isolated wild flowers. Degradation (in particular the creation of swampy patches of scrub woodland) has however perhaps also created new habitats.
116. The River Piddle itself holds significance as a 'chalk stream', a relatively rare habitat of particularly high biodiversity value. Whilst no longer in traditional management, meadowland and fields nonetheless provide some value as foraging places for birds and small mammals. The river itself is an attractive feature and is crossed by a ford at Turnerspiddle (see FIG. 27 below).

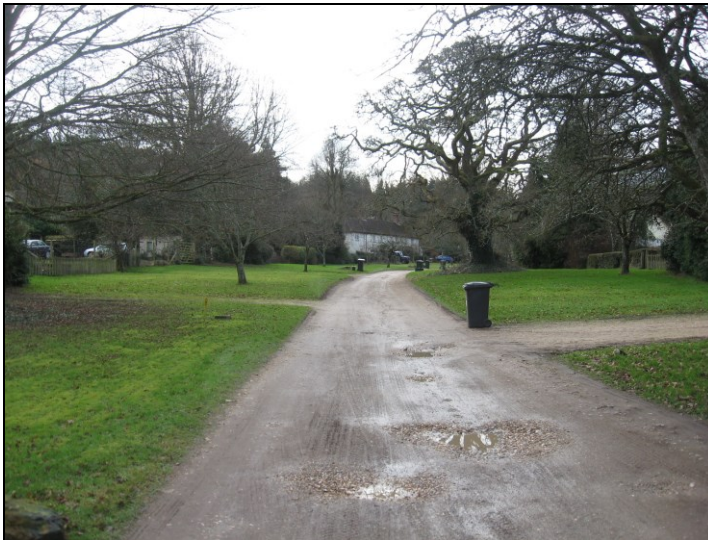
**FIG. 28:** *The broad access to Bladen Valley. Note broad verges and large trees. Enclosure of the verge with hedges has compromised the character of the estate further up.*

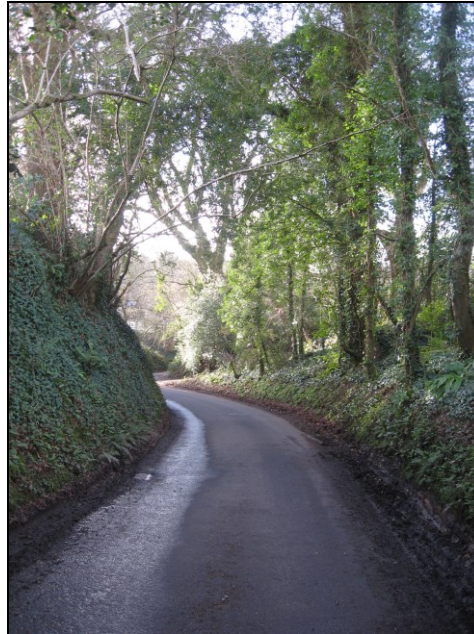
**FIG. 29:** *The Hollow. Trees tower above the sunken road providing considerable character.*

plantations began during the eighteenth century. Woodland immediately abutting the conservation area is however of twentieth century origin. This woodland, which sees pines give way to broadleaf trees closer to the village, lends character to The Hollow and the entry into Briantspuddle (see FIG. 29 below). Here a number of individual trees reach to a considerable height.

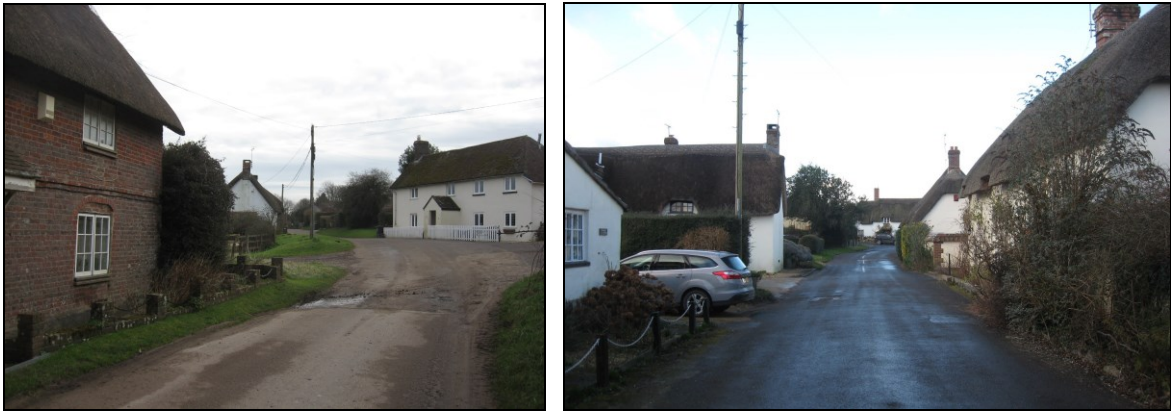
**FIG. 30:** *Framing of space. Left: west end of Affpuddle. Right: Briantspuddle, looking towards the crossroad. In both cases buildings informally frame space, and their arrangement provides further interest where views are closed or deflected.*

55. The majority of cottages of the nineteenth century and earlier occupy street edge positions, often with shallow garden frontage or verge. Where clusters of such buildings occur, such as adjacent to the crossroads at Briantspuddle, in Throop and at the west end of Affpuddle, this provides an intimate and enclosed feel to the street. Cruck Cottage in Briantspuddle (see FIG. 4) is an obvious exemption to the pattern, the spacious plot within which it stands more typical of later housing and historic buildings of high status. Pavement edge development helps lend an impression of increased density in the historic core of Briantspuddle (see FIG. 30), where it is likely to provide a good impression of the historic character of Affpuddle.

89. Amongst buildings that were formerly thatched include Moor Lane House and the barn at West Farm in Affpuddle (FIG. 30). Thatch was replaced with solid roofing on West Farm (house) post-war, but more recently reinstated. A number of properties in Bladen Valley have also lost their thatched roofs.

126. Historic visual character is richest where historic buildings form clustered groups, including adjacent to the cross roads in Briantspuddle, at the west end of Affpuddle, and in Throop. At these locations buildings play a particularly important role in framing space, terminating views, and turning corners (see FIG. 30 below). Here occasional variations in form and position adds visual interest

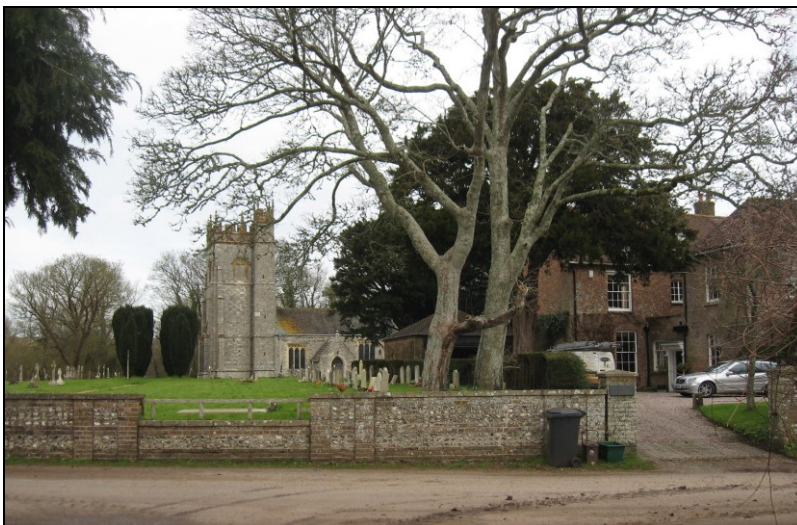
**FIG. 31:** *Visual interest. The grouping of the parish church and old vicarage in Affpuddle, combined with tall and spreading trees and an attractive backdrop provide particular visual quality in Affpuddle. The view wasn't so open historically given structures formerly in the foreground have been removed.*

127. Designed architectural compositions such as Bladen Valley and Briantspuddle Dairy have a strongly picturesque character. Other important compositions include the parish church and old vicarage in Affpuddle, views of which are enhanced by the surrounding trees (see FIG. 31 below).

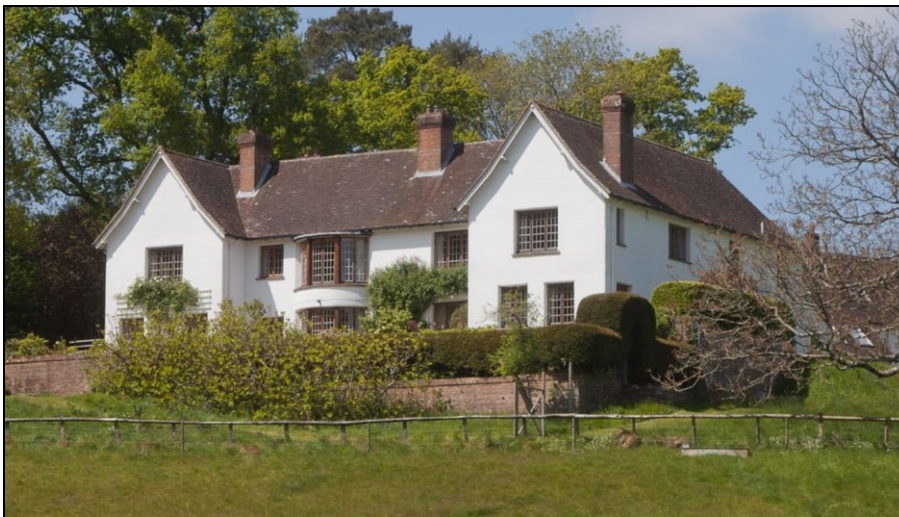
**FIG. 32:**  
*Blackdown House. The grandest Bladen Estate Arts and Crafts design within the conservation area. The house standing within an attractive landscaped setting.*

- Various agricultural buildings at pre-existing farms, including the dairy building at Tonerspudde Farm (FIG. 13 below).
- Blackdown House – (see FIG. 32) one of the most substantial dwellings built by the estate within a landscaped setting.

- *Unlisted Bladen Estate buildings:* Whilst many buildings constructed by the Debeneham Estate have been listed, many others (see History section) have not. Amongst the most notable unlisted domestic buildings is Blackdown House (FIG. 32 below), which is a good examples of the Arts and Crafts design style otherwise exemplified at a more modest scale by Bladen Valley.

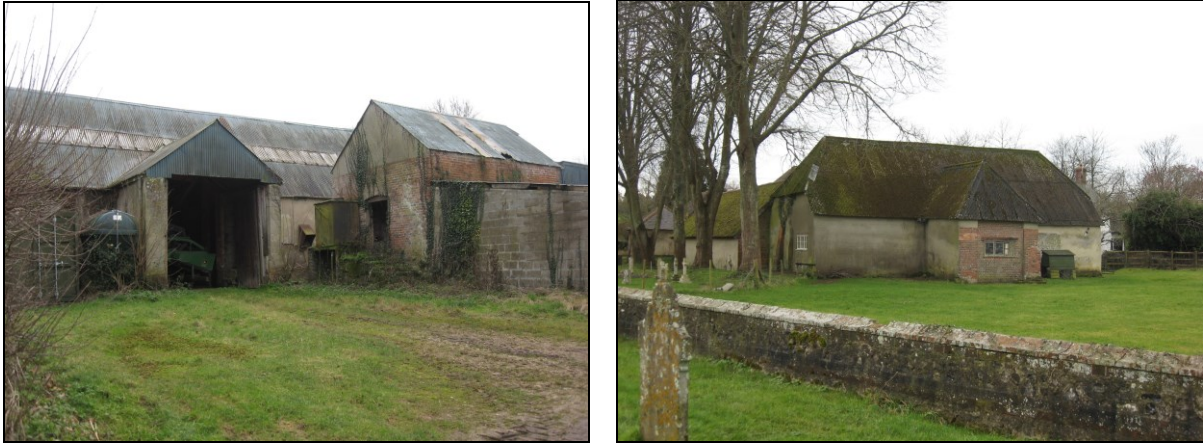
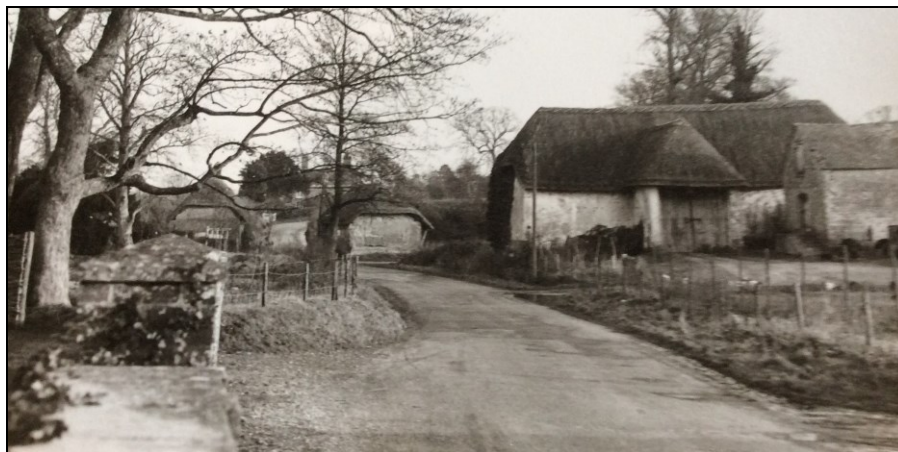
**FIG. 33:** *Buildings of interest. Top left: early nineteenth century granary and barn Affpuddle – the barn was once thatched and is dated 1802 by the RCHM – see old photo below. Top right: Stable Barn, Affpuddle, viewed from the churchyard.*

117. An area of ground opposite Camelot in Affpuddle which was the former site of a cottage, today appears used as an informal dump for garden refuse. Open to view from the road, this harms the appearance and general amenity of the streetscene. Further dumping of material was noted in the green space east of West Farm. This was once the farm's rick yard, still known locally as 'Rickpound'. The space plays an important role in the setting of historic threshing barn and granary located on its east side (see FIG. 33) given a historic functional relationship.

- *West Farm (house), barns, cart shed and granary, Affpuddle:* Two notable groups of agricultural buildings stand opposite and adjacent to the parish church (see FIG. 33 below). These include a much patched cob barn and brick granary at West Farm identified in the 1970 RCHM survey (Dorset Vol II South East Part I) as monument 38. The building footprint is illustrated on page 1xvi of the same volume. For some reason the buildings were not subsequently added to the statutory list. The RCHM indicates that the barn is one of a group of four locally whose main dimensions are almost identical. These include North Barn (Affpuddle) and the village hall in Briantspuddle each of which are listed Grade II, and Wood Barn which is reached by following green lane adjacent to West Farm and is similarly unlisted. The similarities in design are accounted for by all

having been built at roughly the same time during a period of broader modernisation on the Moreton Estate. The barn roof was originally thatched and hipped until apparent replacement during the 1960s. The granary stands on brick arches and is similar in design to that now occupied by the post office in Briantspuddle. Huge potential exists to enhance these buildings which would benefit from sensitive repair and reinstatement of lost features including the thatched roofs. The thatch roof of the farmhouse has previously been reinstated.

131. Insofar as it is possible to observe, domestic buildings generally appear to be good condition. The conservation area otherwise contains a large number of disused agricultural structures (see for example FIG. 33), amongst which the condition of the barn at West Farm is of particular concern. A derelict cob boundary wall also runs along the main street in the same village (see FIG. 37).
132. The finger posts in Affpuddle, Briantspuddle and on Yearling's Drove east of Turnerspuddle are in poor condition and no longer maintained by the County Council.
133. Given the fact that the water meadows have, for the most part, not been subject to traditional management for several decades or more, some parts are now in very

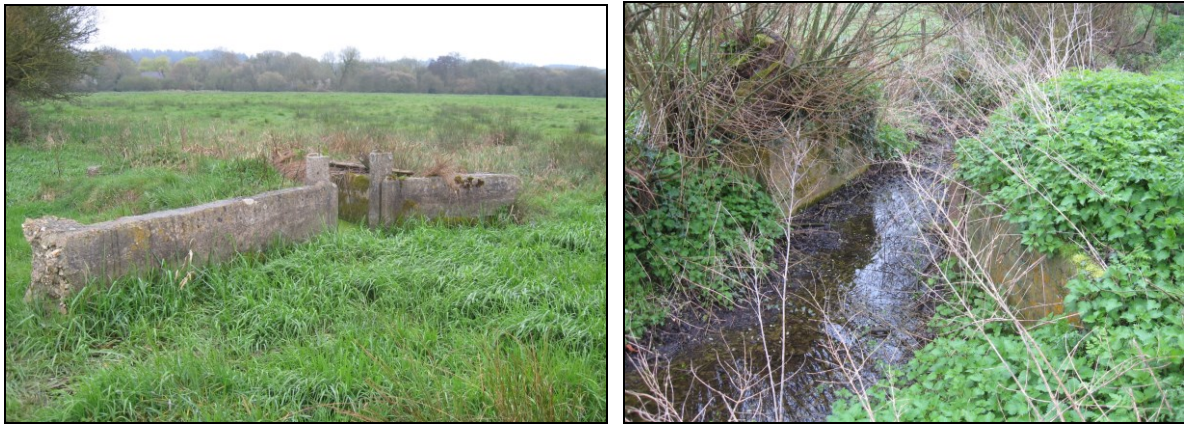
**FIG. 34:** Structures related to past water management. Above left: fragmentary concrete structure which once held a sluice gate, south west of North Barn, Affpuddle. Above right: structure adjacent to the track between Throop and Turnerspuddle. Below left: remnants of another sluice north of the mill in Affpuddle. Below right: interesting concrete bridge north of Throop.

- *The water meadows:* As discussed elsewhere in this document, the water meadows, and in particular those at Affpuddle, hold historic, social and economic significance in terms of their place in the history of agricultural improvement and land management. According to Historic England water meadows are more generally an under-recorded, under-designated type of heritage asset. The meadows contain a range of often fragmentary structures related to past management (see examples in FIG. 34 below).
