## Policy Group – 22 November 2017

### Piddle Valley Conservation Area review

# **Piddle Valley Conservation Area Appraisal**

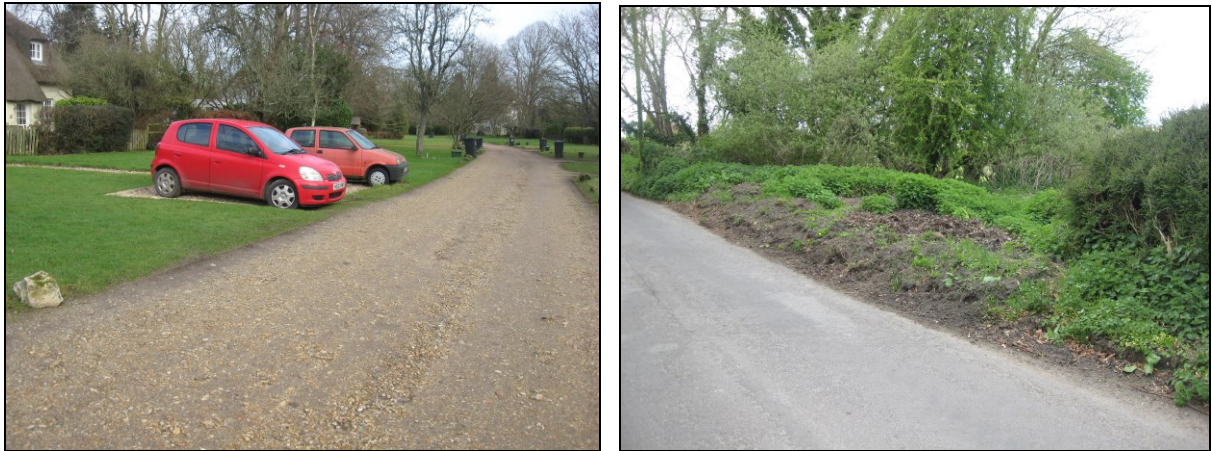
**FIG. 35:** *Problem areas. Left: hardstanding and parking in Bladen Valley. These incursions on the verge harm the character and appearance of the estate. Right: fly tipping along the road edge in Affpuddle. The group of trees is the site of a former dwelling, the steps and part of the boundary wall to which survive.*

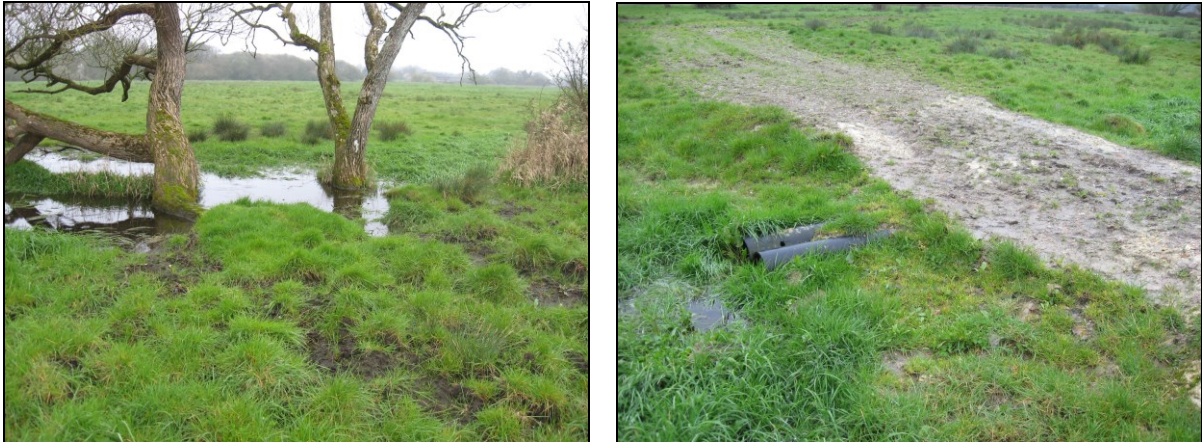
**FIG. 36:** *Deterioration of the water meadows. Two scenes in the meadows on the north side of Affpuddle showing the poor condition of former carrier channels which have become filled, broken, churned up and swampy.*

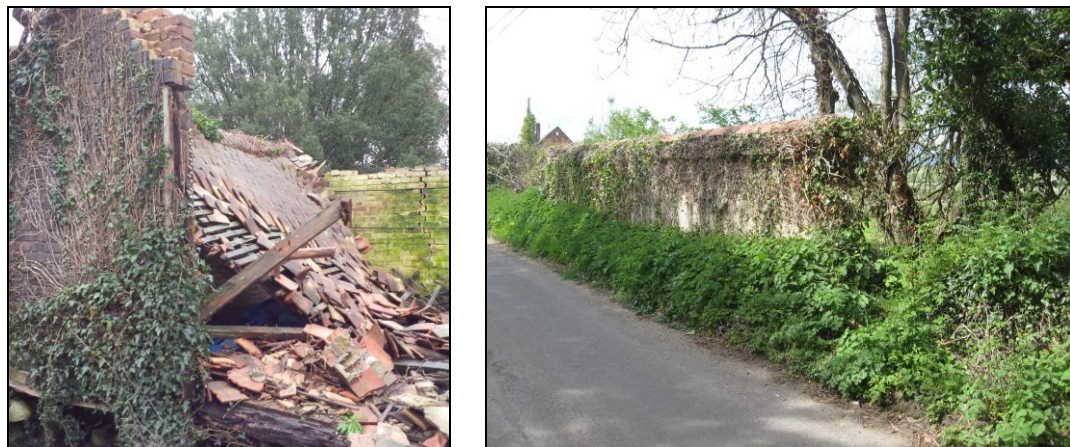
**FIG. 37:** *Derelict buildings and structures. Left: the listed granary at East Farm, Affpuddle. Right: ivy covered remnants of a cob boundary wall, Affpuddle.*
