Consultation Service Report for  
Weymouth & Portland Borough Council

# Weymouth Seafront Toilet Review

Report Commissioned by  
Martin Hamilton & Matt Ryan

April - May 2017

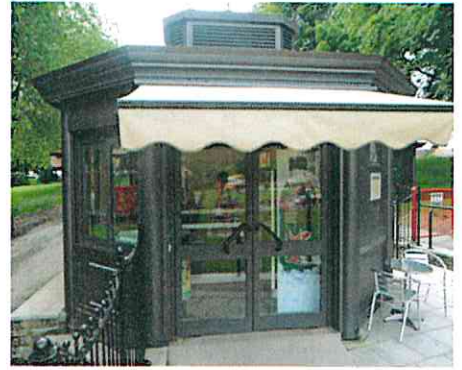
On the BTA's visits to comparative town's it was noted that a number of parks and gardens were utilizing a different style of structure for public toilet provision – a Kiosk. First encountered in Bristol, the unit pictured is directly beside a large children's play park. It therefore services the needs of all users within the park and observations showed that it was extensively used by dog walkers, runners, and parents with children, business persons during lunch and even van drivers and taxi / coach drivers on their commute.

These facilities were run and serviced by the council and while revenues were subject to seasonal variations it was generally accepted that these facilities were run on a cost neutral basis. Some consideration had been given over to leasing these facilities out to local entrepreneurs but as yet no plans had been accepted.

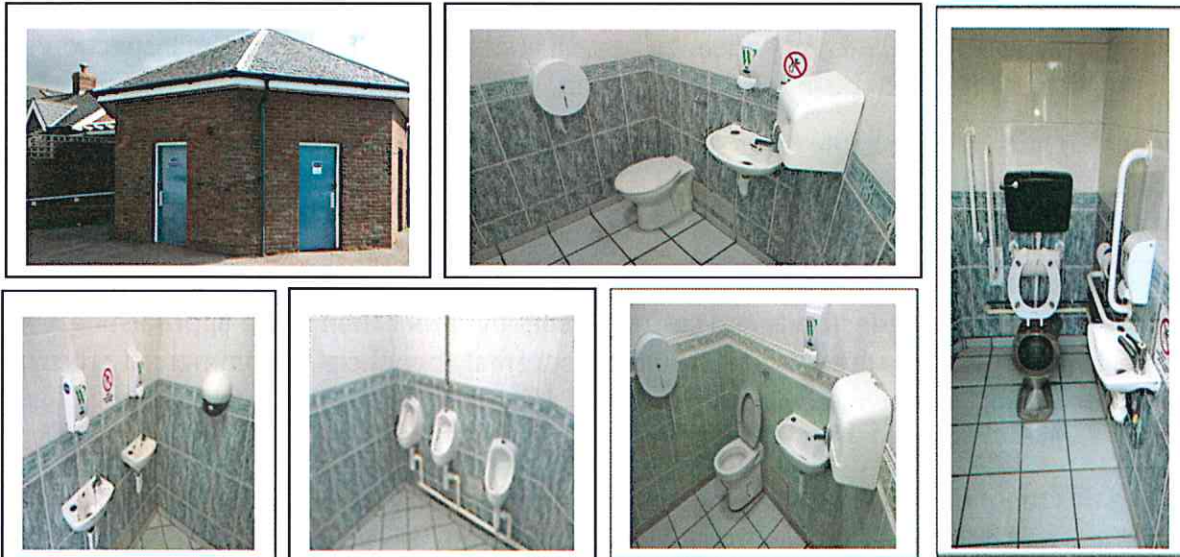
This modern building is situated at the far end of the Promenade, however there is very limited parking close by. Currently pedestrian visitors reaching this point would be unsure/unaware that the building exists. Some additional signage would be helpful.

<b>Male facilities:</b>	1 x cubicles	3 x urinals	2 x washbasins
<b>Female facilities:</b>	3 x cubicles	3 x washbasins	
<b>Accessible facilities:</b>	1 x 24 hr Accessible unit		
<b>Baby change facilities:</b>	1 x Fold down Baby change bed

The toilets are well equipped and appear to be well maintained, and during the inspection all elements were found to be in full working order.

We would recommend some additional signage at the end of the promenade and perhaps at the approach to the junction.

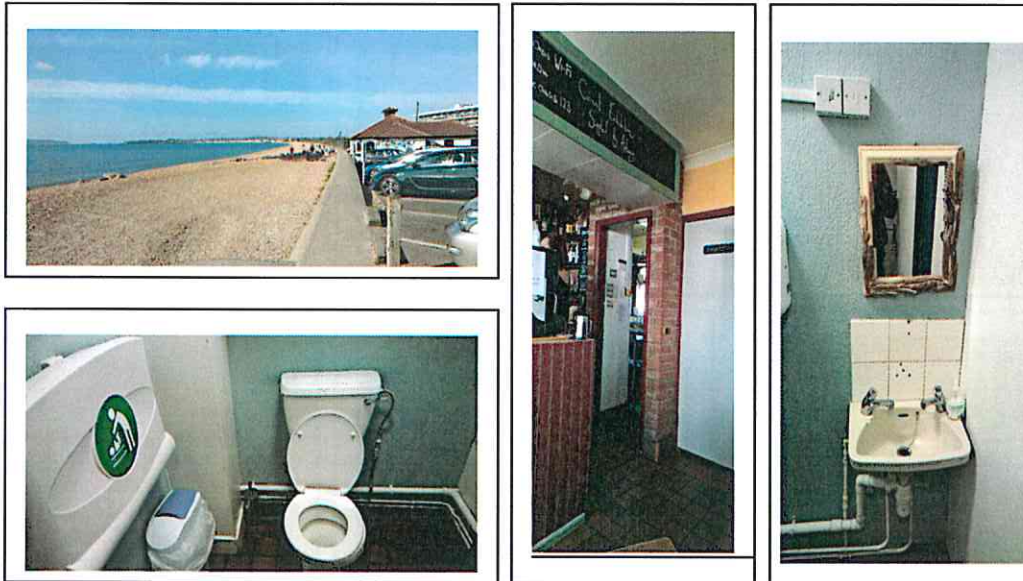
This modern building is situated at the end of the promenade and offers very limited parking. Whilst the parking is chargeable – this fee is refunded - by the restaurant - if you are purchasing food or beverages. Use of their in-house toilets is FREE for customers.

<b>Male facilities:</b>	1 x cubicles	0 x urinals	1 x washbasins
<b>Female facilities:</b>	1 x cubicles	1 x washbasins	
<b>Accessible facilities:</b>	None		
<b>Baby change facilities:</b>	1 x Fold down Baby change bed

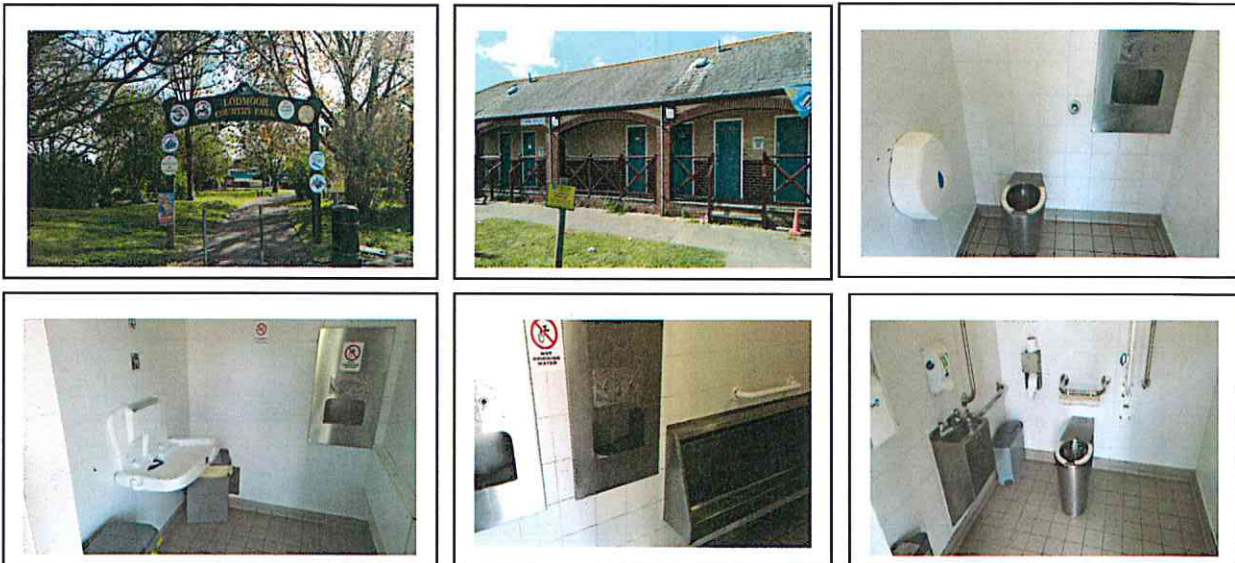
A substantial block of toilets servicing this major park and adjacent seafront. The exterior walls and doors paintwork needs attention and signage is poor and potentially confusing. The area around the block is very poorly kept and is heavily littered in places.

**Male facilities:** 3 x cubicles 2 x 4bay S/S urinals 3 x washbasins  
**Accessible facilities** 1 x accessible unit  
**Baby change facilities:** 1 x Baby change unit

These facilities are fitted with stainless steel fixtures to prevent anti-social activity or reduce the effects of misuse during peak holiday periods or out of hours. The lack of proper toilet seats is causing some concern and is often off-putting for many older persons and children. A number of faults were detected on my visit, for example... lights out, soap dispensers empty, handdryers not functioning. A constant stream of visitors was observed approaching these facilities – however due to the reasons stated above, many were also turning away to go in search of alternative conveniences.

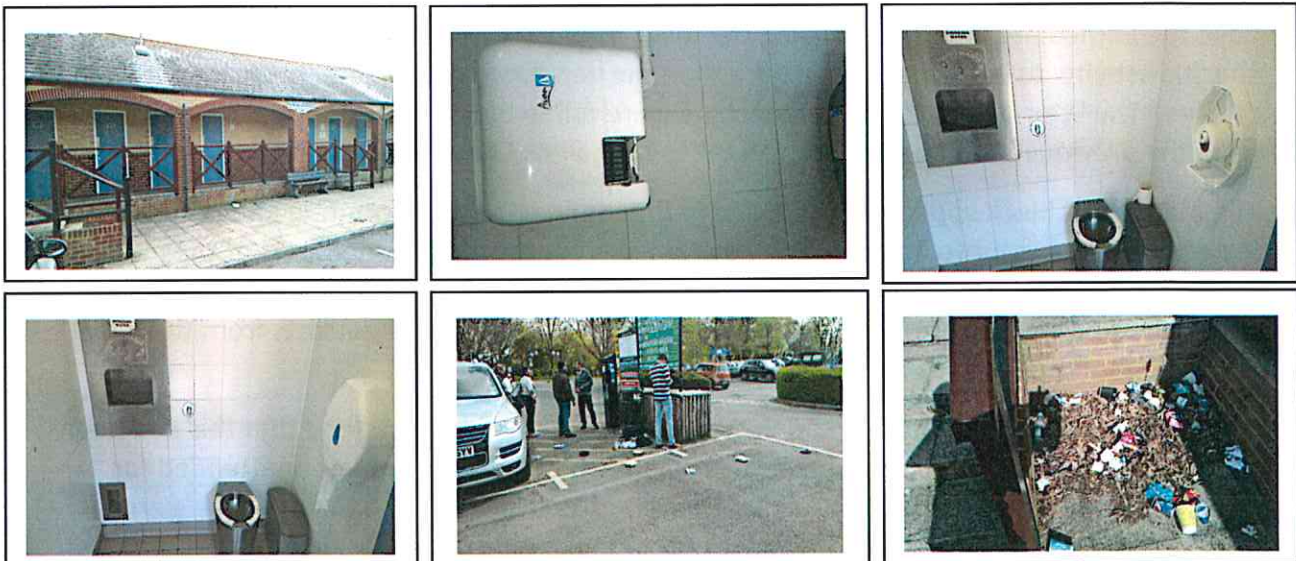
Like the Male units on the reverse side these facilities are struggling to cope with the volume and demands of their current usage. In addition to the need for an upgrading of fixtures - the installation of a bin or bins would seriously help to control the build-up of substantial debris and dirty nappies outside the units. Better signage is also required.

<b>Female facilities:</b>	8 x cubicles	8x washbasins
<b>Accessible facilities:</b>	None on this side	
<b>Baby change facilities:</b>	None on this side

These facilities welcome a substantial number of visitors each week and significantly help to ease the town's burden. However they appear to be forgotten or not correctly scheduled for the cleansing squads - as repeated visits were made and little change observed.

The internal fittings are mainly stainless steel and we would understand that this had been requisitioned to cope with an anti-social problem – if these units are left unattended for long periods and the park is easily accessed even after the hours of darkness. There are a number of new materials that are being used to replace the original stainless steel, which serve a similar function but with a more pleasing finish.

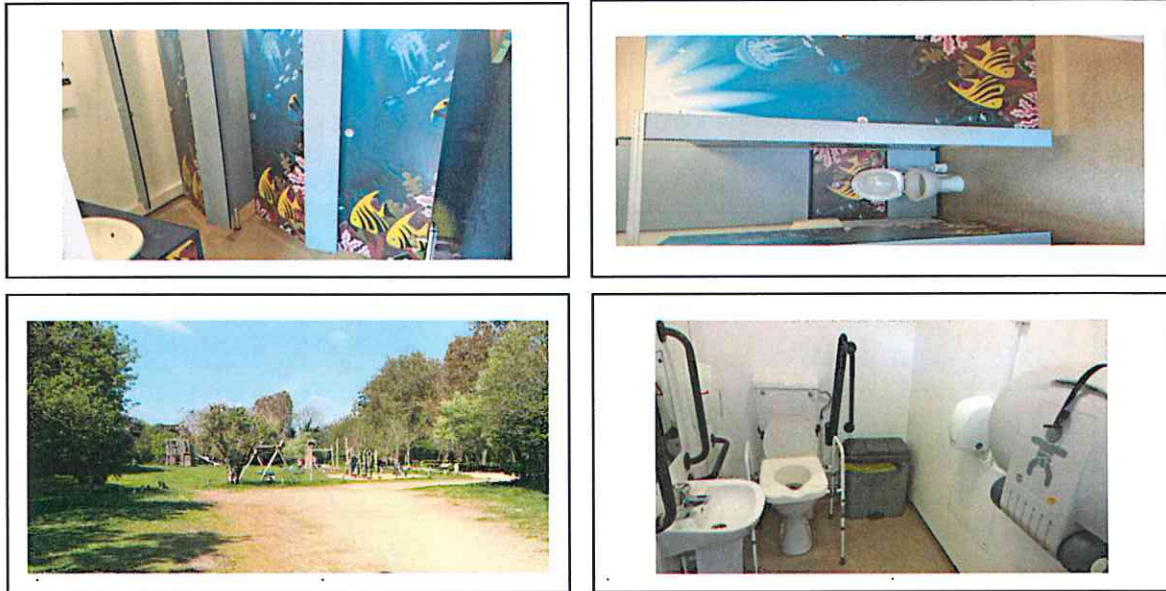
## SEALIFE PARK & CHILDRENS PLAY AREA

This particular park appears to be the only additional toilets located at this site. It contains 3 separate toilet blocks each with male, female, accessible and baby change facilities.

The toilets appeared to be reasonably well maintained, however there were a number of littering and cleaning issues observed. Access was gained via a set of steep stairs, and this would always be of concern regarding health and safety (slips, trips and falls).

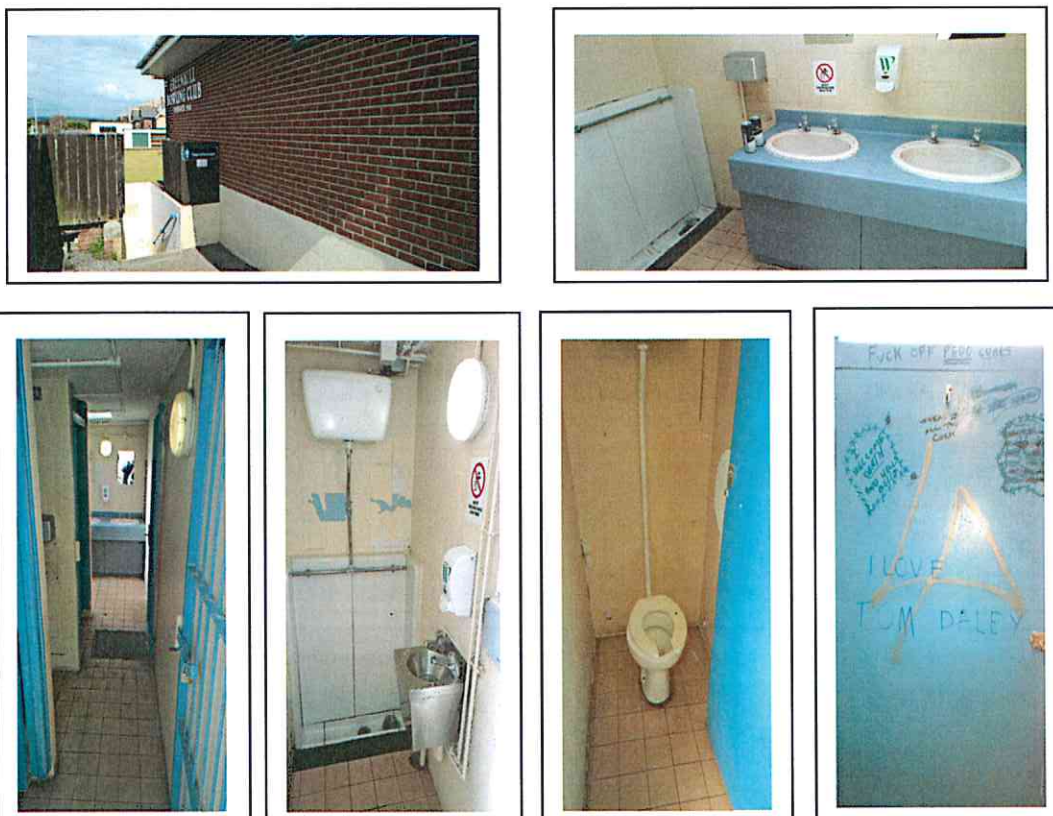
These toilets are located underground and although signposted from the lower promenade, serve only a small number of passing visitors and beach front users. Their main function is probably to facilitate the small drinks kiosk and the large putting green adjacent.

**Male facilities:**                      2 x cubicles    5 x urinals    2 x washbasins

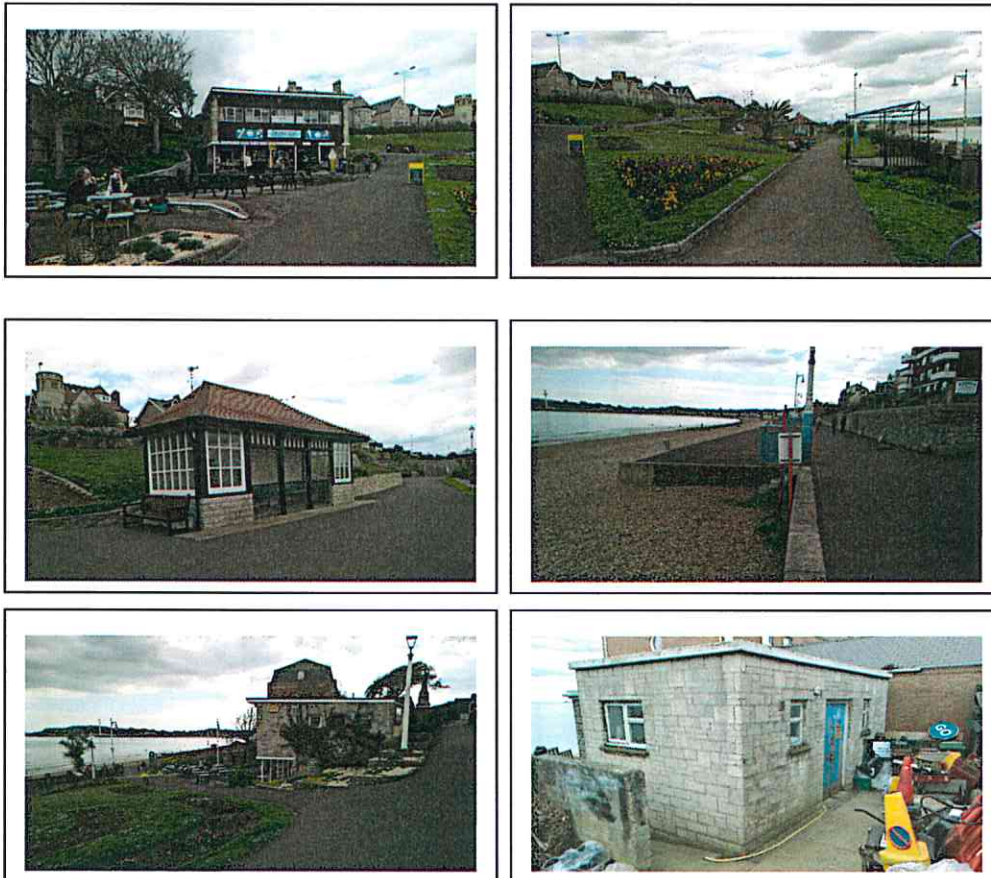
## GREENHILL GARDENS – Overview & Considerations

A sizeable café / restaurant is located at the southerly entrance to the Gardens, and there appears to be no provision for anyone utilising this much more popular area. One of the features of this area is a bandstand which attracts substantial numbers of visitors when concerts or music events take place.

This area appears to be a favourite spot of visitors and tourists, however it is totally lacking in reasonable toilet provision. Directly above the café we discovered a small block building that is being utilised as a maintenance store for council equipment. The current café owner suggested that this building had previously been a toilet block servicing the park, although no other evidence of any previous usage could be gained. Consideration could be given to investigating if this building could be better utilised as a public amenity, as the demand for public relief is probably considerably greater here, than at the other end of the park.

This could also be another area where a portable unit could be brought in to service the demand during concert or festival periods. It was noted that the promenade widened considerably at the Gardens entrance and could facilitate portakabin-type toilets; providing these were self-sufficient and did not require any mains connections, although a more permanent arrangement would always be preferred.

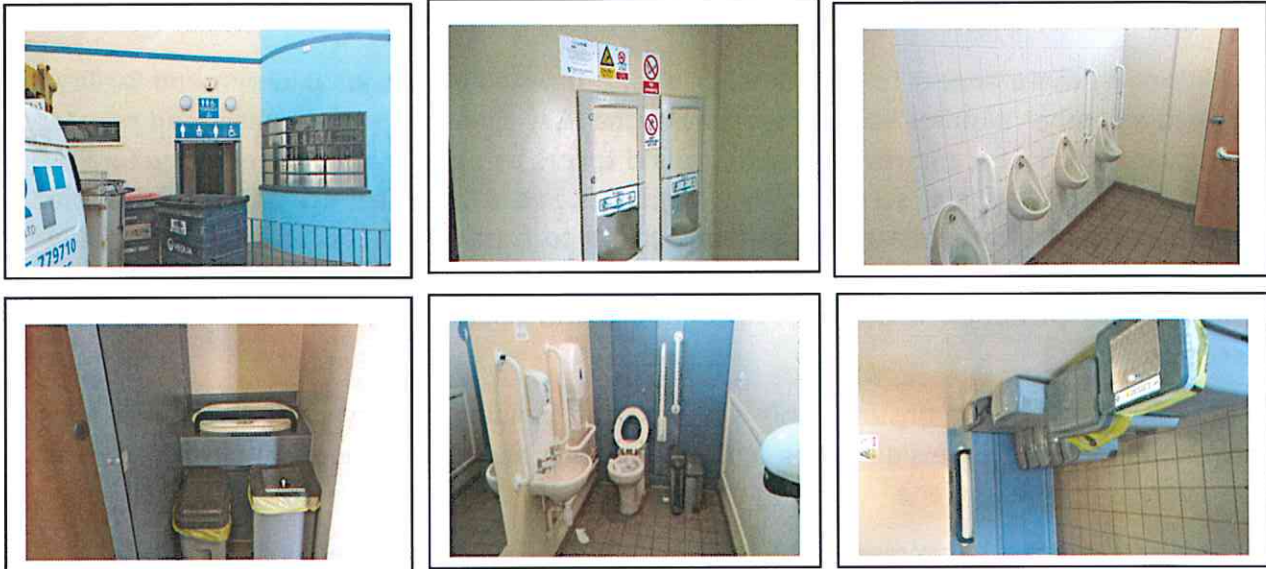
An Art-Deco building situated at the North end of the main promenade. The toilets are located on the L/H side of the building on the ground floor level. These facilities are still reasonably serviceable – but would greatly benefit from an upgrade and redecoration.

<b>Male facilities:</b>	2 x cubicles	4 x urinals	2 x washbasins
<b>Female facilities:</b>	6 x cubicles	4 x washbasins	
<b>Accessible facilities:</b>	1 x accessible unit		
<b>Baby change facilities:</b>	2 x solid beds - 1 in each Male & Female

This unit is very well used and a constant stream of visitors was observed during my survey time. The internal fittings are well worn and probably not sufficient for the volume of traffic being experienced. As with many other units there appears to be a substantial number of SD bins from multiple suppliers – this element needs reviewing. The baby change bed is only accessible by leaning directly over a couple of large Nappy bins – this needs rethought.

Directly outside this unit are multiple entrances to underground facilities that have obviously been replaced. Some consideration might be given to using these old facilities to feed a new overground toilet block at this location.

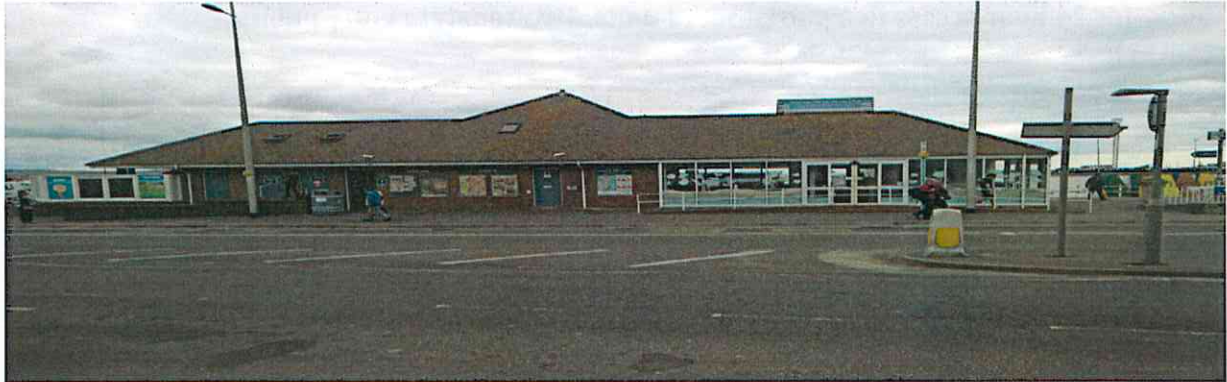
## KING'S STATUE TOILETS – 24HR AND ACCESSIBLE – Data Sheet

As part of the main Promenade building that contains a Café, Haven sales Lounge and a beach observation tower, these toilets are located L/H side at ground level with an access ramp.

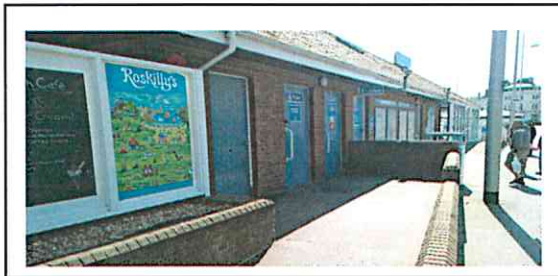
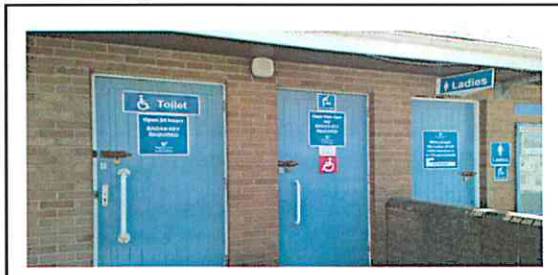
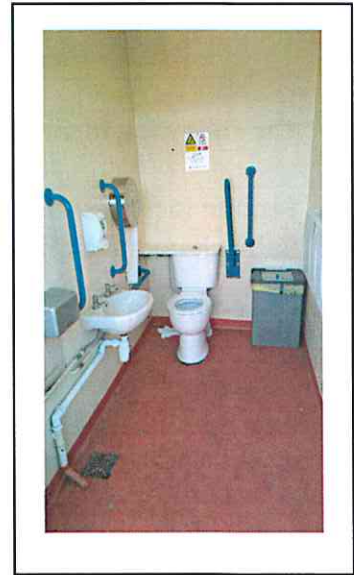
- Accessible facilities:** 2 x accessible unit on ground floor
- Baby change facilities:** 1 x fold down bed in accessible unit

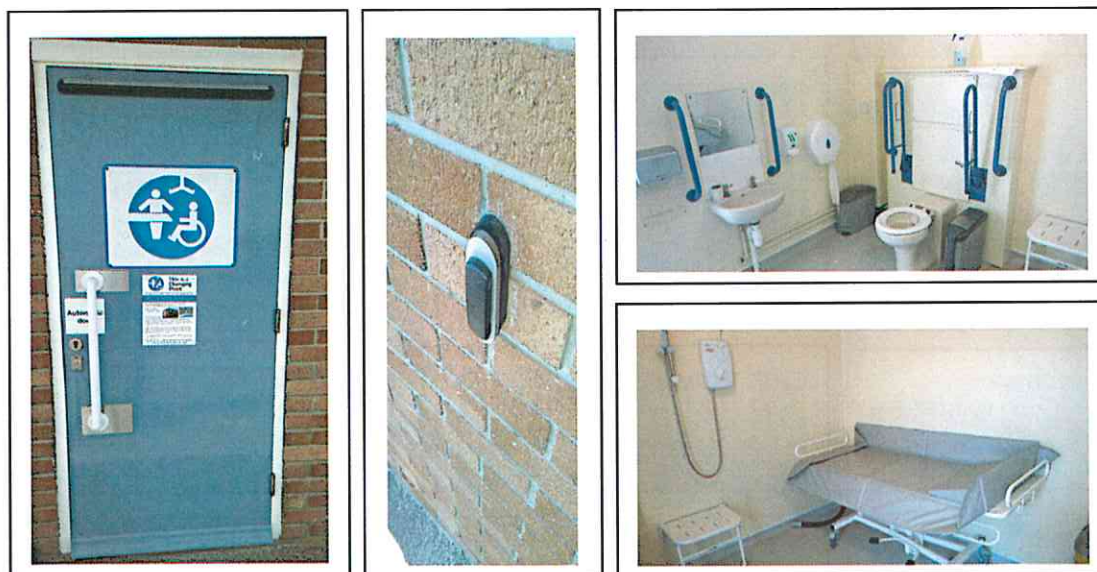
We were extremely pleased to find a Changing Places facility at this location.

<b>Hoist &amp; Track system</b>	fully functional
<b>Adjustable bed</b>	operational
<b>Accessible facilities:</b>	Full

The unit is controlled by a Key-Fob system, rather than a RADAR key and therefore entry is restricted / controlled by the toilet and beach attendants. This probably helps keep the unit in pristine condition for those who really need this type of facility. All equipment appears to be in good working condition but needs to be included in the regular cleaning schedule.

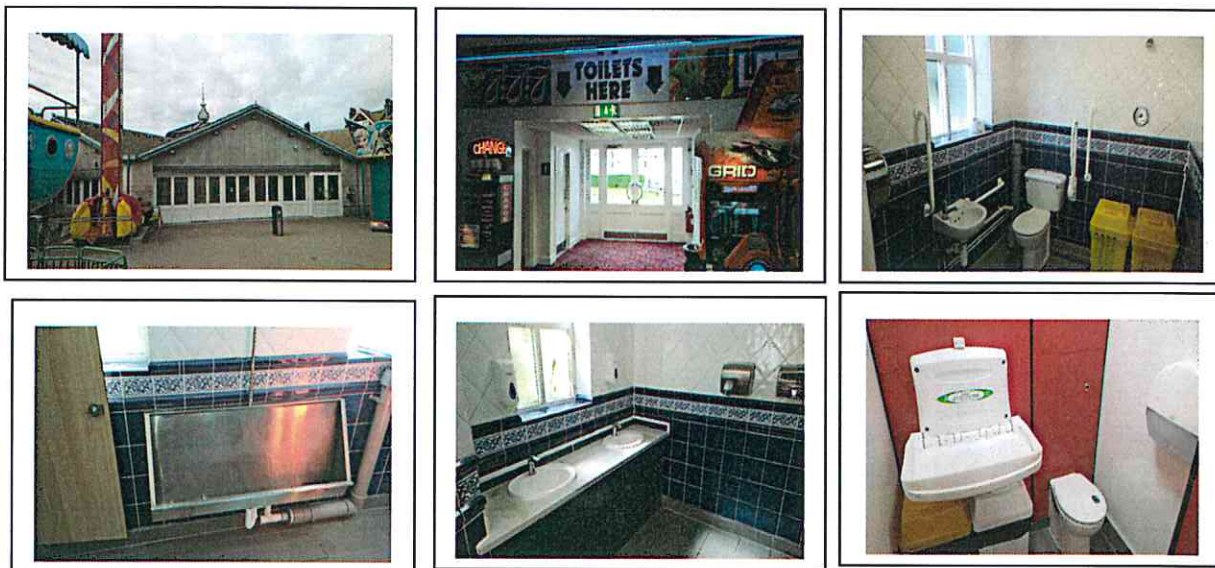
Situated in the middle of an Amusement Park and Children’s Funfair, these toilets are extremely busy and well appointed.

<b>Male facilities:</b>	4 x cubicles	2 x 3bay S/S urinal	2 x washbasins
<b>Female facilities:</b>	7 x cubicles	2 x washbasins	
<b>Accessible facilities:</b>	1 x accessible UNISEX unit		
<b>Baby change facilities:</b>	1 x fold down bed in Female toilet

When spoken to, management confirmed their willingness to allow public access. They also reported that they have problems relating to beach users and the removal of sand regularly found inside the units.

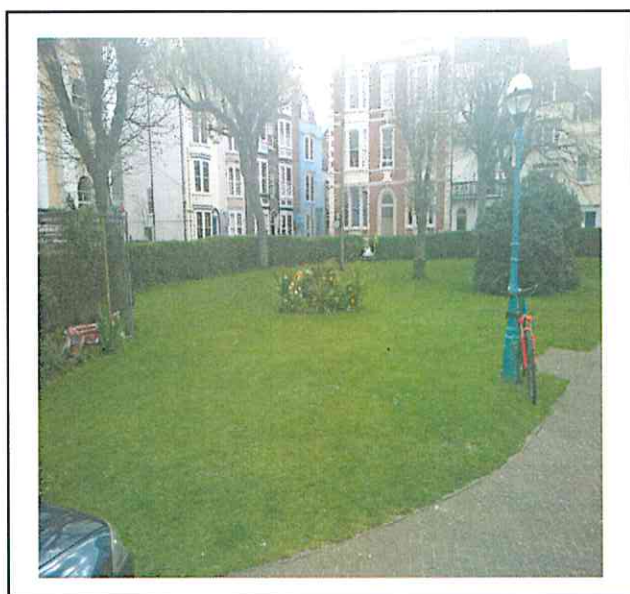
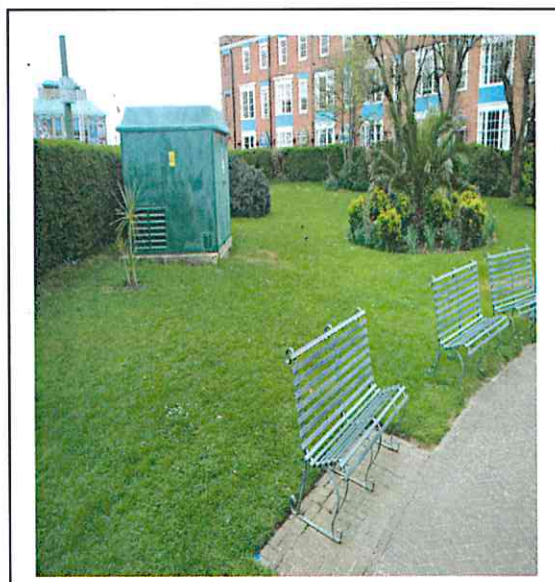
However, to the rear and side of this building are some extensive grassed areas. These might be considered suitable for siting portable or temporary units during the summer season or bank holiday periods. I could understand some resistance from local residents whose homes would be overlooking this area.

These two grassed areas could be of significant benefit if the council was looking to position additional seasonal portable units, where there already is a very high traffic flow, and particularly because toilets are already known to be located in this area.

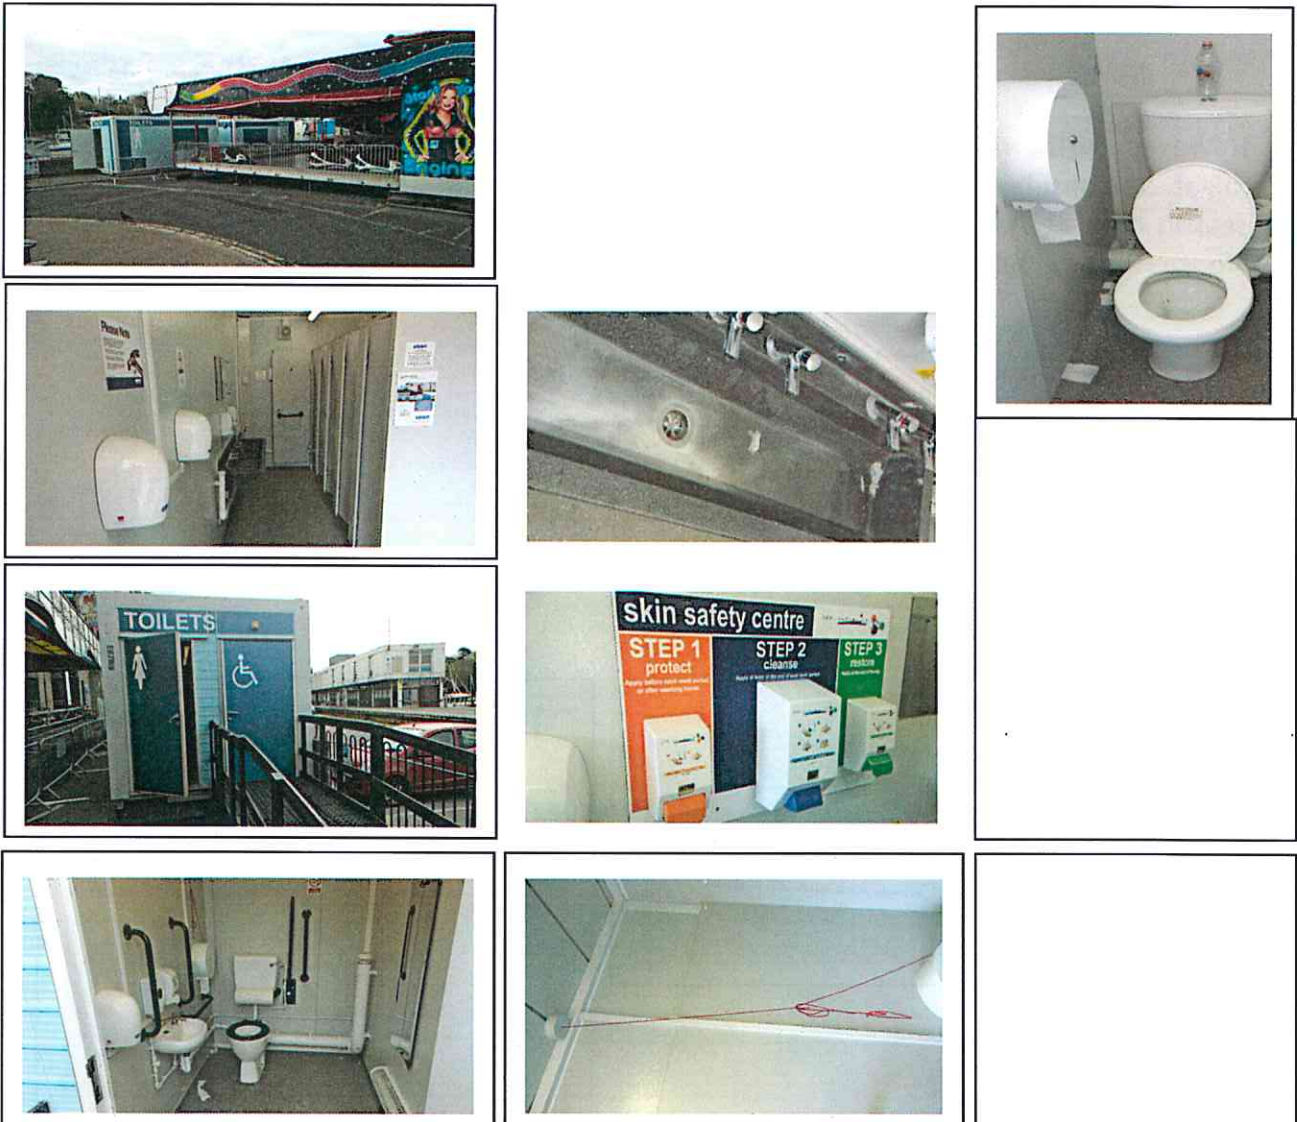
Situated close to and in front of the Pavilion

- Male facilities:** 5 x cubicles 1 x 3 bay urinal 1 x 3 bay washing trough
- Female facilities:** 5 x cubicles 1 x 3 bay washing trough
- Accessible facilities:** 1 x accessible units
- Baby change facilities:** None

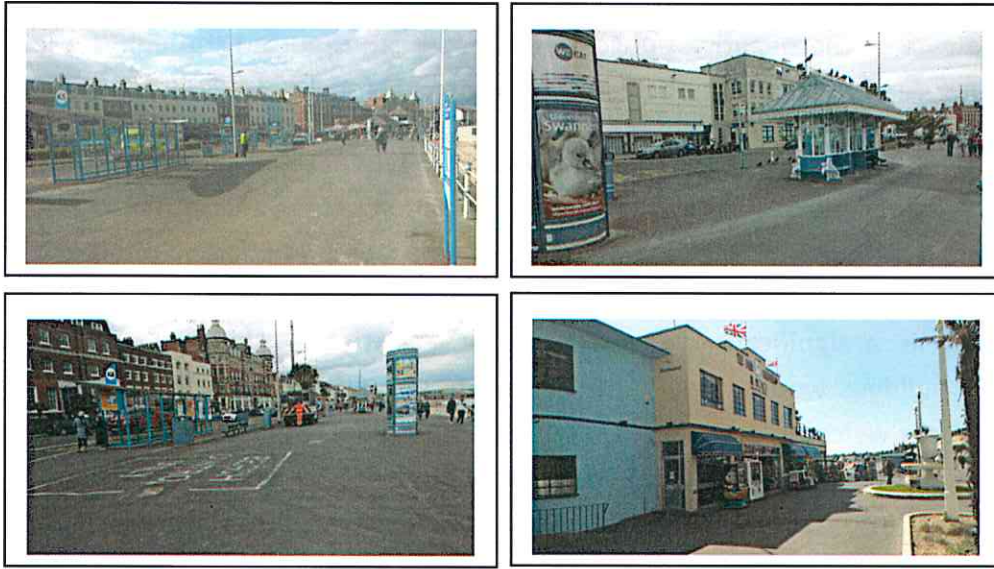
Whilst traversing the full length of the promenade we became aware of a number of areas where the promenade's width extends considerably.

Consideration could be given to the positioning of either temporary portable units or indeed permanent 24hr Automatic Public Toilets (APT's), at these extended sites.
