High Angle Battery HLS Historic & Archaeological Features Management Plan

Reference: AG00567711

Produced on behalf of
Weymouth & Portland Borough Council
by
Dorset Wildlife Trust

HIGH ANGLE BATTERY MANAGEMENT PLAN 2015-2020

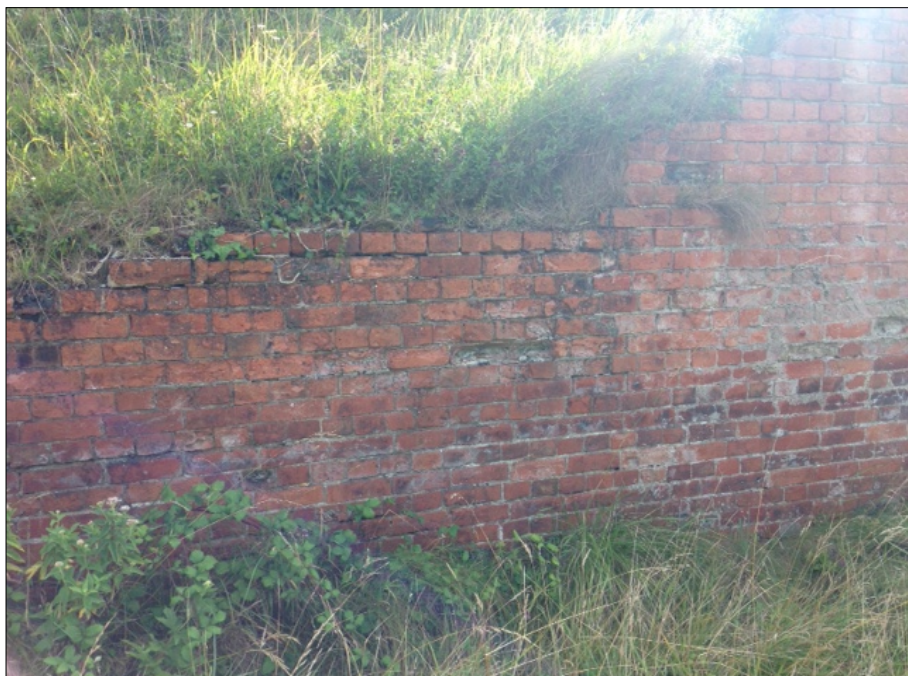
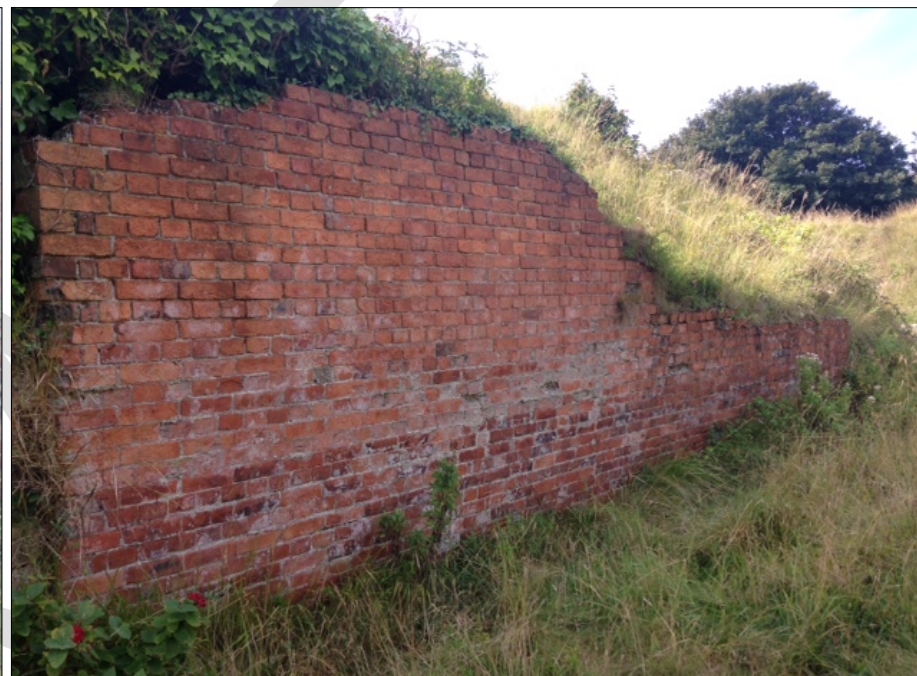
Area 1. (see Works Map)

Location	Payment Code	Description	Outline of work	Date of work	Organisation responsible for work
1.	HAP	Brick wall repair	<ul style="list-style-type: none"> Some pointing required along brick retaining wall. Mortar sample will need to be analysed to determine specification. Seek further technical advice. 	Spring 2018	WPBC

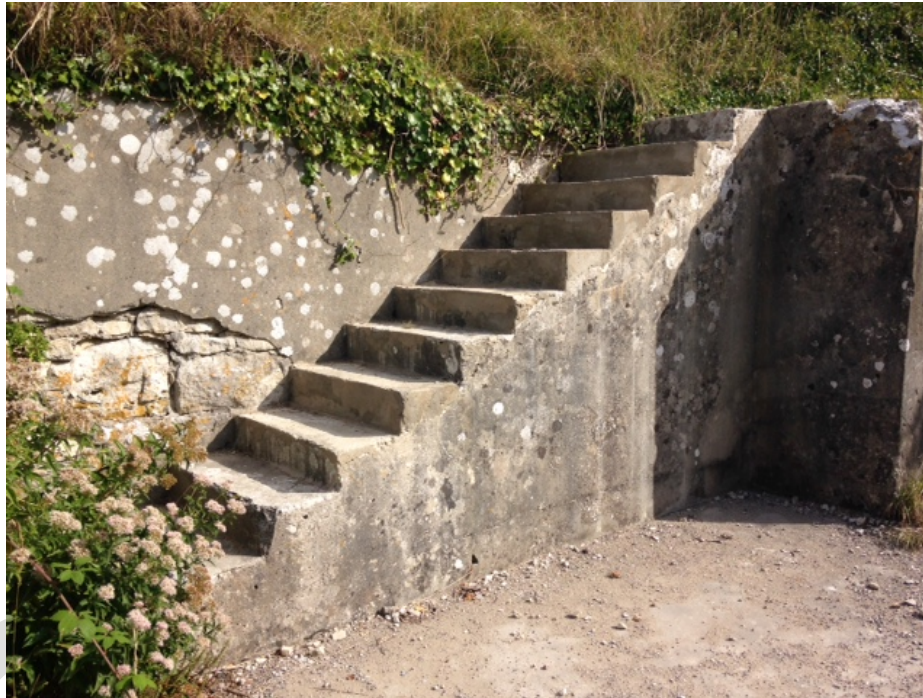
Area 2. (See Works Map)

Location	Payment Code	Description	Outline of work	Date of work	Organisation responsible for work
2.	HAP	Concrete repair	<ul style="list-style-type: none"> • Steps require re-profiling to improve access, safety and protection of original material • Several emergency repairs have been carried out on site to steps. It is acknowledged that these repairs are substandard but will only be undone on the flat areas marked G due to cost constraints. If the budget allows then further areas will be repaired in a more sympathetic manner. <p>A sample of concrete was analysed by Sandberg Consulting Engineers. This identified that the sample was early concrete with graded aggregate. The analysis will be investigated and a specification will be provided from this. It may be necessary to carry out several trial areas in order to get a suitable match both in texture and finish.</p> <ul style="list-style-type: none"> • Seek further Technical/Historic England advice as required. 	TBC	WPBC

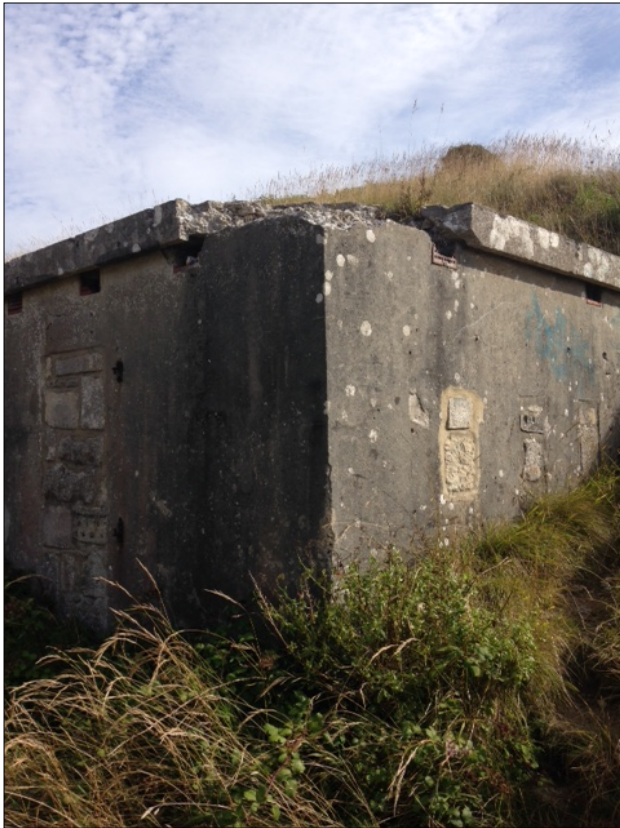
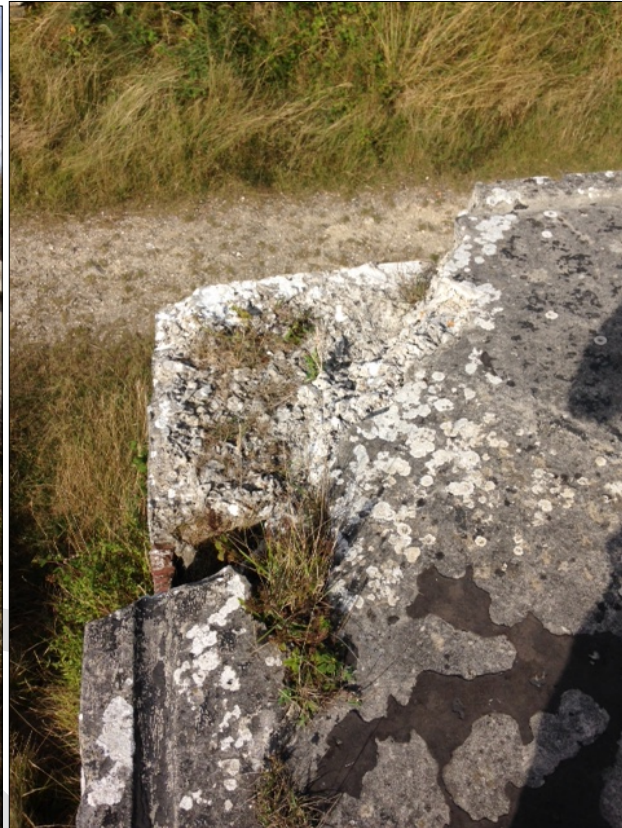
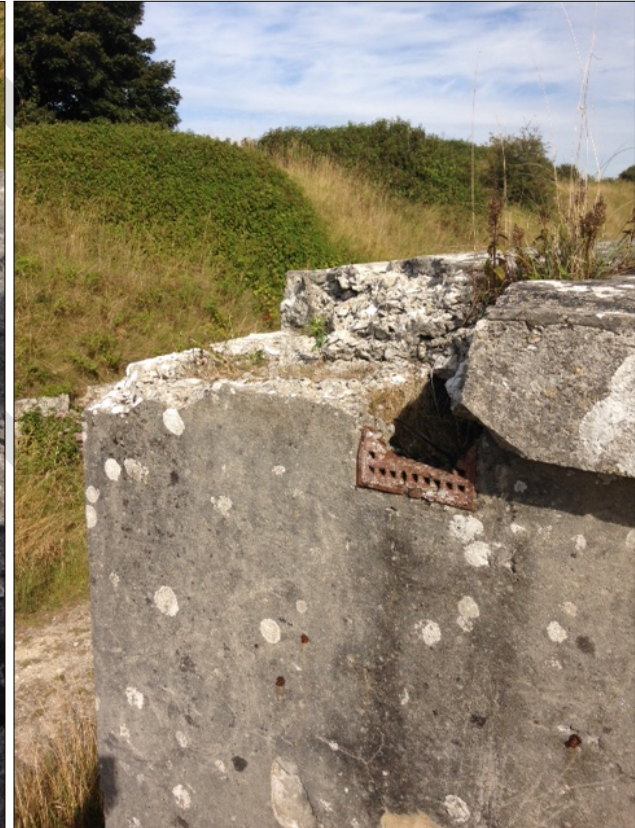
Area 3. (See Works Map)

Location	Payment Code	Description	Outline of work	Date of work	Organisation responsible for work
3.	HAP	Concrete repair	<ul style="list-style-type: none"> • The corner of the bunker is eroding, although it has not completely caved in it needs work to restore the original corner and protect it from further damage. • A sample of concrete was analysed by Sandberg Consulting Engineers. This identified that the sample was early concrete with graded aggregate. The analysis will be investigated and a specification will be provided from this. It may be necessary to carry out several trial areas in order to get a suitable match both in texture and finish. • Seek further Technical/Historic England advice as required 	Spring 2018	WPBC

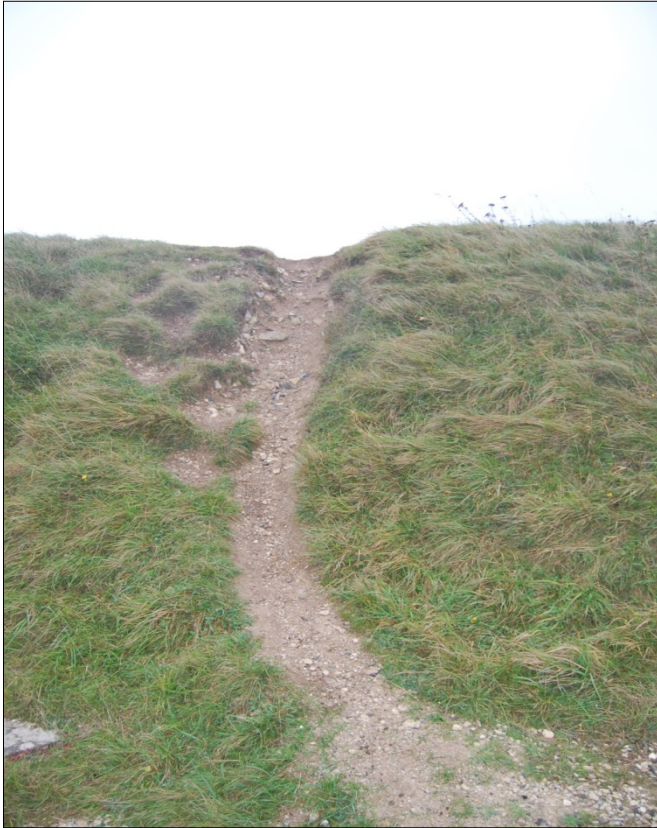
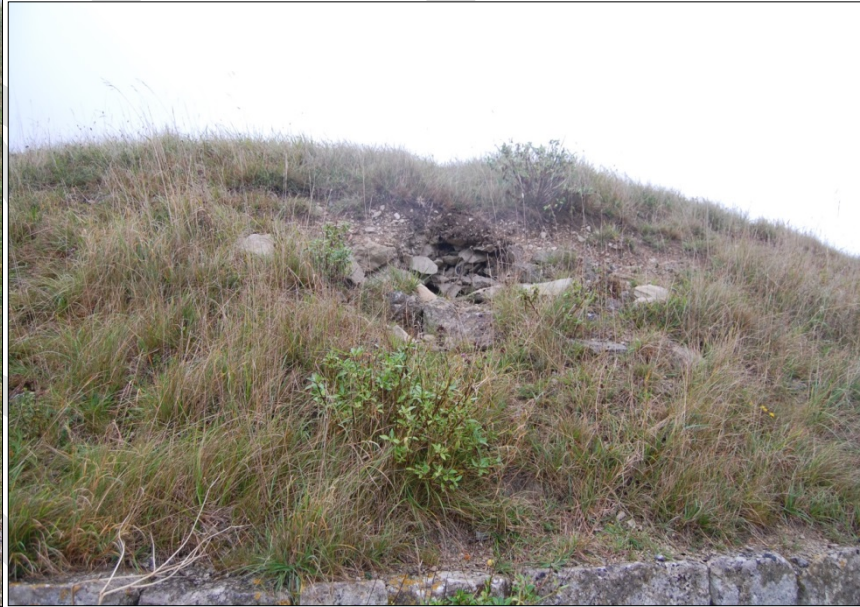
Area 4. (See Works Map)

Location	Payment Code	Description	Outline of work	Date of work	Organisation responsible for work
4.		Feature protection	<ul style="list-style-type: none"> • Erosion from visitors descending down the banks rather than using the steps is causing damage to the slopes. Improvement of the condition of the steps should help manage this, but further signage may be required to prevent future damage. • The contractor will employ a suitably qualified and experienced contractor to accurately locate, measure the existing erosion scar in plan, and who will clean back and record the exposed sections. A list of potential archaeological contractors is available upon request. • Scars of sufficient depth to be filled using biodegradable hessian sandbags filled with archaeologically sterile and graded topsoil and any obvious recent up cast from the scar. • The sandbag will be covered with archaeologically sterile and graded topsoil to a depth of no less than 100mm (4") to make flush with the adjacent earthwork bank. In scars where the depth of erosion is not sufficient for sandbags, a biodegradable hessian mat will be laid over the exposed surface of the scar and filled as described to sufficient depth. 	Spring 18	WPBC/contractor

<ul style="list-style-type: none">• The repair will be covered over with a seeded biodegradable hessian matt pegged (wooden pegs no more than 150mm (6")) into the adjacent extant rampart.• Natural England propose that a pioneer or nurse mix is sown to allow natural recolonization from the surrounding grassland. The benefits of thinly sowing pioneer species include the stabilisation of substrates and the rapid creation of an attractive sward while leaving sufficient bare ground to allow natural recolonization to occur.• Seed Mix for nurse mix. Sown at low rate of 12.5kg/ha. Common Bent (<i>Agrostis capillaris</i>) 10%. Sheep's Fescue (<i>Festuca ovina</i>) 40%. Red Fescue (<i>Festuca rubra</i>) 40%. Smooth Meadow grass (<i>Poa pratensis</i>) 10%		
--	--	--	--	--	--

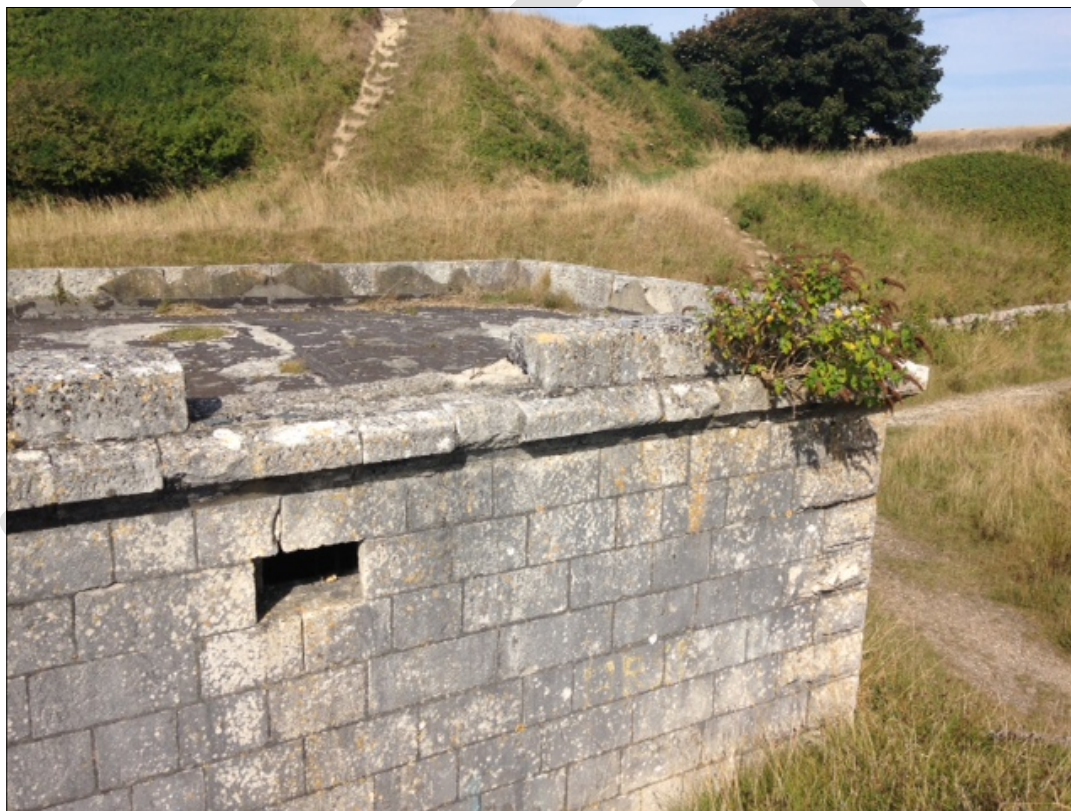
Area 5. (See Works Map)

Location	Payment Code	Description	Outline of work	Date of work	Organisation responsible for work
5.	HAP	Building repair	<ul style="list-style-type: none"> • Replacement of stone block pediment to the Storage Building. The missing stone block is visible at the base of the wall. • The stone to be re-laid as in adjacent areas. It is possible that there may be a deficit of stone. If this is the case then liaison with Historic England will be necessary in order to prioritise specific areas. 	Spring 2018	WPBC

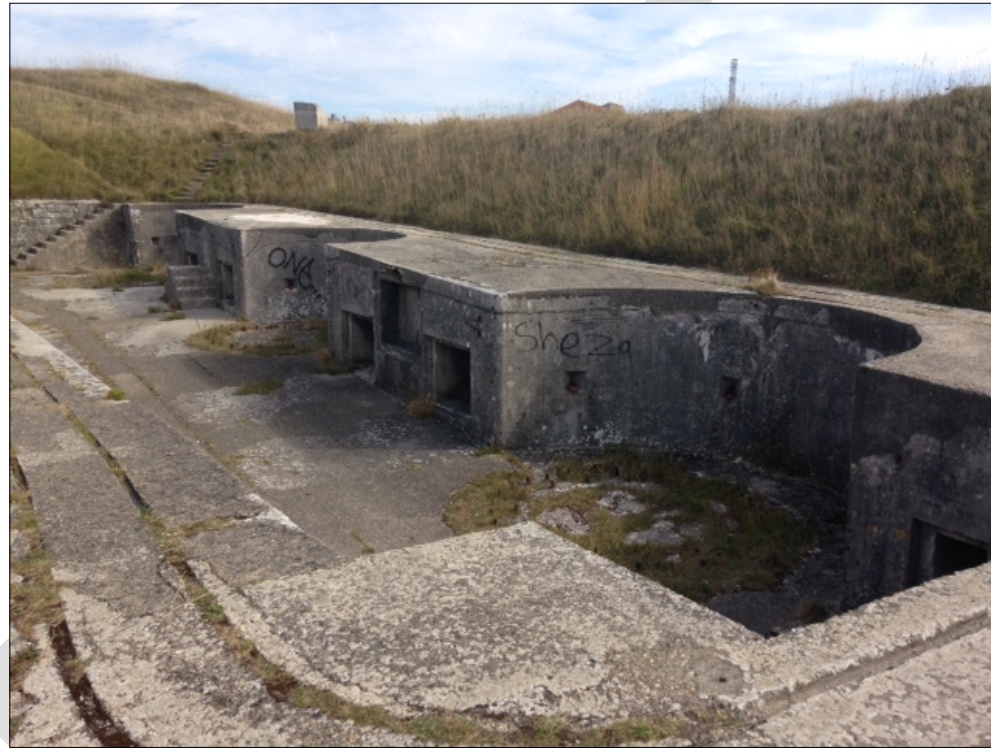
Area 6. (See Works Map)

Location	Payment Code	Description	Outline of work	Date of work	Organisation responsible for work
6.	HAP	Feature protection	<ul style="list-style-type: none"> • The five circular gun placements have become overgrown with low level vegetation; these should be cleared to improve the visual interpretation of the features. • Achieved by: Strimming path ways within HAB. Clearing vegetation off all stonework – walls, entrances and buildings and removal of arisings from site. Cutting back of woody shrubs that are growing into the paths and on top of stonework. Removal of all arisings. • Use of herbicides as a method to control scrub must be authorised by Natural England HLS – May to September only. 	<p>Winter 2017</p> <p>Spring – Autumn 2018 (if required)</p>	WPBC

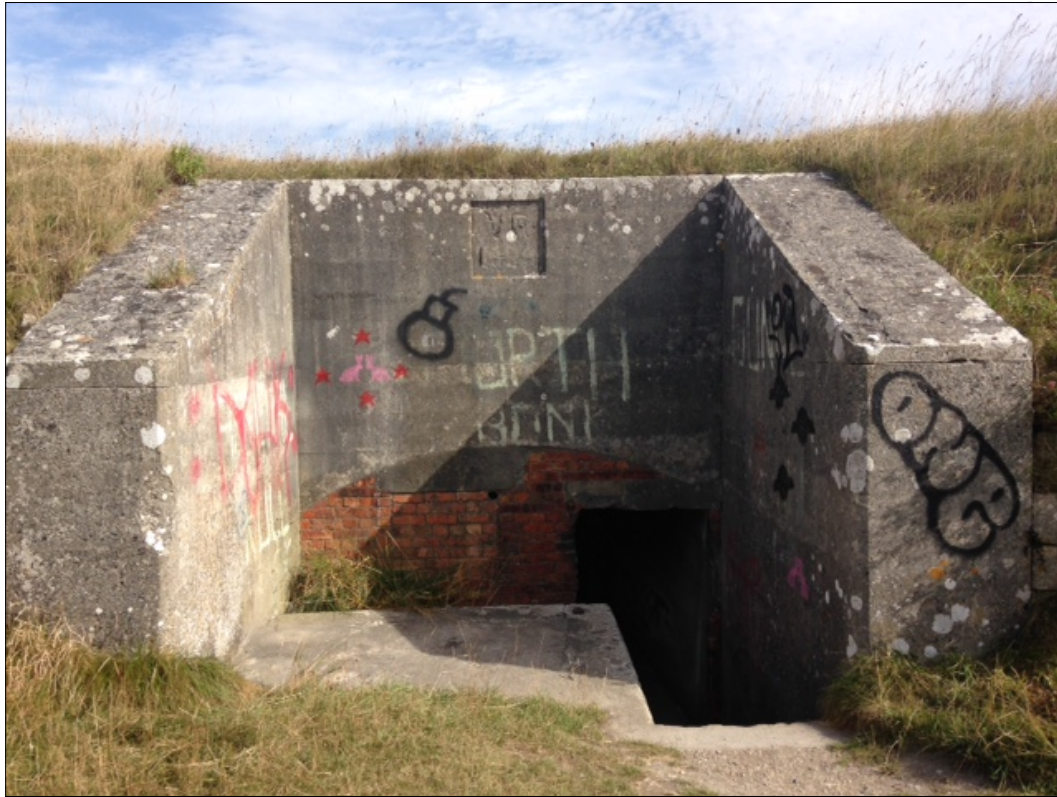
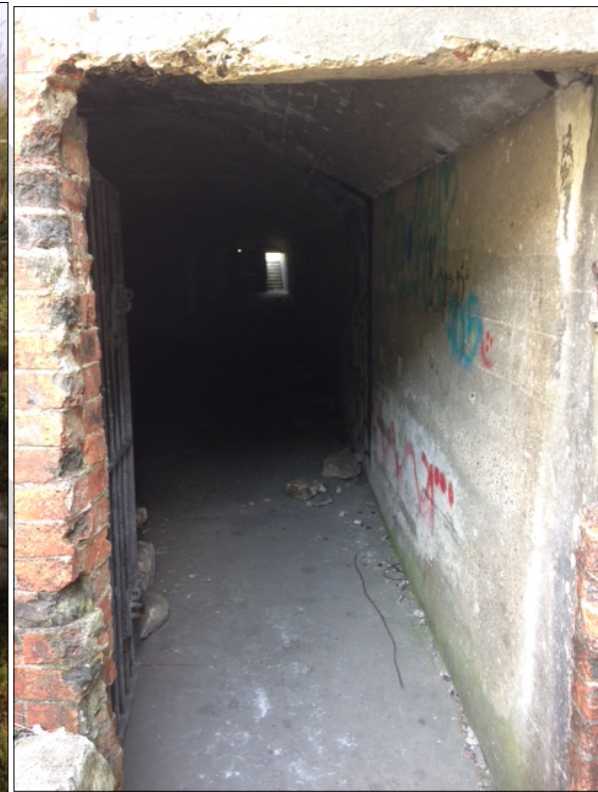
Area 7. (See Works Map)

Location	Payment Code	Description	Outline of work	Date of work	Organisation responsible for work
7.	HAP	Concrete repair	<ul style="list-style-type: none"> • Concrete repair required to tunnel entrance brickwork which has been chipped. Gate also to be secured shut. • A sample of concrete was analysed by Sandberg Consulting Engineers. This identified that the sample was early concrete with graded aggregate. The analysis will be investigated and a specification will be provided. It may be necessary to carry out several trial areas in order to get a suitable match both in texture and finish. • Seek further technical advice required 	Spring 2018	WPBC

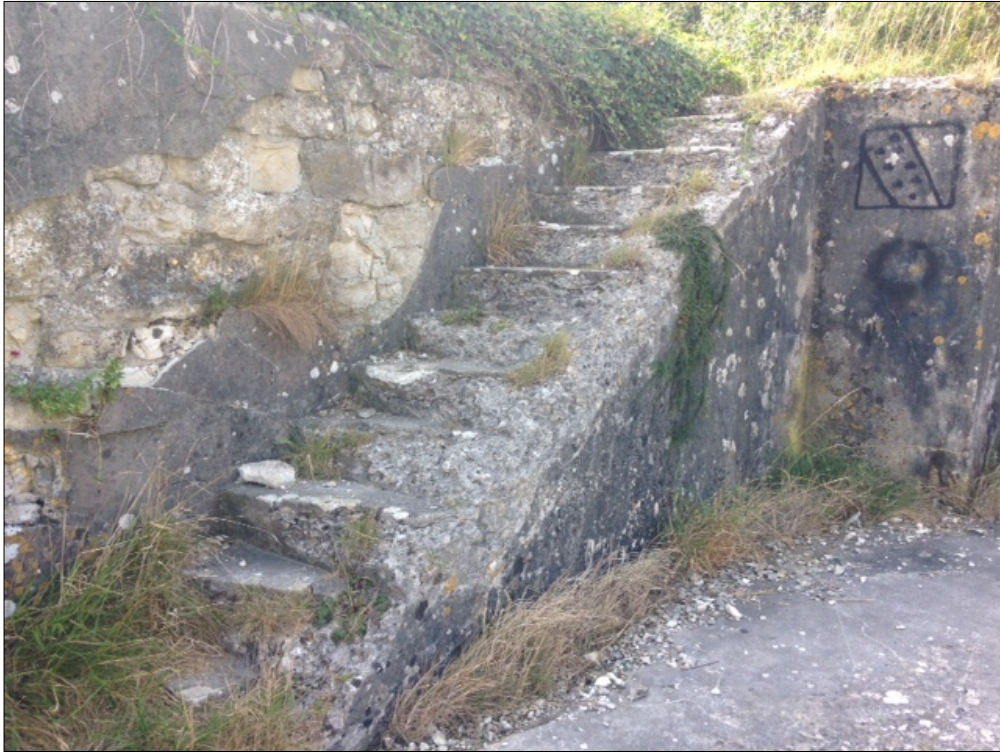
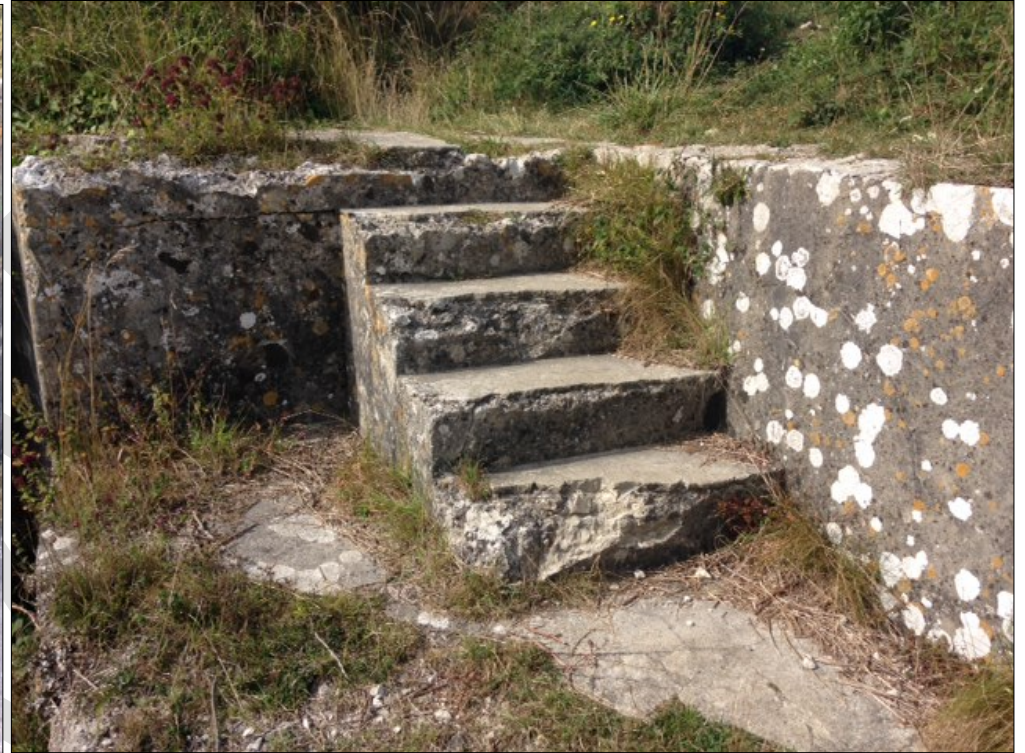
Area 8. (See Works Map)

Location	Payment Code	Description	Outline of work	Date of work	Organisation responsible for work
8.	HAP	Concrete repair	<ul style="list-style-type: none"> Re-profiling work required on the steps and wall to prevent further damage and improve visitor safety in this area. 	Spring 2018	WPBC

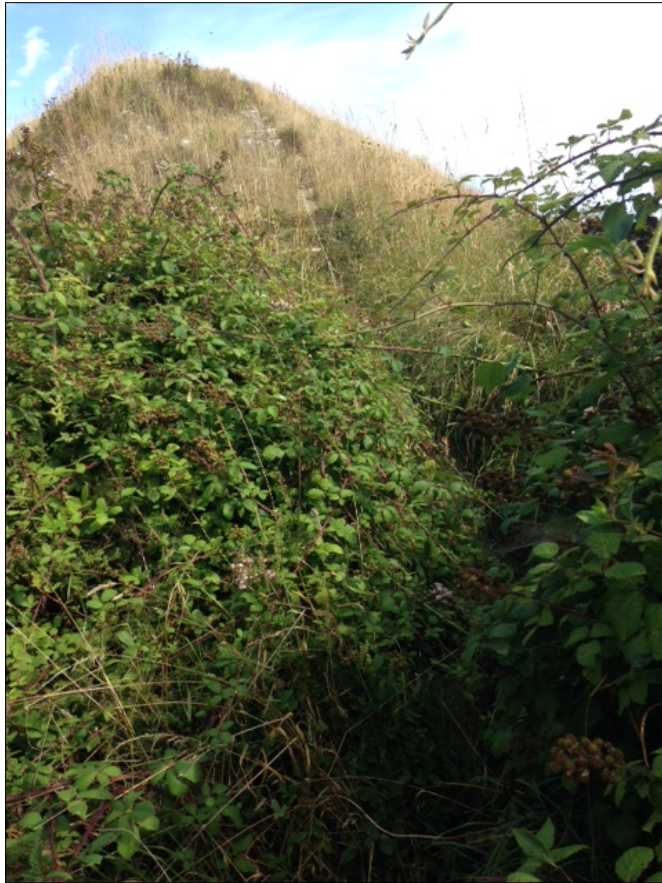
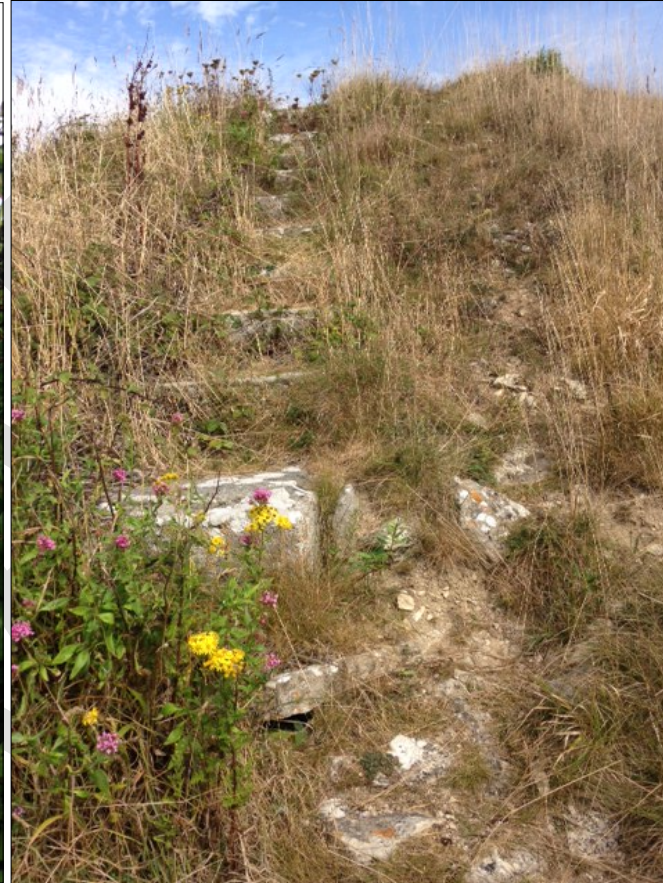
Area 9. (See Works Map)

Location	Payment Code	Description	Outline of work	Date of work	Organisation responsible for work
9.	HAP	Access improvement	<ul style="list-style-type: none"> • Stone steps require repair. Some are overgrown and many are missing, or dislodged. • An interpretation panel at the top of these steps may help persuade visitors from sliding down the embankments and causing erosion. 	Spring 2018	WPBC

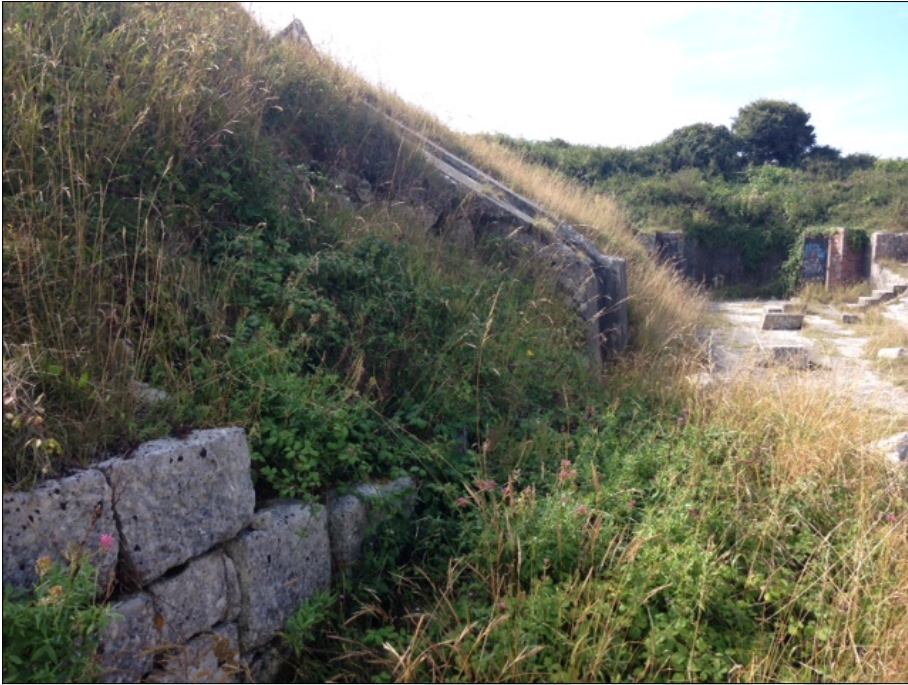
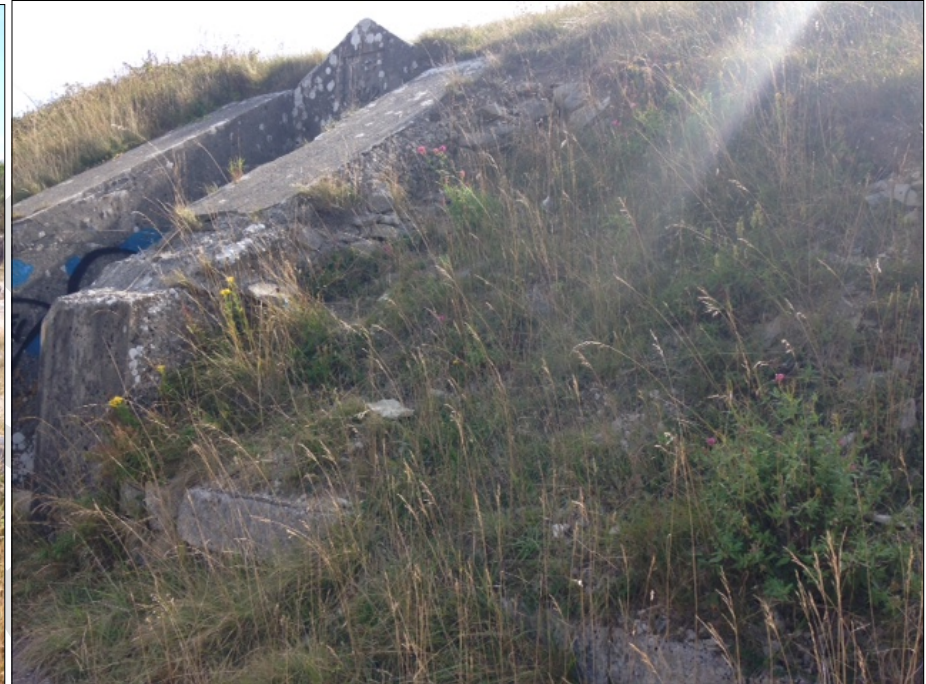
Area 10. (See Works Map)

Location	Payment Code	Description	Outline of work	Date of work	Organisation responsible for work
10.	HAP	Stone walling repair	<ul style="list-style-type: none"> • Banks either side of the tunnel entrance require re-profiling and the stone retaining walls either side of the tunnel entrance require rebuilding. <p>The stone needs resetting without mortar.</p> <ul style="list-style-type: none"> • Seek further technical/Historic England advice required 	Spring 2018	WPBC

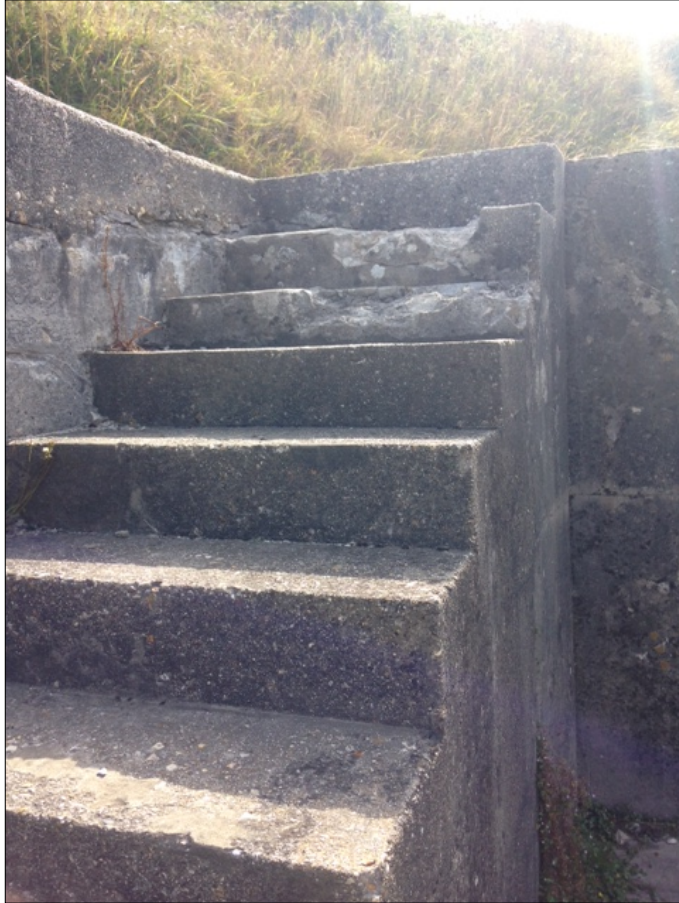
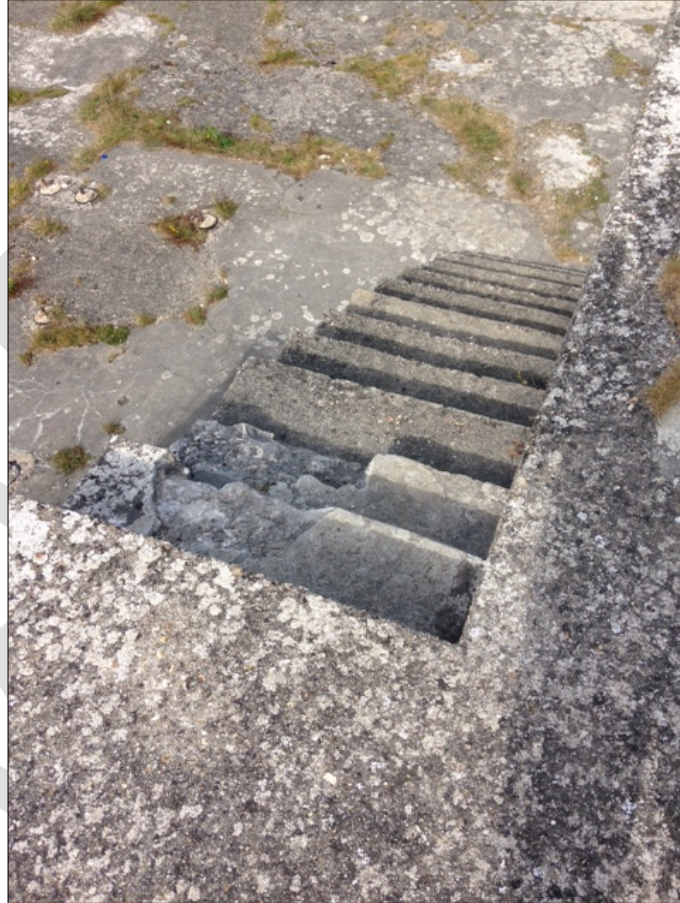
Area 11. (See Works Map)

Location	Payment Code	Description	Outline of work	Date of work	Organisation responsible for work
11.	HAP	Concrete repair	<ul style="list-style-type: none"> Concrete repair to steps required. (Modern concrete acceptable here). 	Spring 2018	WPBC
