# Report No H4042-14A

DINAH'S HOLLOW, MELBURY ABBAS  
PHASE 2 GROUND INVESTIGATION

FACTUAL REPORT ON GROUND INVESTIGATION

Carried out for:  
Dorset County Council

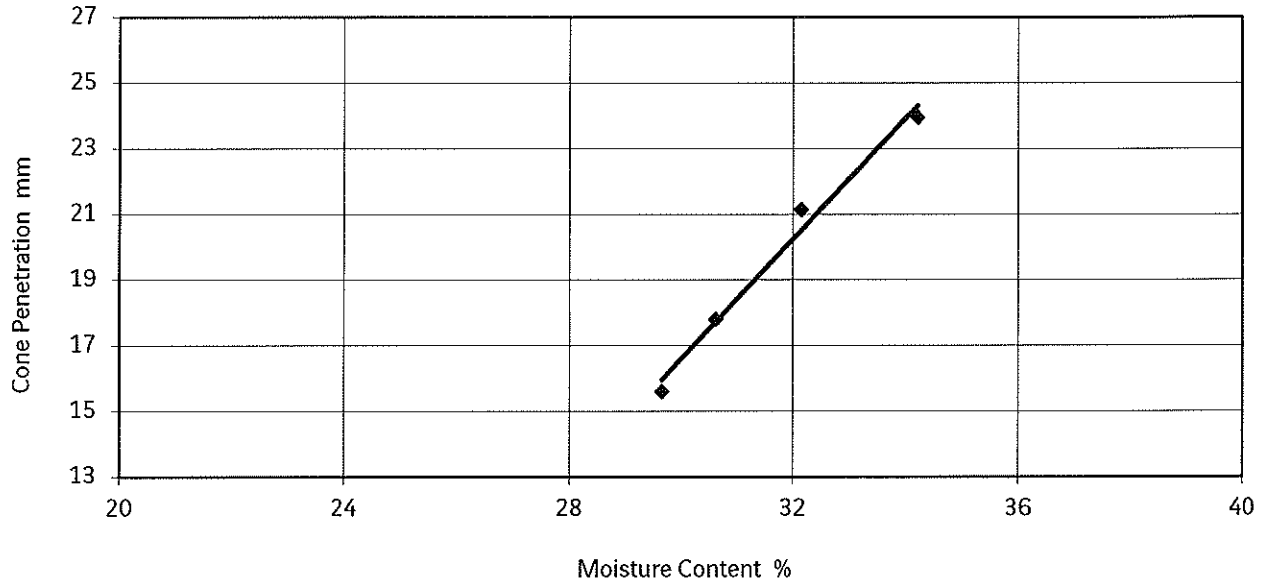
Project Name Dinah_s Hollow and Melbury Church Phase 2 GI Project No. LT1468 Engineer ESG Ltd Employer ESG Ltd	<b>Liquid And Plastic Limit Test</b>	Hole ID BH2-1
		Sample Depth 3.00m
		Sample Number 7
		Sample Type UT
Description Brown gravelly CLAY. Gravel is fine to coarse angular.		Specimen Depth 3.10m
		Specimen Number 1

Natural moisture content:	19%	Percentage retained on 425µm sieve:	58%
Liquid limit:	32%	Preparation of sample:	Wet sieve
Plastic limit:	15%	Remarks:	
Plasticity index:	17%		
Moisture content of soil passing 425µm	44%		
Liquidity index:	1.73
