**Ecological Survey  
For  
Dinah's Hollow  
And  
Church slopes,  
Melbury Abbas, Dorset**

**Dr Annabel King  
(Revision by Danny Alder)**

**Natural Environment Team  
Dorset County Council**

**November 2014**

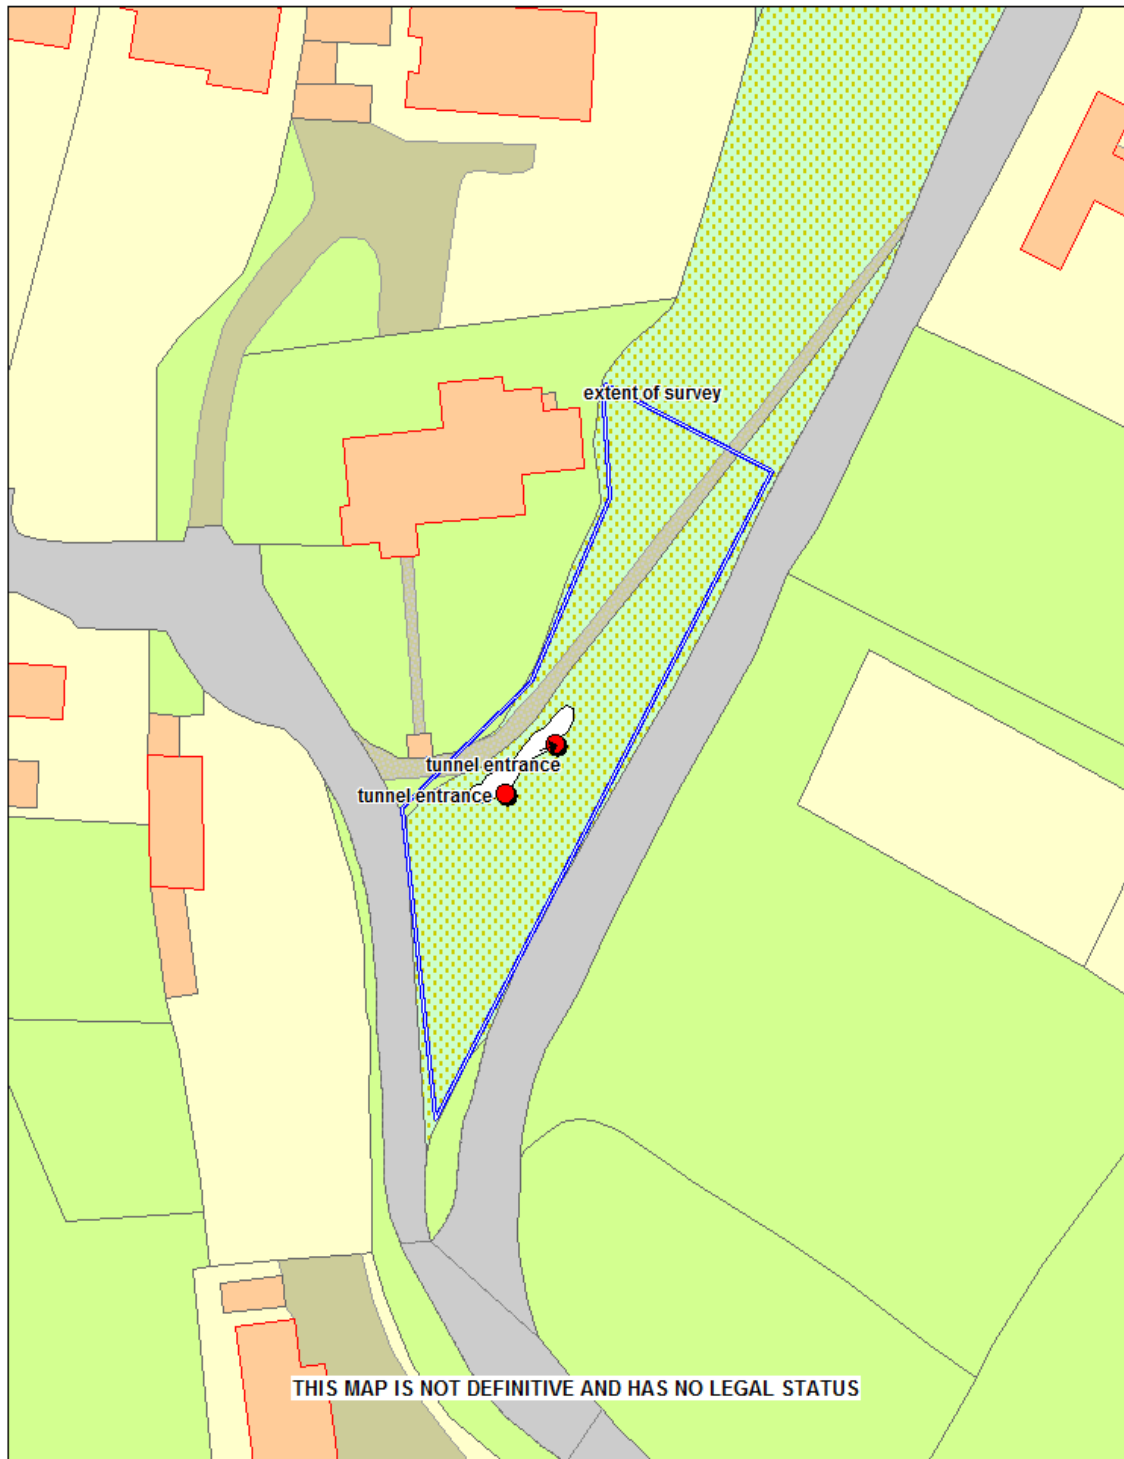
**Appendix 2: Map of the church slopes showing the location of badger tunnels.**

<p><b>Church slopes at Dinah's Hollow</b> Location of badger sett entrances and extent of survey</p>	<p><b>Ref:</b> Date: 15/07/2014 Scale 1:635 Drawn By: Cent X: 388221 Cent Y: 120048</p>	<p>GEOGRAPHICAL INFORMATION SYSTEMS</p>

Two tunnel entrances were found at the base of the rocky outcrop on the church slopes. These did look as though they had been used by badgers but did not look as though they were in current use as there were no footprints or excavated bedding and the tunnel entrances contained windblown leaves. There were however several badger runs through the vegetation on the church slopes and there was also a dead badger on the road below when the site was visited in May – all showing that the church slopes are widely used by badgers even if the tunnels below the rock outcrop are not in current use. Continuous monitoring since 26<sup>th</sup> August 2014, of the sett using camera traps has not shown any evidence of signs of current use by badgers.

Therefore, if the proposed work includes obstructing or destroying these tunnels then it is important that the absence of badgers is proven beforehand. This can be done by using camera traps over a period of time, or other methods in line with Natural England's guidance. The Natural Environment Team at DCC has experience of carrying out this type of work.

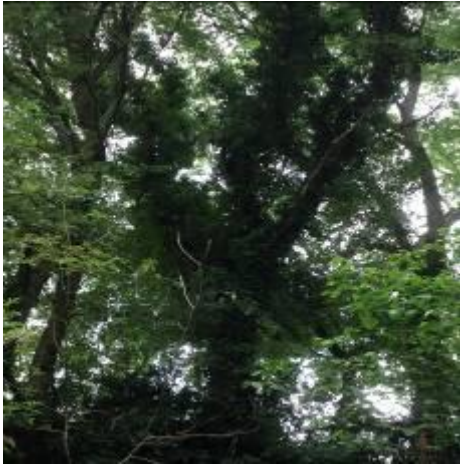
Example of tree with bat roost potential

**Recommendations:** All trees with medium or high potential for bats (see Appendix 2) should be left in situ where possible. Where this is not possible the trees should be 'soft felled' only after a further survey has confirmed no bat roosts are present. Best practice felling techniques should be used and involves felling the tree in sections and lowering each to the ground gently so that in the unlikely event of bats being present they are unharmed. The sections of tree are then left in place overnight to allow any bats to leave and find an alternative roost.

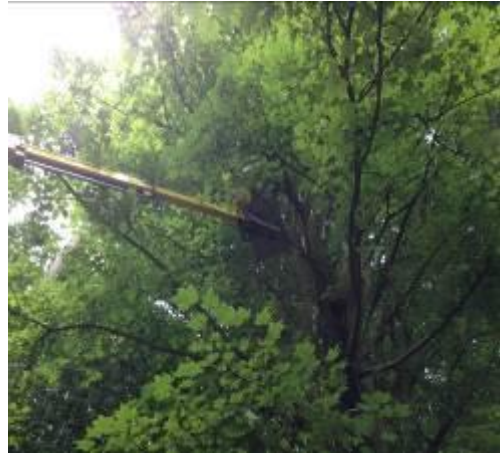
- No bats or bat roosts were found during the survey
- Six trees were downgraded to Low bat potential
- Four trees remain at Medium potential
- One tree (a sycamore on the west bank adjacent to the 285m road marking) was upgraded from Medium to High potential for roosting bats as it contained several areas with dead wood and rot holes which could not be reached with the endoscope. This tree was also searched by tree climbing but it was still not possible to completely investigate the suitable crevices and rot holes.

Searching the Sycamore with High bat roost potential

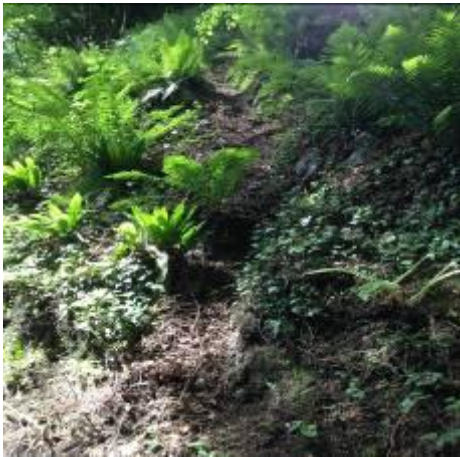
A badger run on the west verge of Dinah's Hollow below the sett

The proposed work methods for Dinah's Hollow will need to be evaluated for their impact on the badger sett. For the time being a buffer zone of 20m around the identified extent of the sett is suggested.

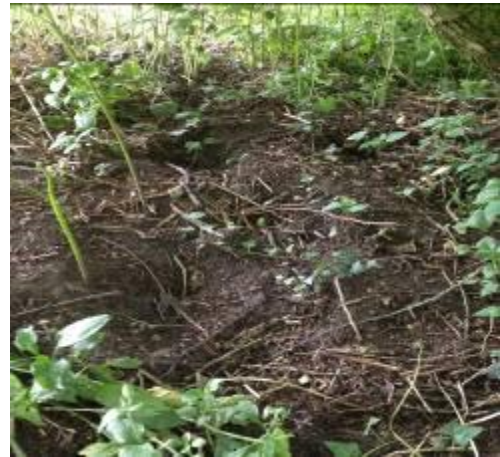
Badger latrine at the top of the east verge of Dinah's Hollow

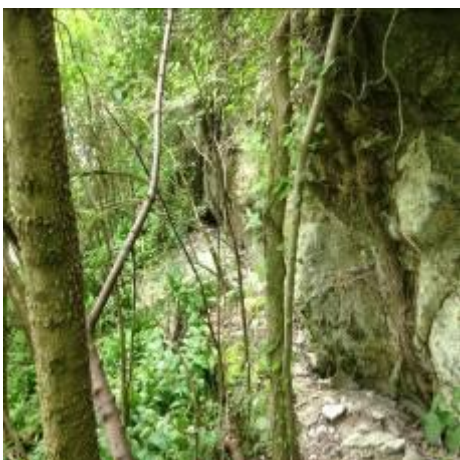
Location of badger sett entrances below the rock outcrop on the church slopes

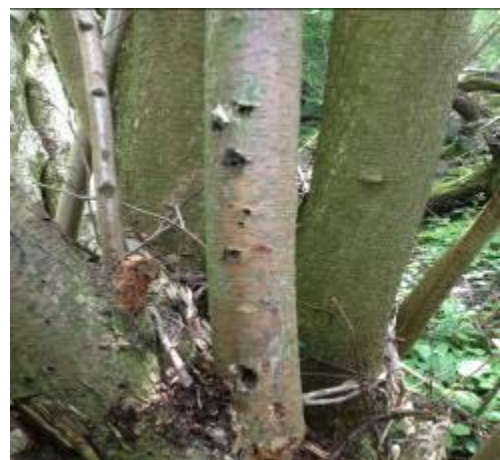
Greater-spotted woodpecker feeding damage at Dinah's Hollow
