**DINAH'S HOLLOW STABILISATION  
OPTIONS REPORT**

*Dorset County Council*

**285400AF-HLT/1**

<b>Report Title</b>	:	<b>Dinah's Hollow Stabilisation Options Report</b>
<b>Report Status</b>	:	<b>Issue 2</b>
<b>Job No</b>	:	<b>285400AF-HLT/1</b>
<b>Date</b>	:	<b>November 2014</b>

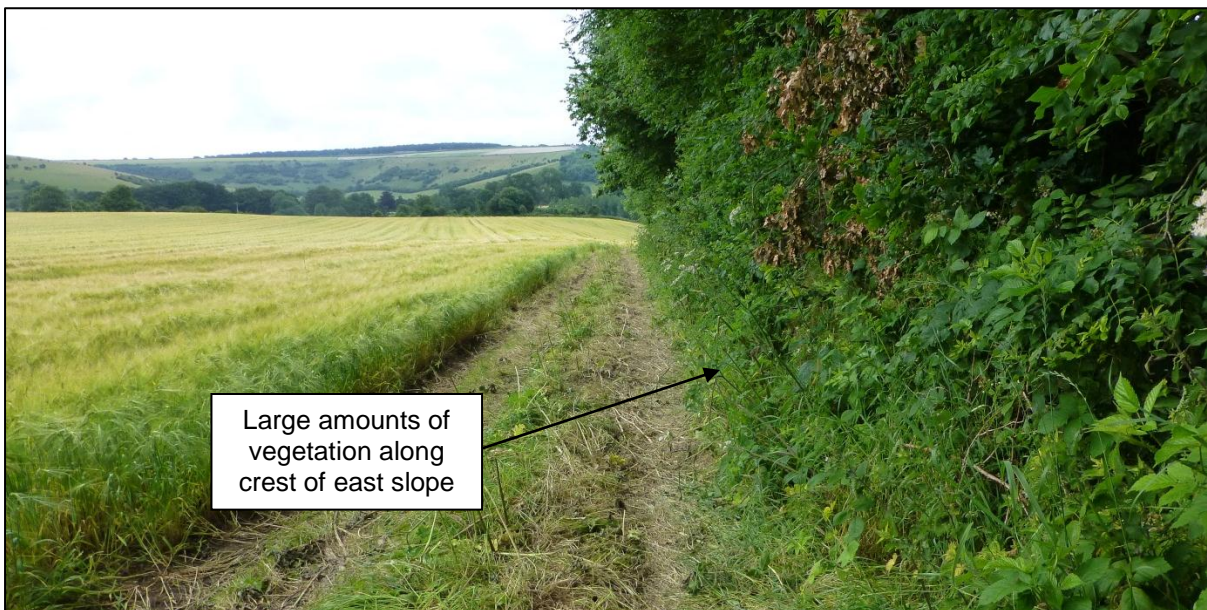
**Figure 11: Barley Growing in the Field to the East of Dinah's Hollow**

- 3.2.17 The topography of the land is sloping towards Dinah's Hollow and the valley in a south westerly direction.
- 3.2.18 Evidence of soil erosion assumed to have been caused by surface water run-off is apparent in the south-west corner of the field, where deposits of sediment have been "trapped" by the fencing.
