C13 DINAHS HOLLOW DRAINAGE SURVEY

Drainage Survey Dinahs Hollow South

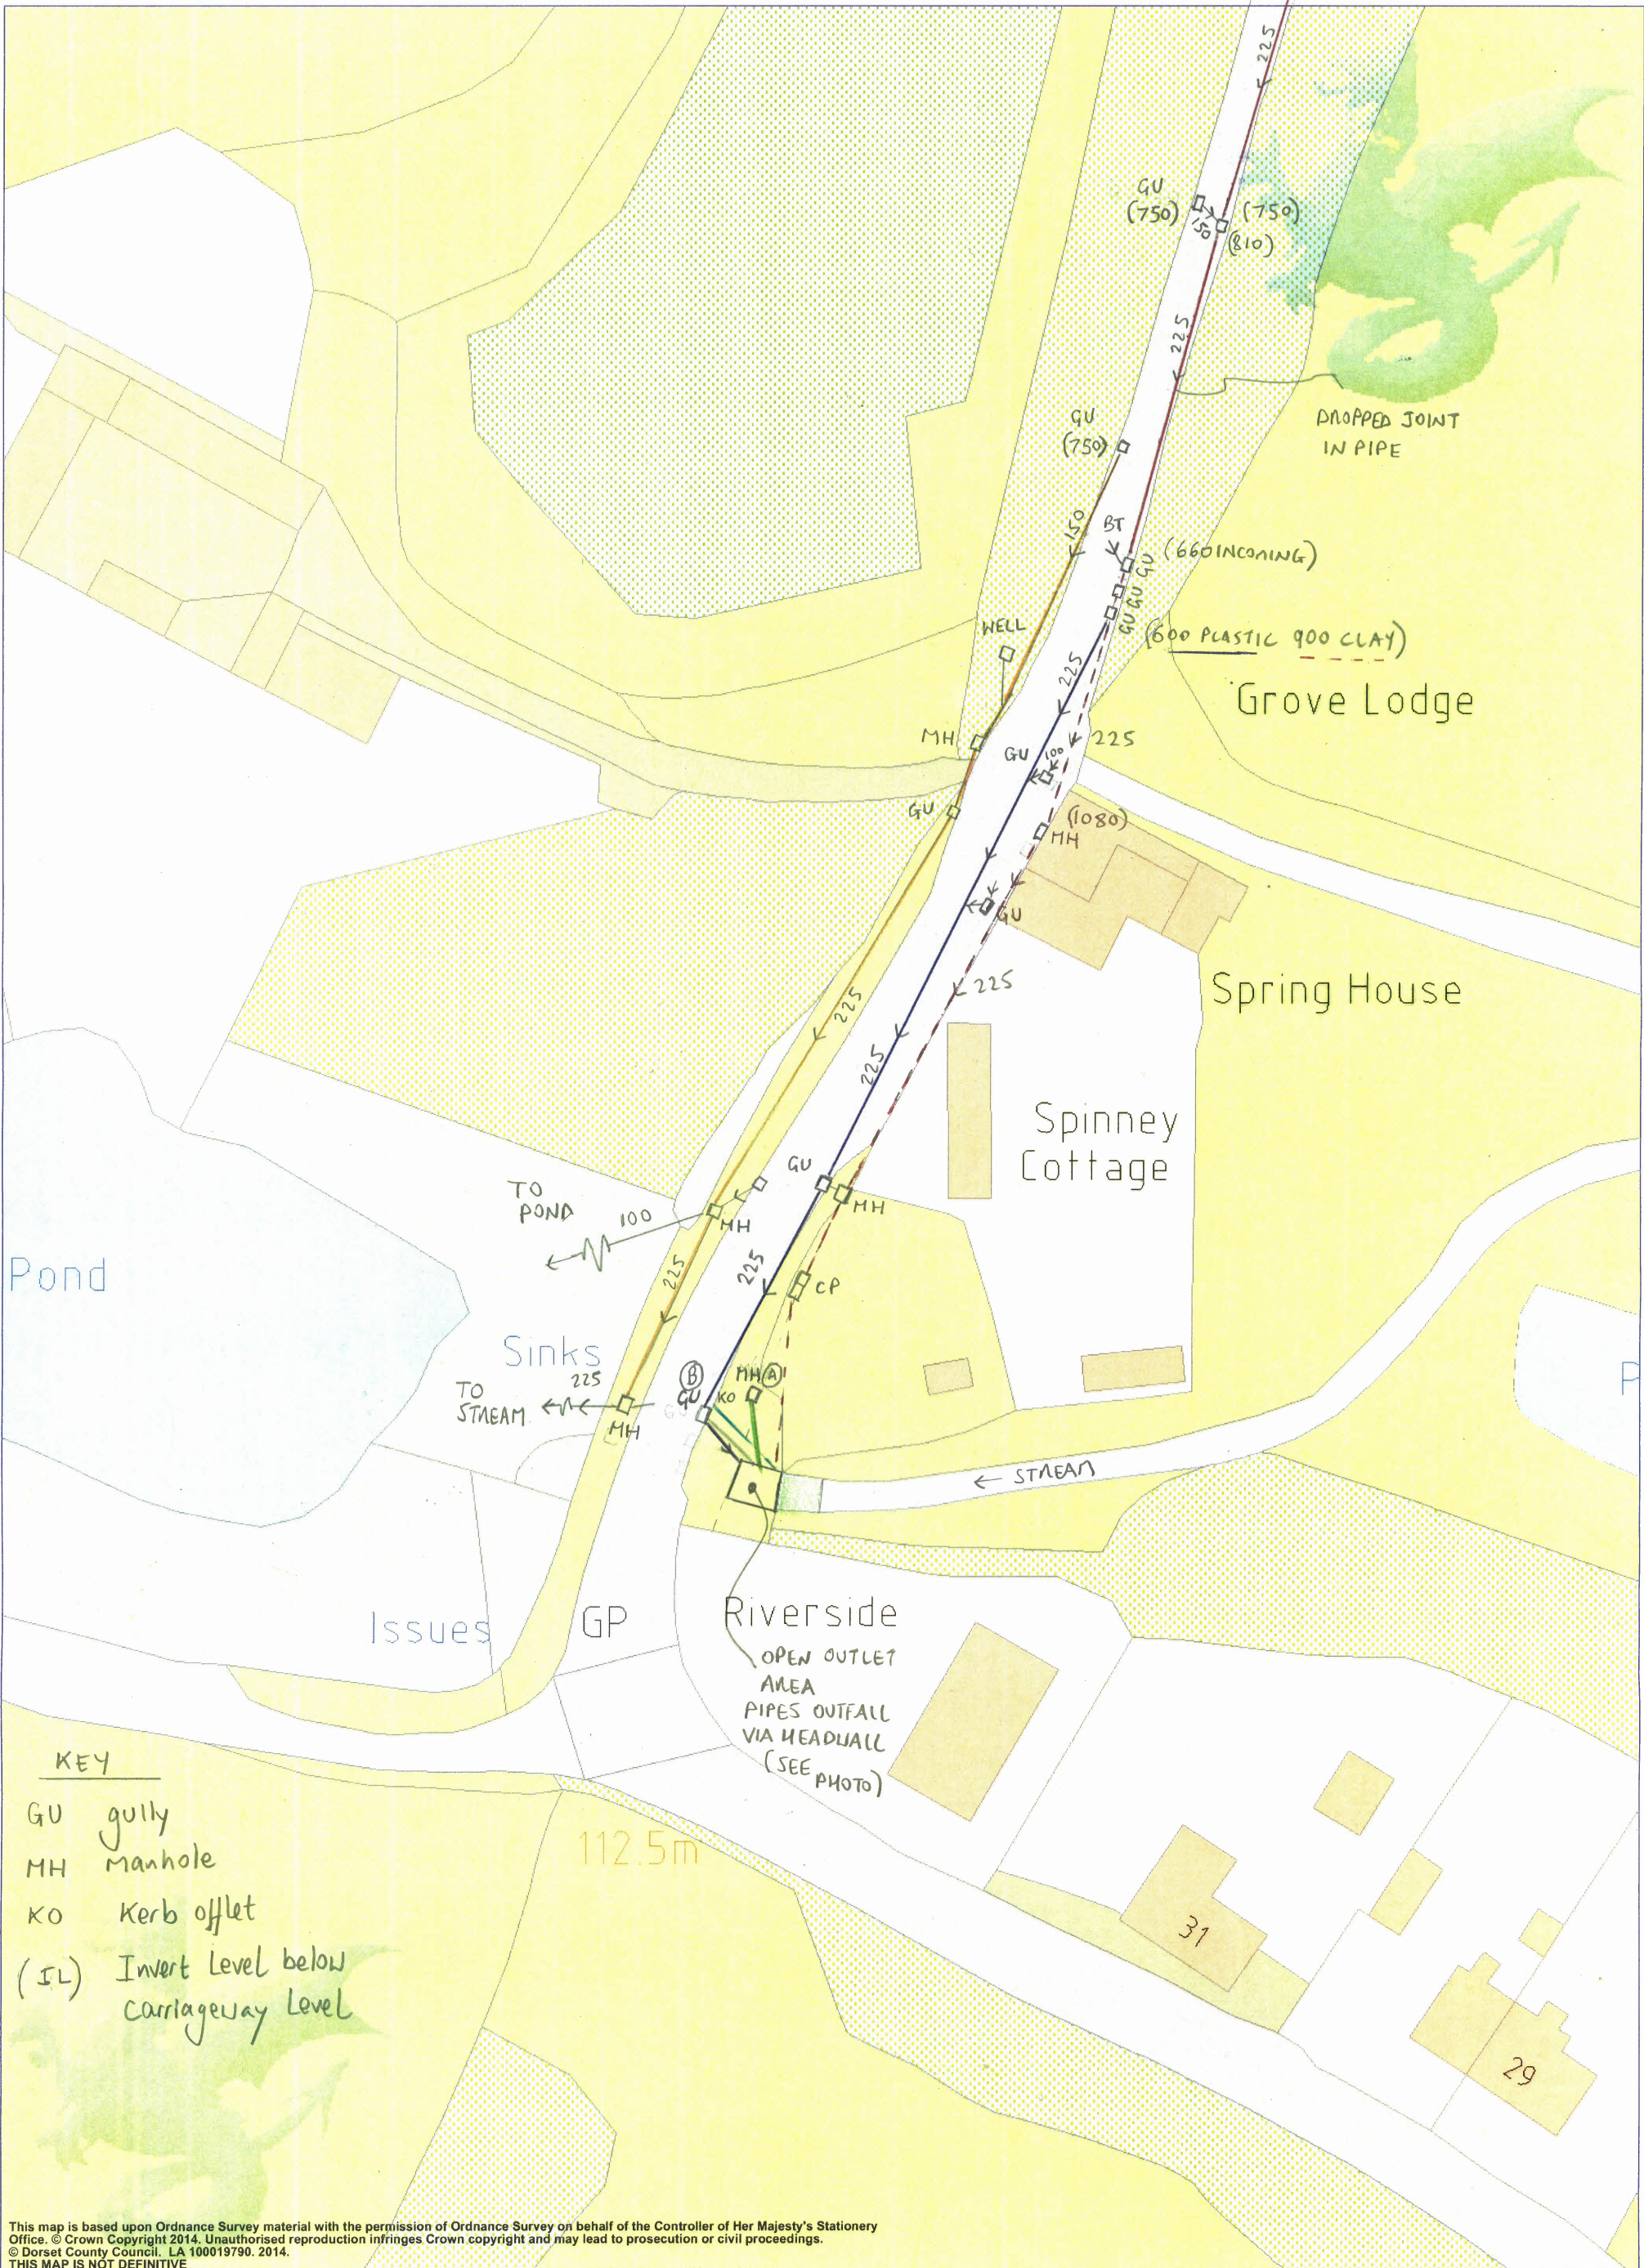
There is currently no drainage through the hollow north of chainage 150 (chainage as marked on road). A general comment is that the majority of the drainage was silted up prior to survey. It is understood that the drainage frequently becomes blocked and requires clearing.

On the east side there is a single 225 pipe linking the gullies north of chainage 90. At approx chainage 90 there is a group of 3 closely spaced gullies.

There are two pipes heading south from the south end of this group of three gullies, (a 225 clay pipe and a 225 plastic pipe). The original clay pipe run outfalls at approx 900 below cover level of this gully and a newer plastic pipe run outfalls at approx 600 below the cover at this gully.

The original clay pipe run is in a poor condition and runs south via two manholes and a catchpit to outfall through a headwall into the stream. (See photograph)

The newer plastic pipe run is in a better condition and picks up the gullies on the east side of the road. This pipe run outfalls via gully B (refer sketch and photograph) into the stream.

There are three further pipes outfalling into the headwall at the stream. (See photograph.)
