Dorset Highways: Code of Practice for the Classification of Highway Safety Hazards & Defects

Version 2.0, Revision 1
October 2018

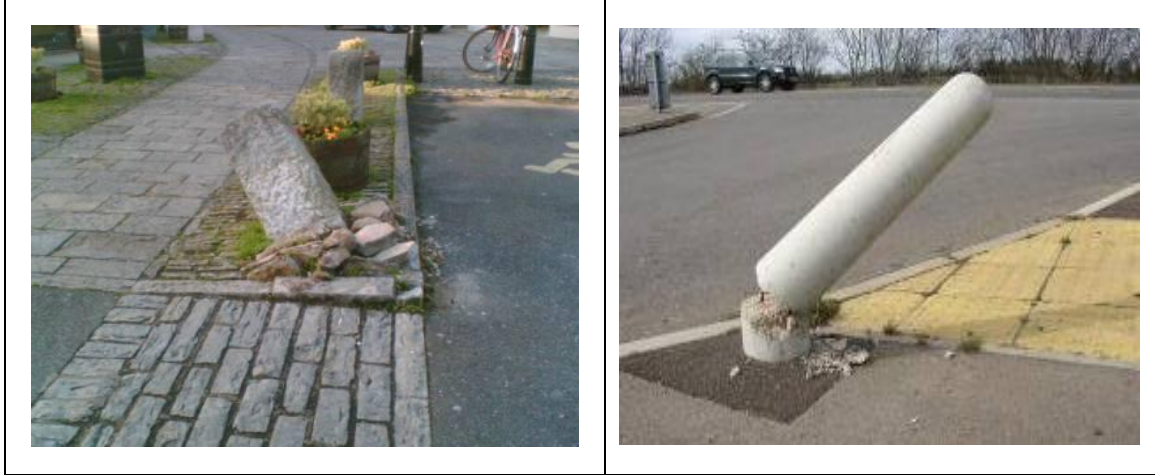
Carriageways – Bollard: Damaged - BLDG

A non-illuminated bollard which is damaged and/or unstable and poses an immediate hazard to highway users.

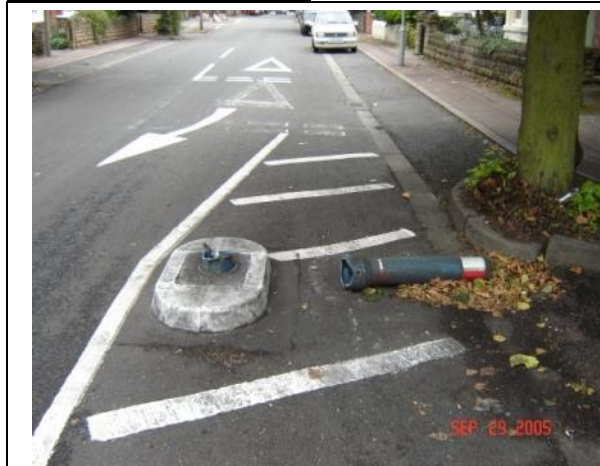
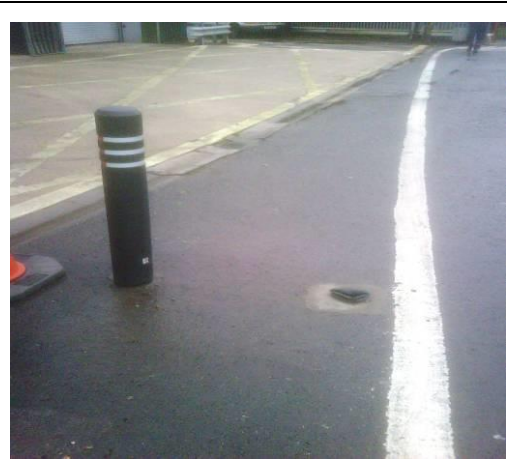
Carriageways – Bollard: Missing - BLMS

A non-illuminated bollard which is missing and presents an immediate hazard to highway users.

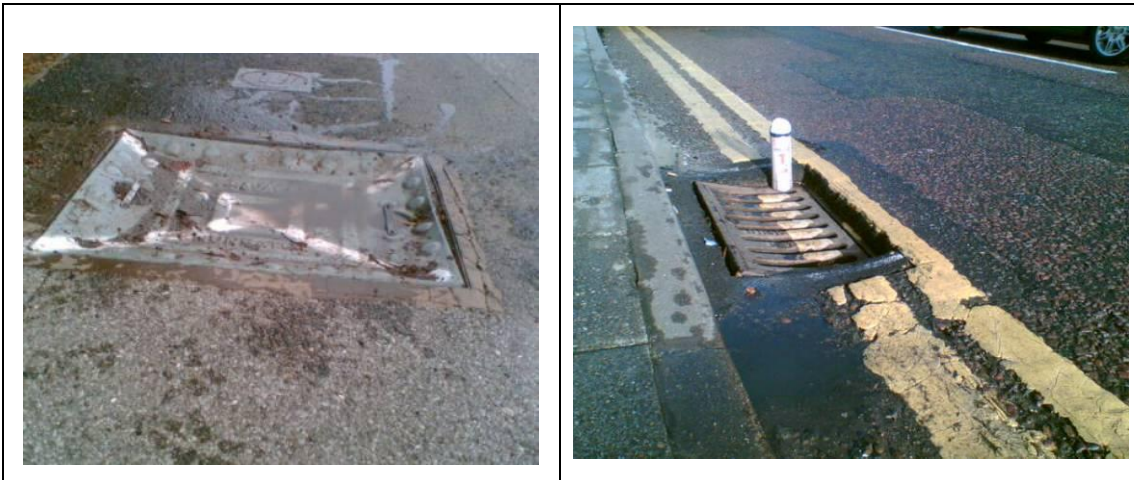
Carriageways – Cover / Grating: Broken, Damaged, Cracked or Corroded - MCD

Any cover, grating, frame or box in the carriageway which is broken, damaged, cracked or significantly corroded. Where it is clear that the cover is the responsibility of a Statutory Undertaker (e.g. gas, water or telecoms) and NOT the County Council the defect should be recorded using the defect option: Carriageways – Utility Cover: Broken, Damaged, Cracked or Corroded.

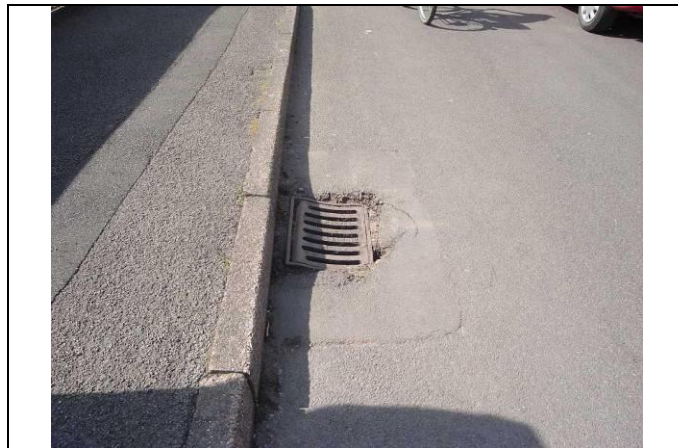
Inspection chamber covers, gully gratings and other ironwork causing a step-in level to the surrounding carriageway surface. Where it is clear that the cover is the responsibility of a Statutory Undertaker (e.g. gas, water or telecoms) and NOT the County Council the defect should be recorded using the defect option: Carriageways – Utility Cover: Difference in Level.

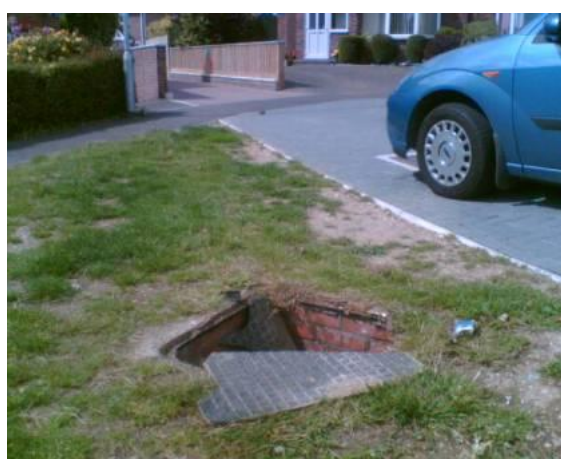
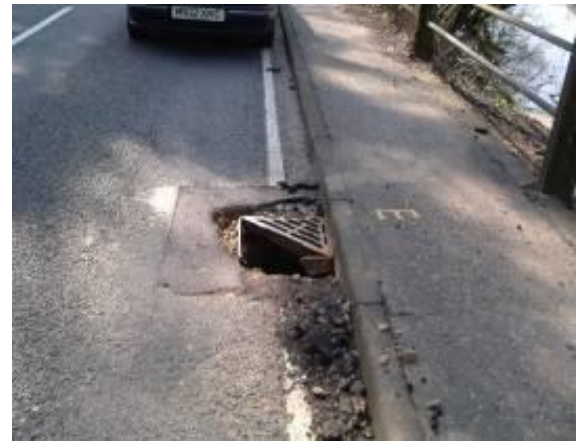
Carriageways – Cover / Grating: Missing - MCS

A missing Inspection chamber cover, gully grating or other ironwork anywhere within the carriageway. Where it is clear that the cover is the responsibility of a Statutory Undertaker (e.g. gas, water or telecoms) and NOT the County Council the defect should be recorded using the defect option: Carriageways – Utility Cover: Missing.

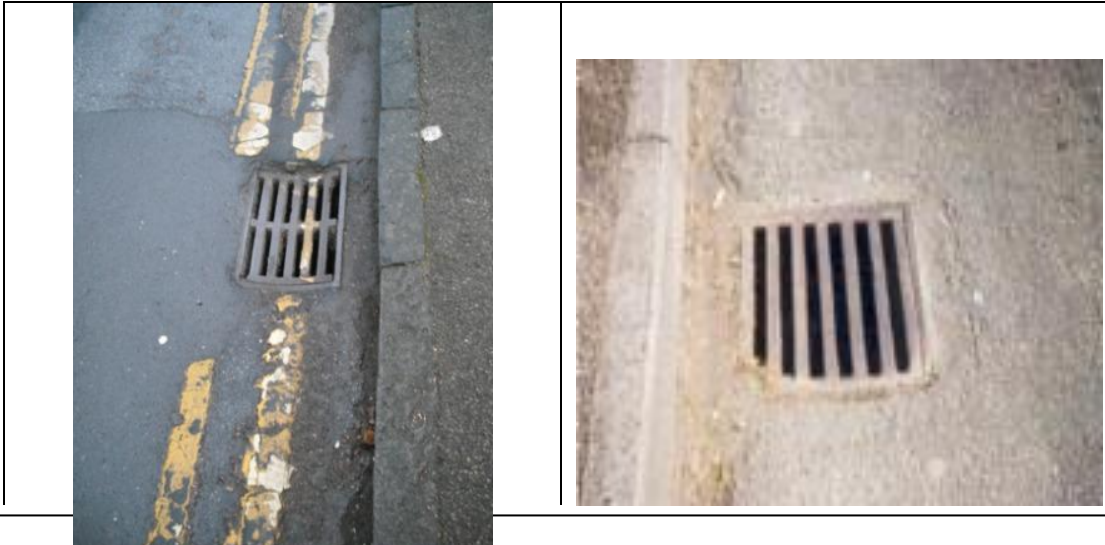
Where a gully grating has been installed with the drainage slots running parallel to the direction of vehicular traffic.

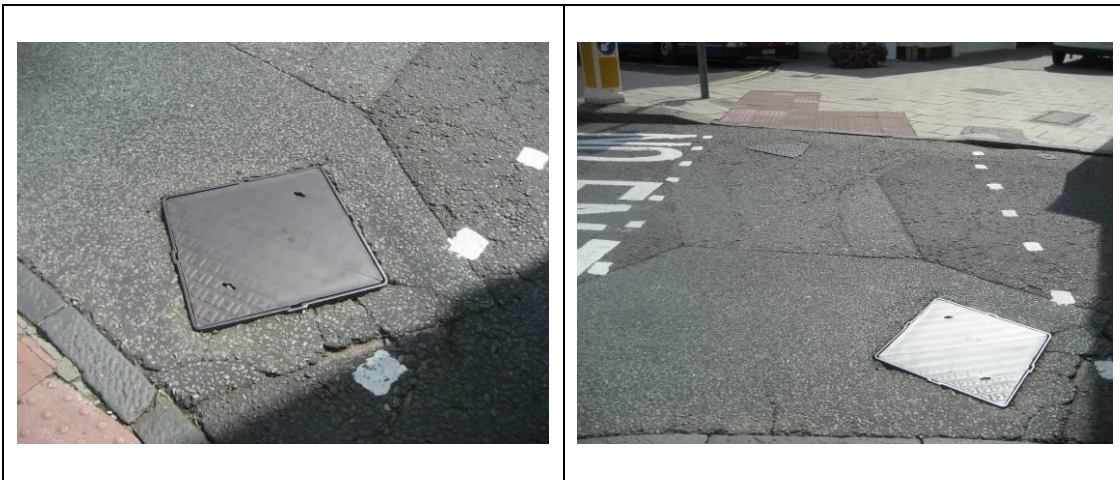
Carriageways – Cover / Grating: Significantly Worn / Smooth Cover - MCSM

Significantly worn or smooth covers which pose a potential skidding / slipping hazard to highway users, e.g. cyclists or motorcycles. Where it is clear that the cover is the responsibility of a Statutory Undertaker (e.g. gas, water or telecoms) and NOT the County Council the defect should be recorded using the defect option: ‘Carriageways – Utility Cover: Significantly Worn / Smooth Cover’.

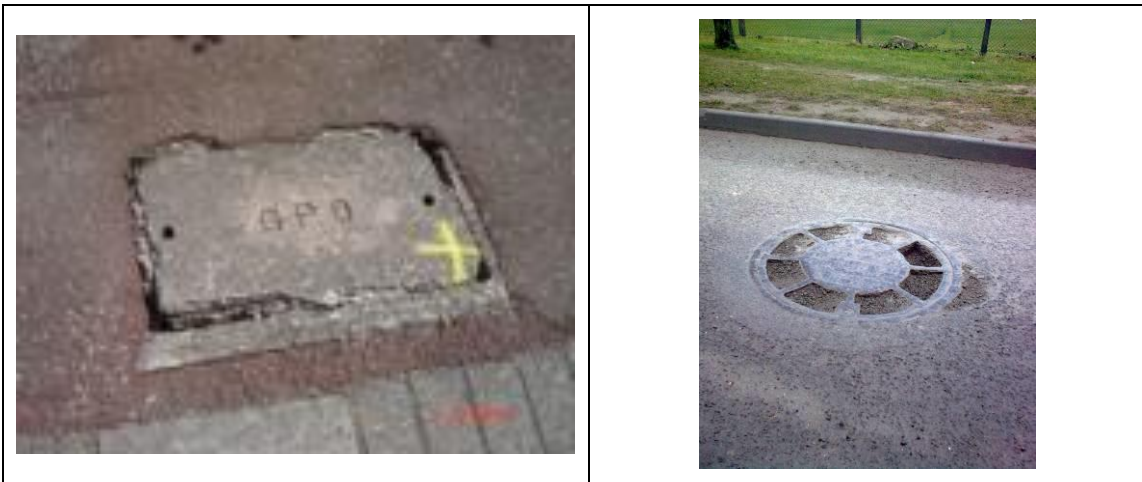
Carriageways – Utility Cover: Broken, Damaged, Cracked or Corroded – Sec 81

Any cover, grating, frame or box in the carriageway which is broken, damaged, cracked or significantly corroded, and where it is clear that the cover is responsibility of a Statutory Undertaker.

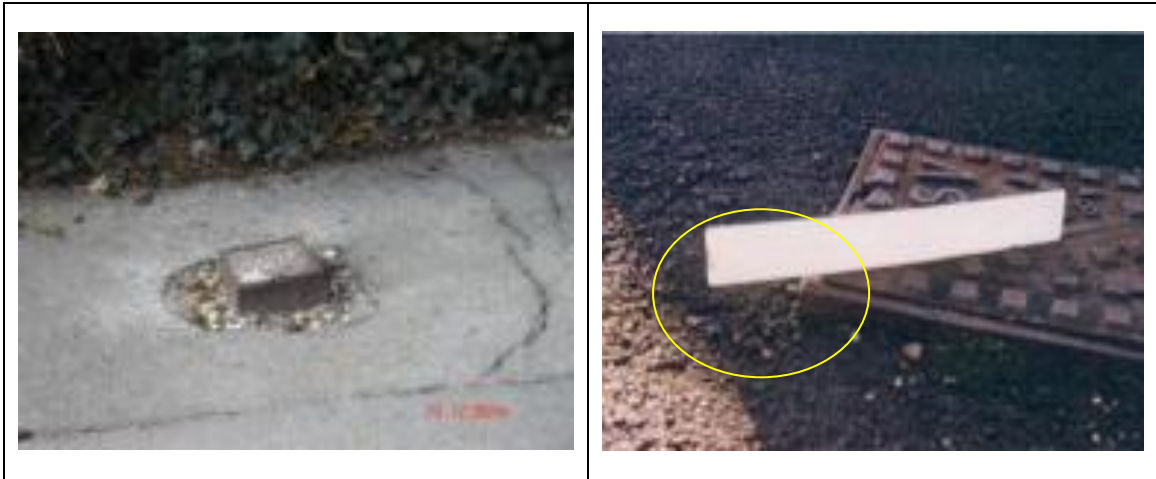
Inspection chamber covers and other ironwork, which are clearly the responsibility of a Statutory Undertaker, causing a step-in level to the surrounding carriageway surface.

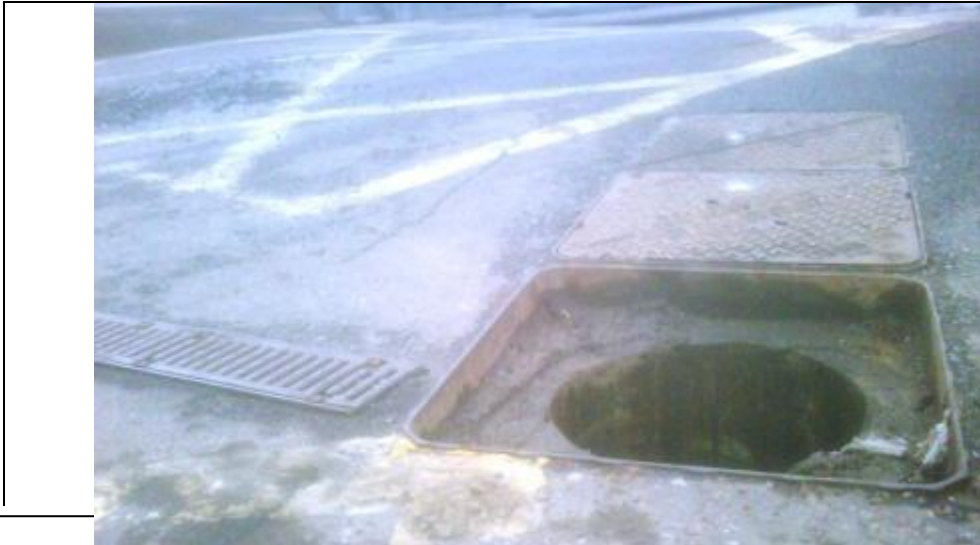
Carriageways – Utility Cover: Missing – Sec 81

A missing Inspection chamber cover, gully grating or other ironwork anywhere within the carriageway, which is clearly the responsibility of a Statutory Undertaker.

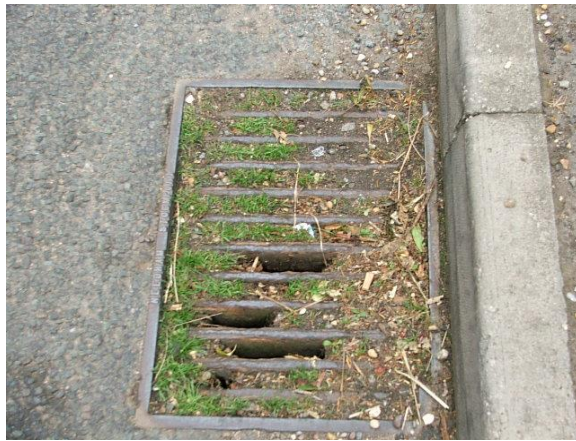
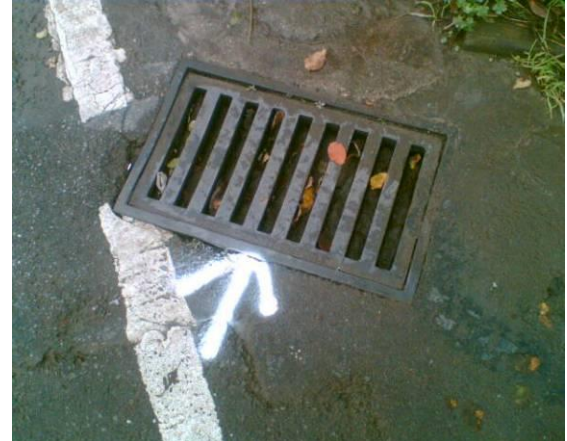
Where a gully chamber is partially or full of detritus and/or other material to a point where the outlet is >75% blocked and likely to cause flooding on the carriageway.

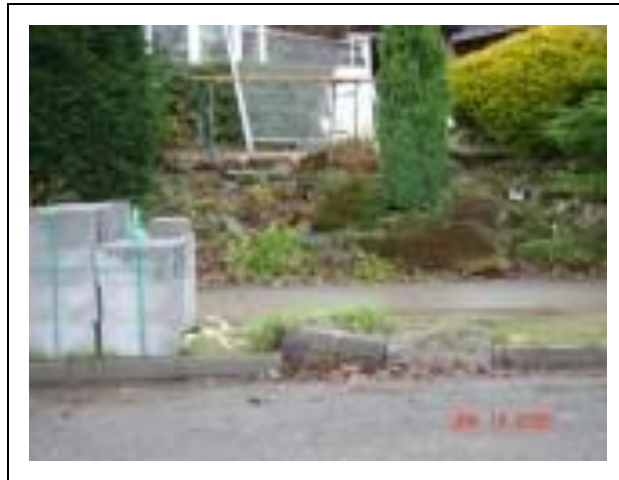
Carriageways – Miscellaneous: Damaged Caused by Identifiable Third Party -

Where the carriageway has been damaged to an extent that poses a hazard to the highway user and the cause of the damage has been / can be established.

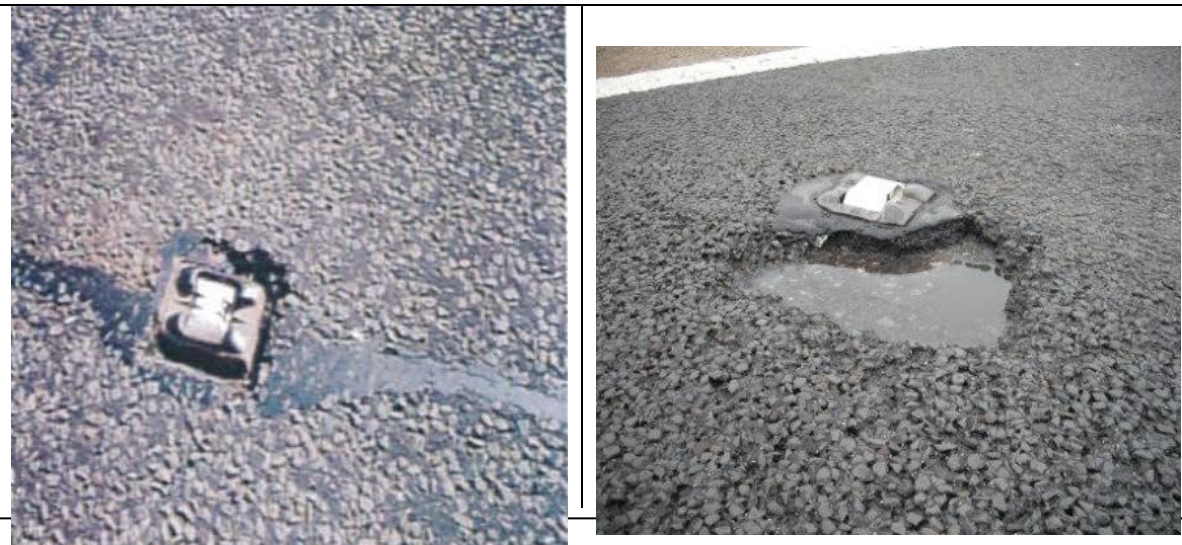
Carriageways – Miscellaneous: Road Studs / Cats Eyes – Loose / Rocking Casing - RSLD

Where the metal casing of a road stud / cats eye is loose and/or rocking to such an extent that it may be dislodged by vehicular traffic.

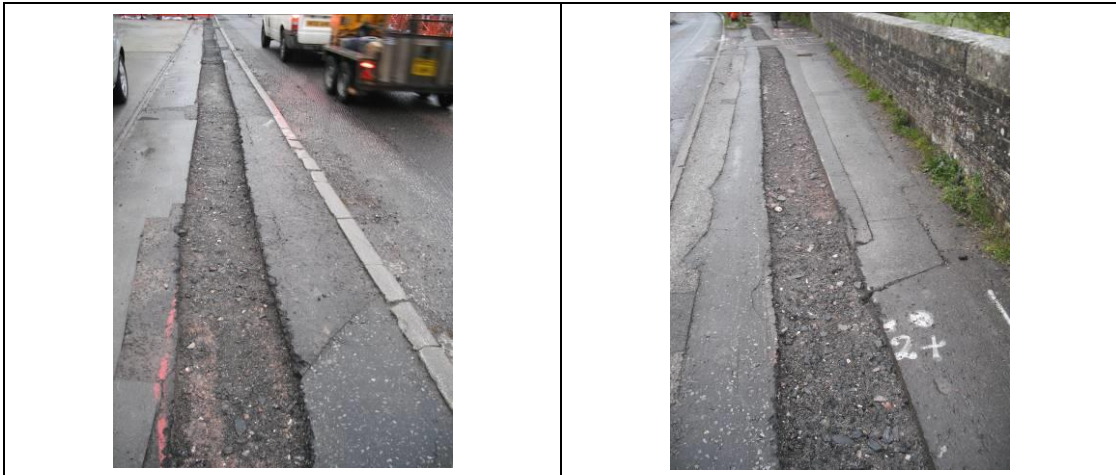
An unattended excavation in the carriageway which is not sufficiently guarded and signed. For detailed guidance on appropriate signing & guarding see the Department for Transport's 'Safety at Street and Road Works' (2002).

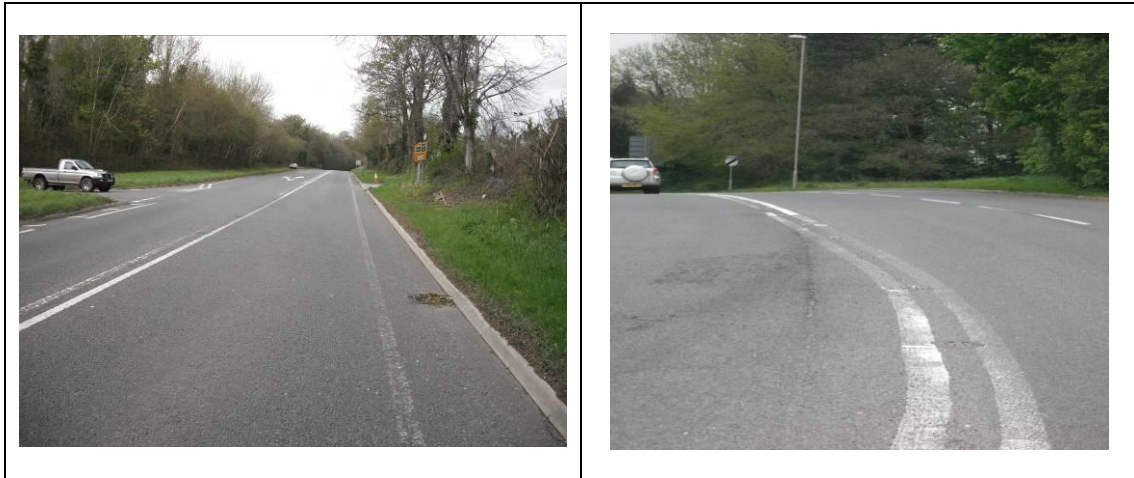
Carriageways – Road Markings: Significantly Worn Continuous Double White Centre Lines - WLMS

Double white centre line to the Traffic Signs Regulations and General Directions (2002) diagram number 1013.1 A, where any one line has been significantly worn away and is not clearly visible.

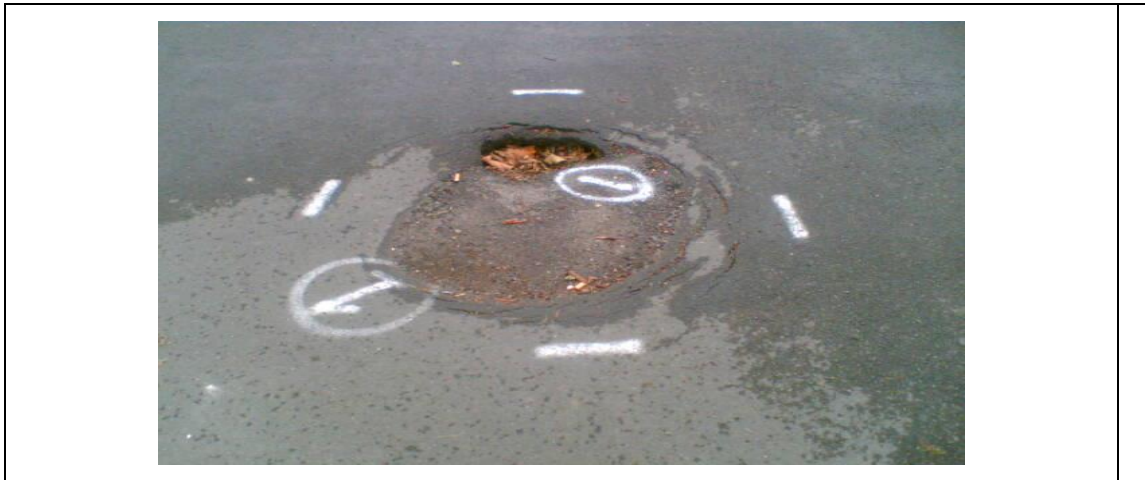
An unguarded area of the carriageway which has become significantly depressed or where substrata has been washed away creating a visible void underneath the carriageway surface course, and which poses an immediate hazard to highway users.

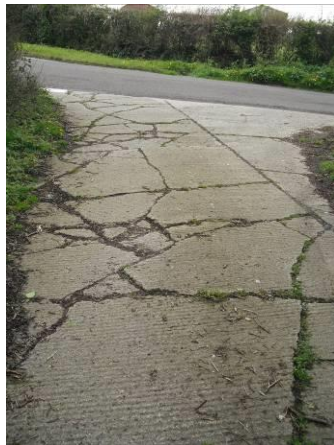
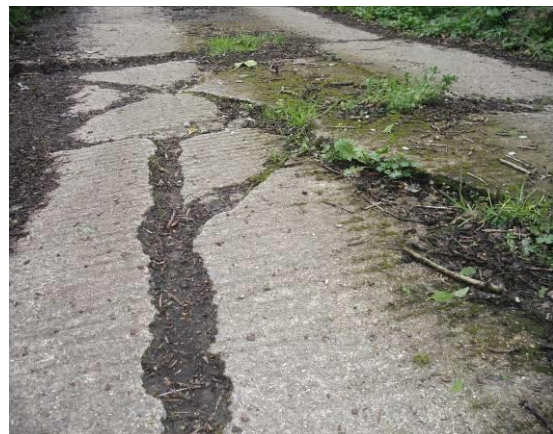
Carriageways – Surfacing: Concrete Carriageway – Miscellaneous Surface Defects - CWM

Miscellaneous defects in the surface of a concrete carriageway, such as spalling, popouts or potholes.

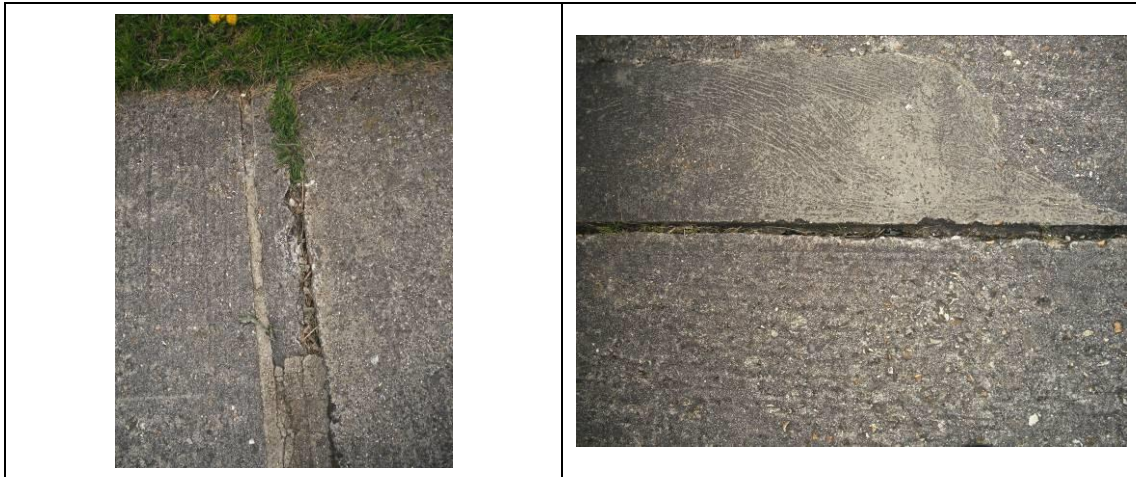
Carriageways – Surfacing: Concrete Carriageway - Missing Joint Seals - CWJS

Where the joint seal between two elements of a concrete carriageway has significantly deteriorated.

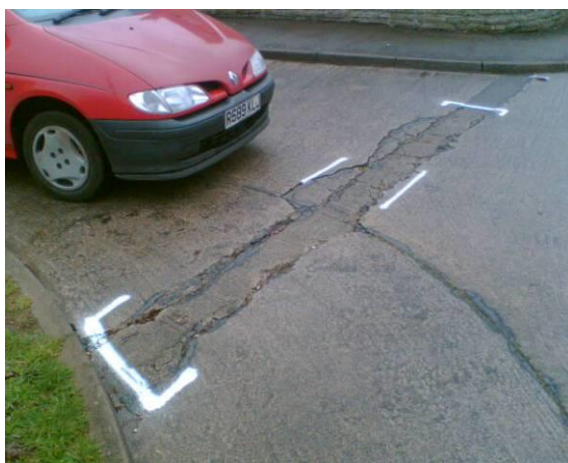
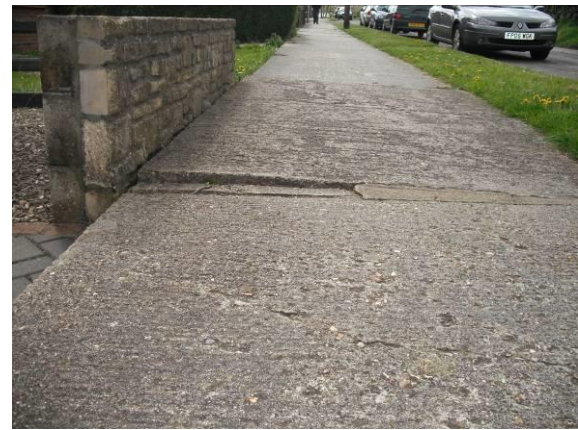
Vertical projection caused by a step-in level between adjoining elements of a concrete carriageway.

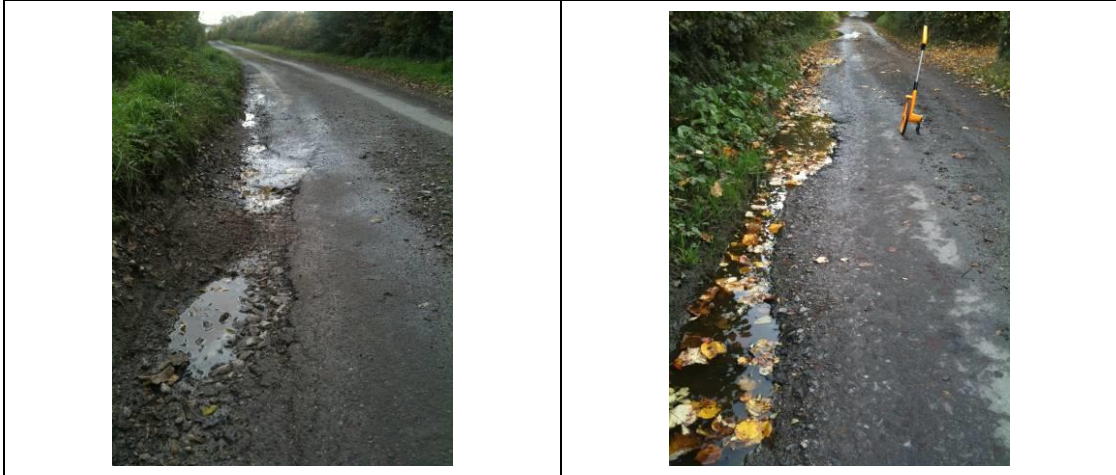
Carriageways – Surfacing: Localised Edge Deterioration - CWE

Localised breaking away or erosion at the edge of an unrestrained road surface.

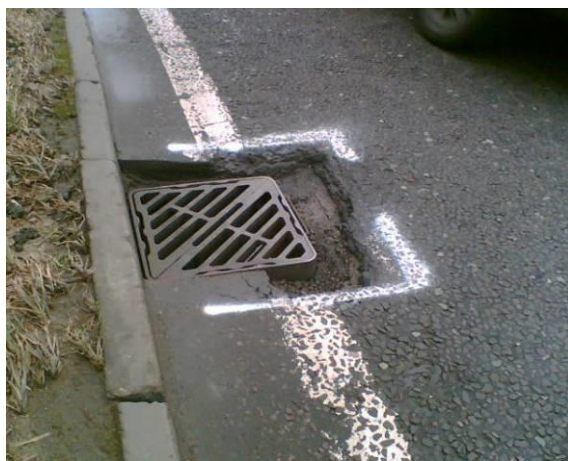
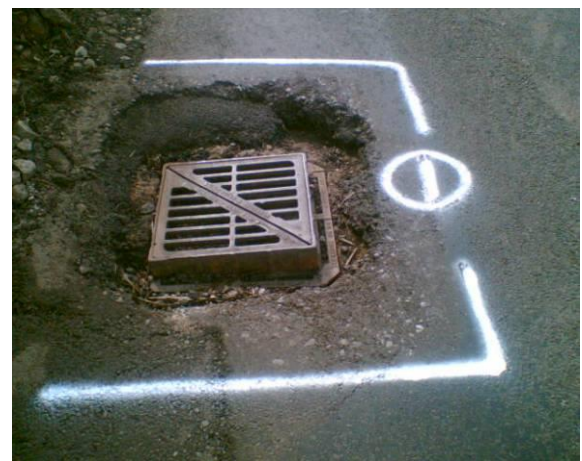
Loss of carriageway surface material adjoining ironwork, such as inspection chamber covers or gully gratings, leaving a pothole like defect.

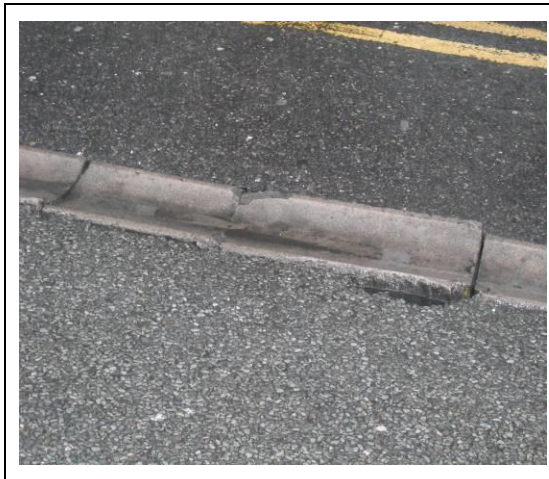
Where a modular paving unit, e.g. channel block, flag stone or paviour, is moving or rocking and creating a vertical difference in level with the adjoining carriageway surface.

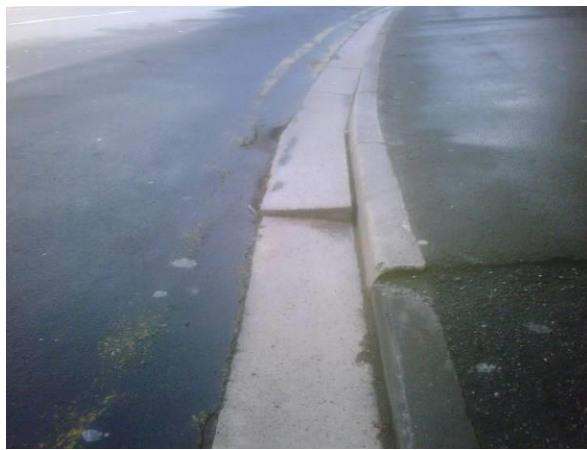
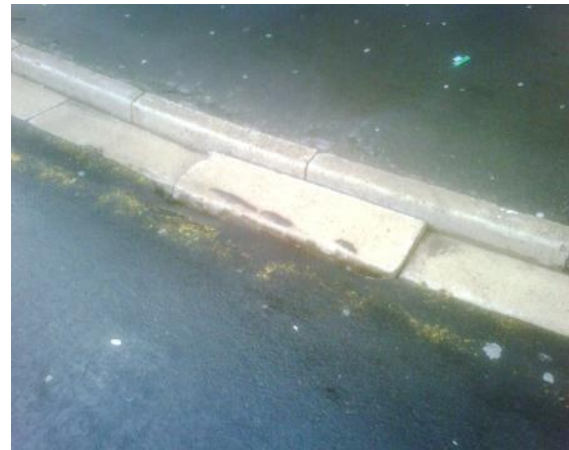
Sample Photographs:

Any modular paving unit, e.g. channel block, flag stone or paviour, creating a vertical difference in level with the adjoining carriageway surface.

Impact Rating	Criteria
High	Greater than 300mm Wide AND Greater than 40mm Deep
Medium	Less than 300mm Wide AND Greater than 40mm Deep
Low	Greater than 300mm Wide AND Greater than 20mm Deep

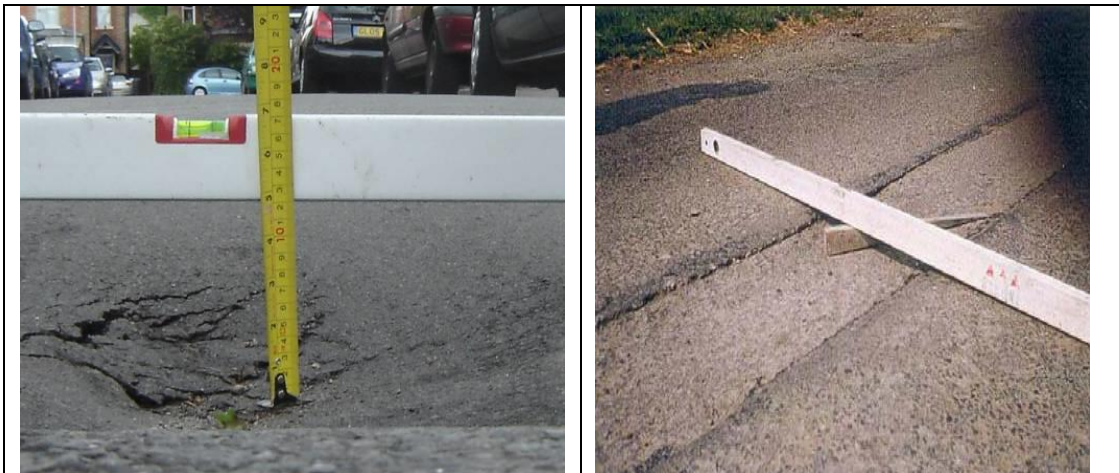
Sample Photographs:

Where the surface height of a patch or reinstatement creates a vertical difference in level with the adjoining carriageway surface. If it appears to be a utility patch within its guarantee period (typically 2 years) then please contact the traffic team for advice.

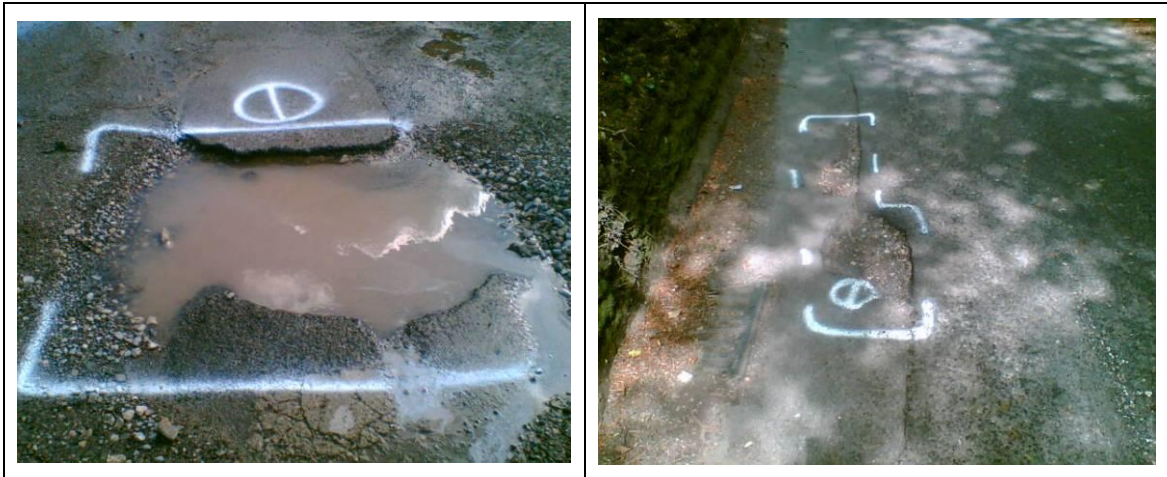
Sample Photographs:

Loss of surfacing material from a patch or reinstatement creating a pothole like defect within the carriageway surface. If it appears to be a utility patch within its guarantee period (typically 2 years) then please contact the traffic team for advice.

Impact Rating	Criteria
High	Greater than 300mm Wide AND Greater than 40mm Deep
Medium	Less than 300mm Wide AND Greater than 40mm Deep
Low	Greater than 300mm Wide AND Greater than 20mm Deep

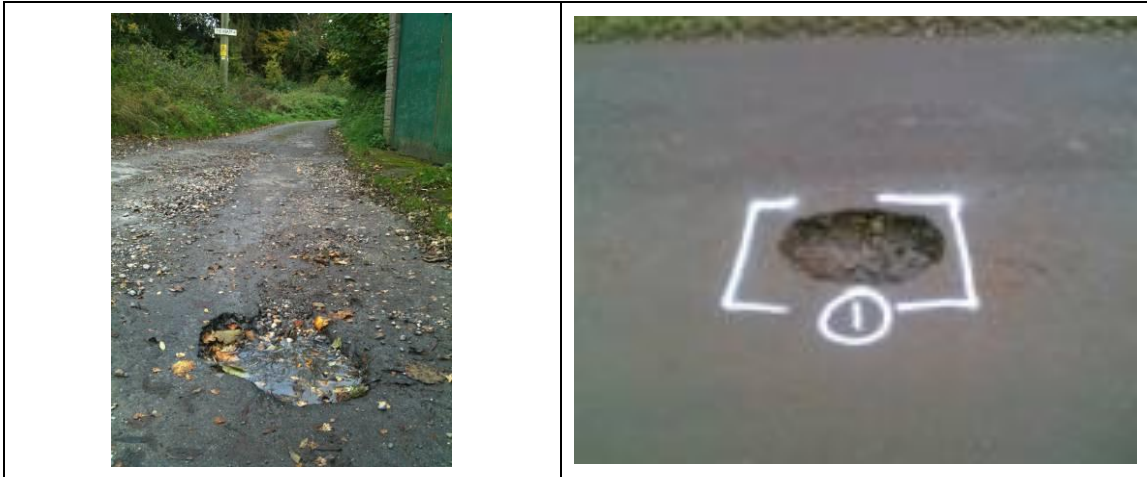
Sample Photographs:

Loss of material from the carriageway surface creating a pothole, sharp edged depression or void.

Impact Rating	Criteria
High	Greater than 300mm Wide AND Greater than 40mm Deep
Medium	Less than 300mm Wide AND Greater than 40mm Deep
Low	Greater than 300mm Wide AND Greater than 20mm Deep

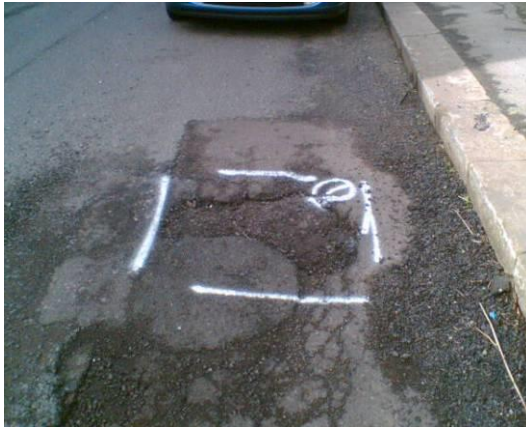
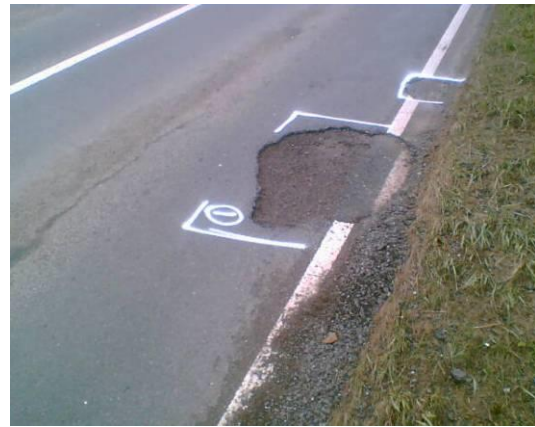
Sample Photographs:

The loss of stone and/or chippings from a bituminous carriageway surface course.

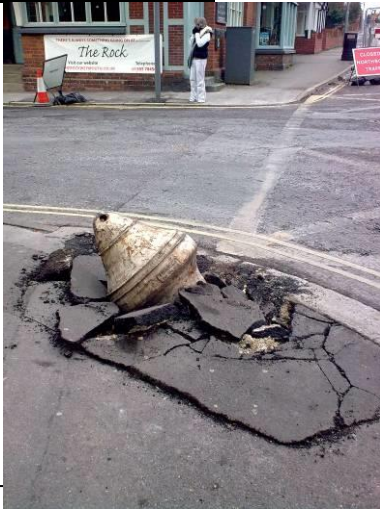
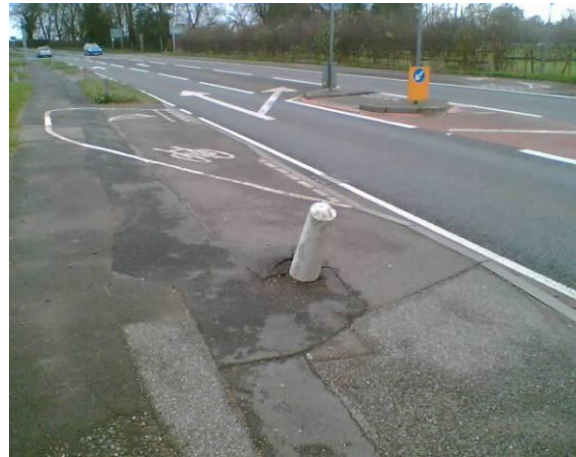
Sample Photographs:

Footways Bollard: Damaged - BLDG

A non-illuminated bollard which is damaged and/or ~~unstable, and~~ unstable and poses an immediate hazard to highway users.

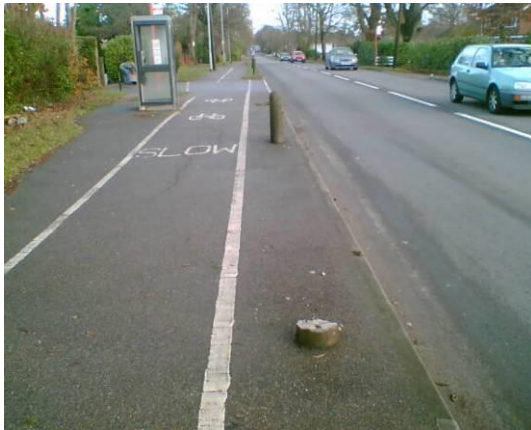
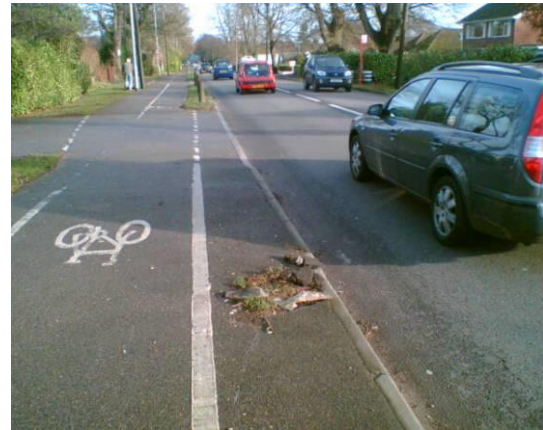
Sample Photographs:

Footways –Bollard: Missing - BLMS

A non-illuminated bollard which is missing and presents an immediate hazard to highway users.

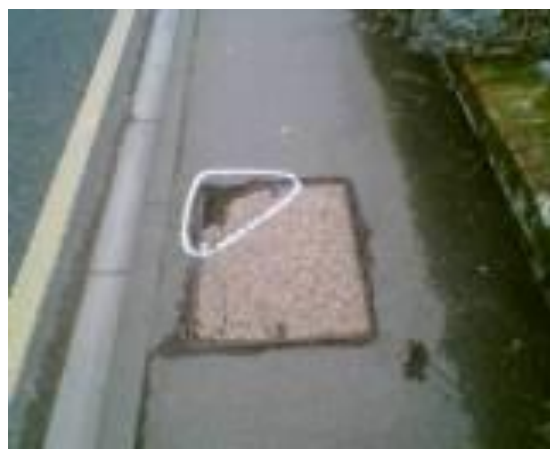
Sample Photographs:

Footways – Cover / Grating: Broken, Damaged, Cracked or Corroded - MFD

Any cover, grating, frame or box in the footway which is broken, damaged, cracked or has a corroded cover or grating. Where it is clear that the cover is the responsibility of a Statutory Undertaker (e.g. gas, water or telecoms) and NOT the County Council the defect should be recorded using the defect option: Footways – Utility Cover: Broken, Damaged, Cracked or Corroded.

Impact Rating	Criteria
High	Severely Damages or Missing Components
Medium	Damaged and Moving
Low	Damaged but Secure

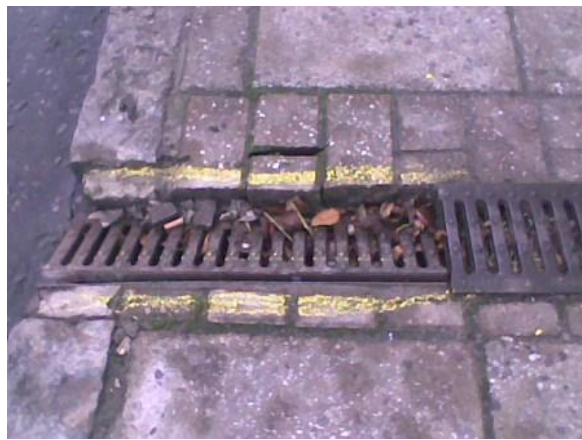
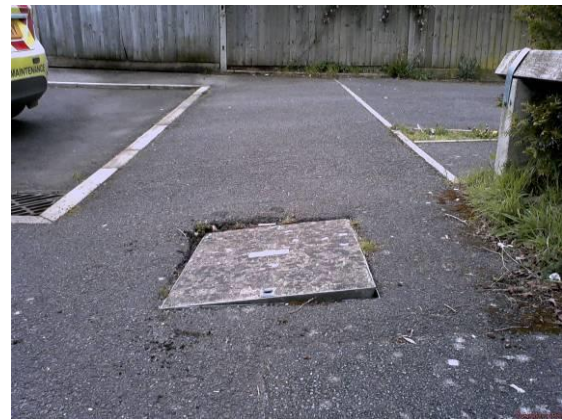
Sample Photographs:

Inspection chamber covers, gully gratings and other ironwork causing a step-in level to the surrounding footway surface. Where it is clear that the cover is the responsibility of a Statutory Undertaker (e.g. gas, water or telecoms) and NOT the County Council the defect should be recorded using the defect option: Footways – Utility Cover: Difference in Level.

Impact Rating	Criteria
High	Greater than 20mm Difference in Level

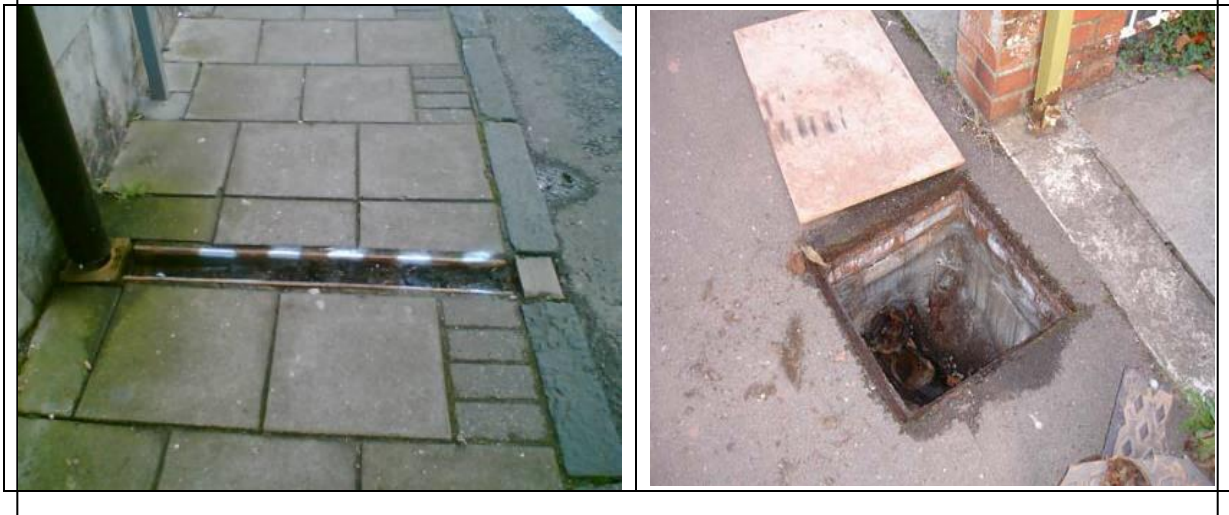
Sample Photographs:

Footways – Cover / Grating: Missing - MFSH

A missing cover or gully grating anywhere within the footway. Where it is clear that the cover is the responsibility of a Statutory Undertaker (e.g. gas, water or telecoms) and NOT the County Council the defect should be recorded using the defect option: Footways – Utility Cover: Missing.

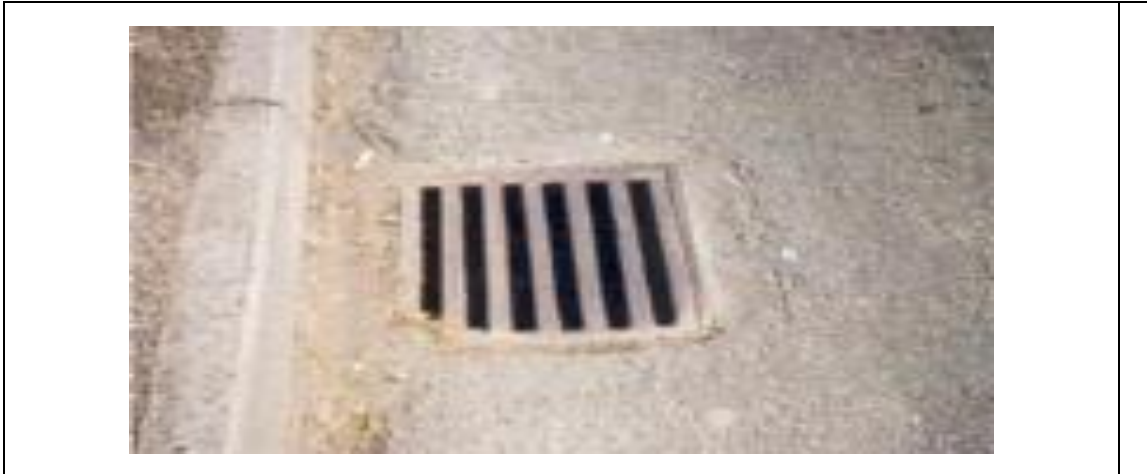
Sample Photographs:

Where a gully grating has been installed with the drainage slots running parallel to the direction of vehicular traffic.

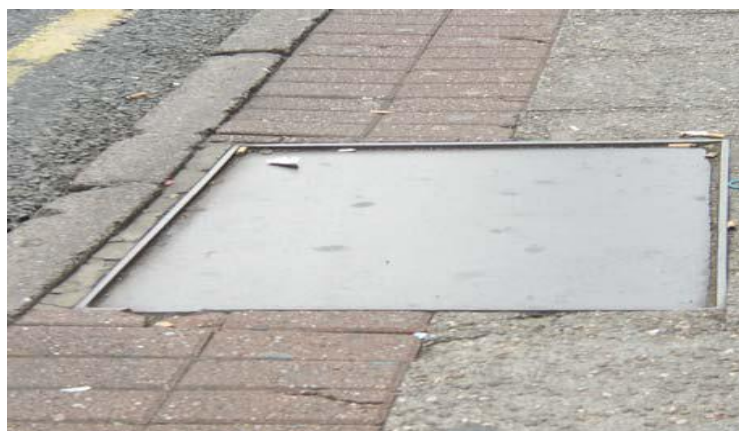
Sample Photograph:

Footways – Cover / Grating: Significantly Worn / Smooth Cover- MFSM

Worn or smooth covers which pose a potential skidding / slipping hazard to highway users. Where it is clear that the cover is the responsibility of a Statutory Undertaker (e.g. gas, water or telecoms) and NOT the County Council the defect should be recorded using the defect option: Footways – Utility Cover: Significantly Worn/Smooth Cover.

Impact Rating	Criteria
Medium	Greater than 75% Worn/Smooth

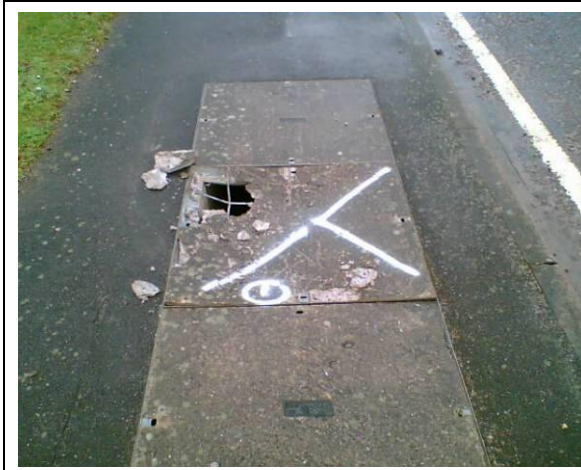
Sample Photographs:

Footways–Utility Cover: Broken, Damaged, Cracked or Corroded – Sec 81

Any cover, grating, frame or box in the footway which is broken, damaged, cracked or has a corroded cover or grating, and where it is clear that the cover is responsibility of a Statutory Undertaker.

Impact Rating	Criteria
High	Severely Damages or Missing Components
Medium	Damaged and Moving
Low	Damaged but Secure

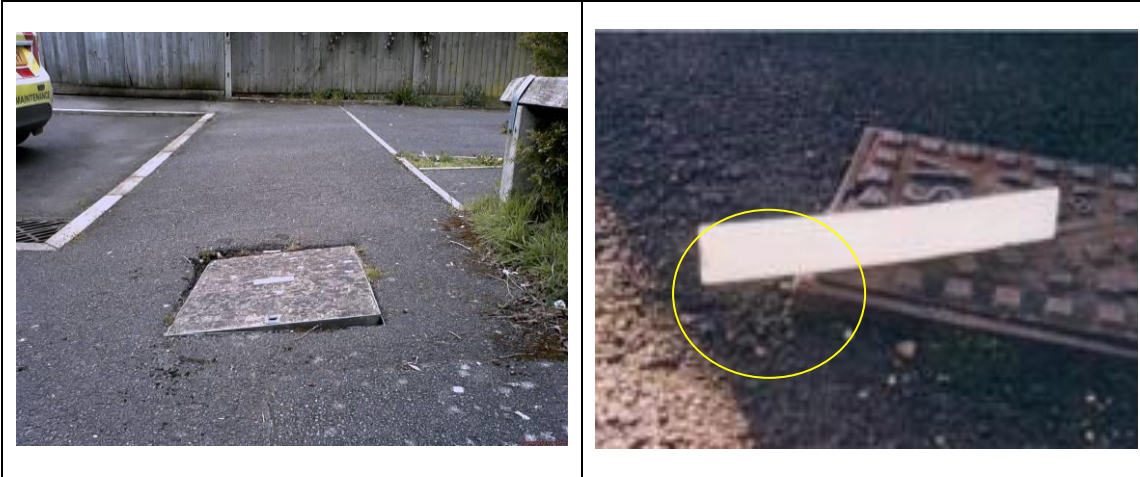
Sample Photographs:

Inspection chamber covers, gully gratings and other ironwork, which are clearly the responsibility of a Statutory Undertaker, causing a **step-in-step-in** level to the surrounding footway surface.

Impact Rating	Criteria
High	Greater than 20mm Difference in Level

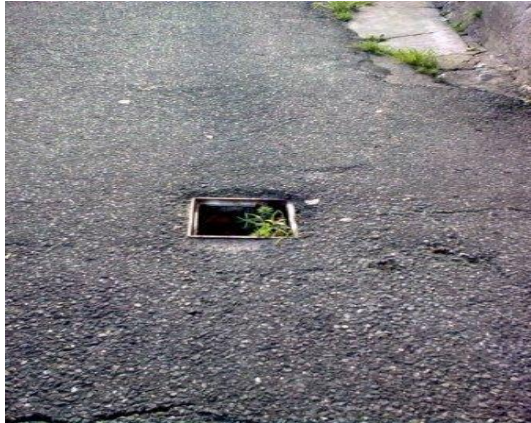
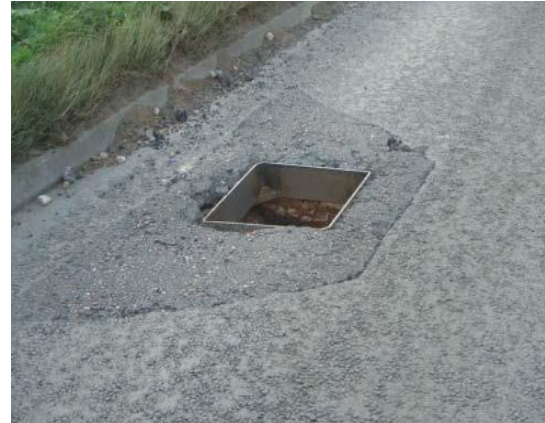
Sample Photograph:

Footways – Utility Cover: Missing – Sec 81

A missing cover or gully grating anywhere within the footway, which is clearly the responsibility of a Statutory Undertaker.

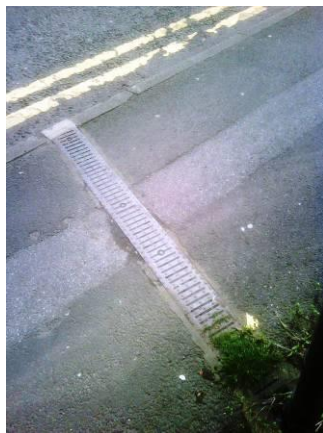
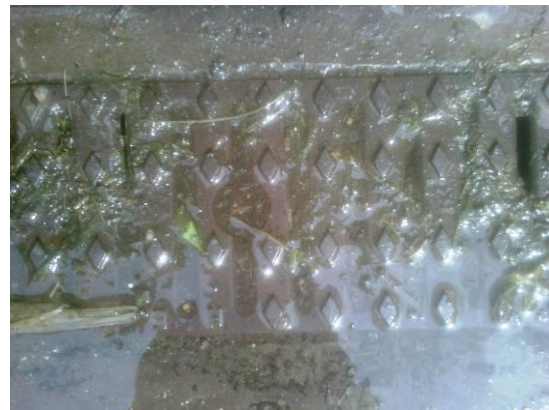
Sample Photographs:

A gully that is clearing water from the footway and stopping the footway from flooding that is partially full of detritus and/or other material to a point where the outlet is 75% blocked. The clearing of slot drains/channels across footways that take **predominantly** private water are the property owners responsibility.

Impact Rating	Criteria
Medium	Greater than 75% Blocked

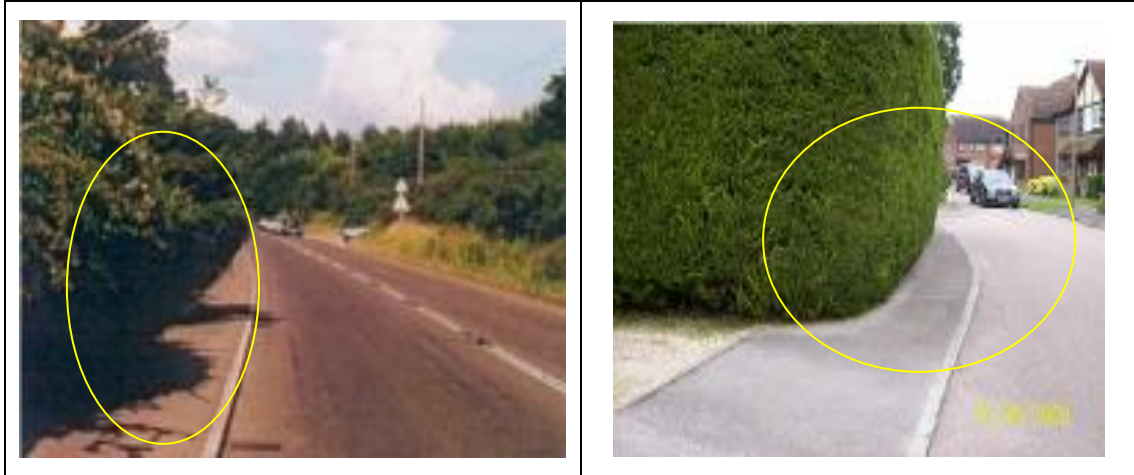
Sample Photographs:

Where any hedge, tree or other vegetation obscures the footway to such an extent that it poses a significant hazard to the highway user.

Impact Rating	Criteria
High	Causing Pedestrians to Divert into Carriageway
Medium	Causing Pedestrians to Significantly Divert Their Path

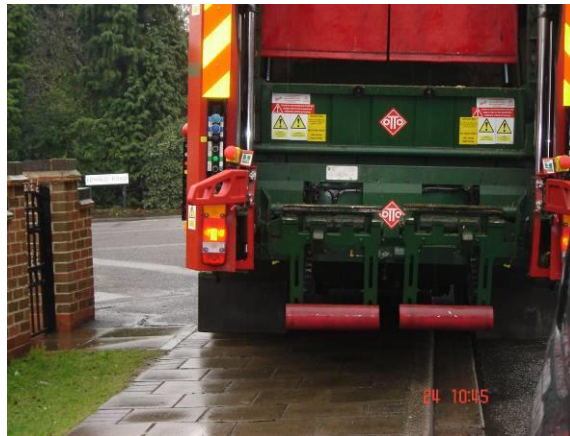
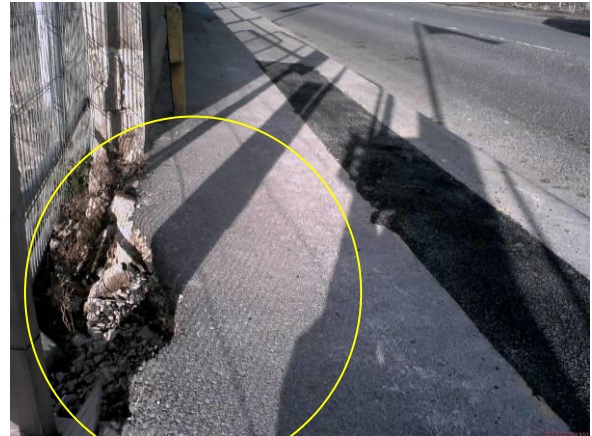
Sample Photographs:

Footways –Miscellaneous: Damaged Caused by Identifiable Third Party

Where the footway has been damaged to an extent that poses a hazard to the highway user and the cause of the damage has been / can be established.

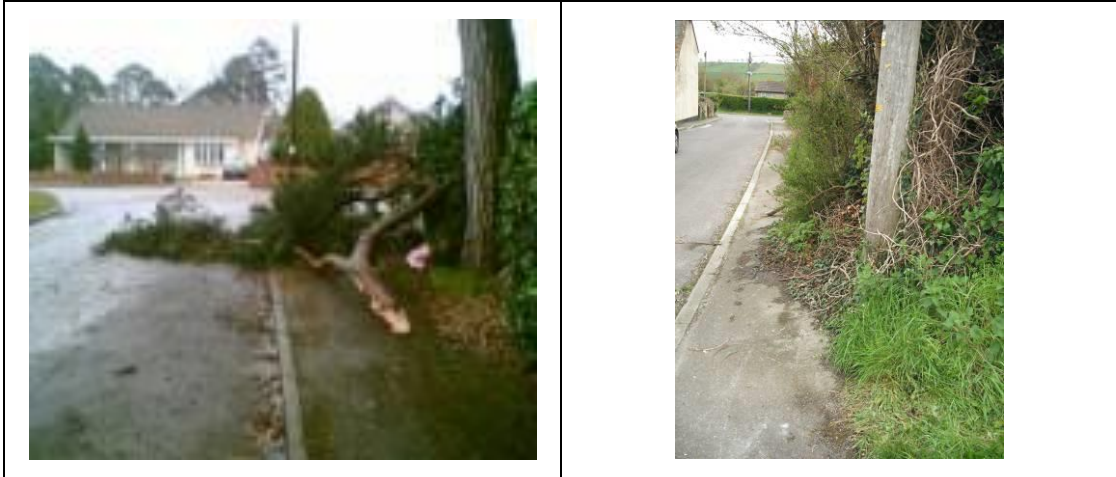
Sample Photographs:

An obstruction in the footway which poses an immediate hazard to the highway user, e.g. a fallen tree or collapsed embankment.
