Dorset Highways: Code of Practice for the Classification of Highway Safety Hazards & Defects

Version 2.0, Revision 1
October 2018

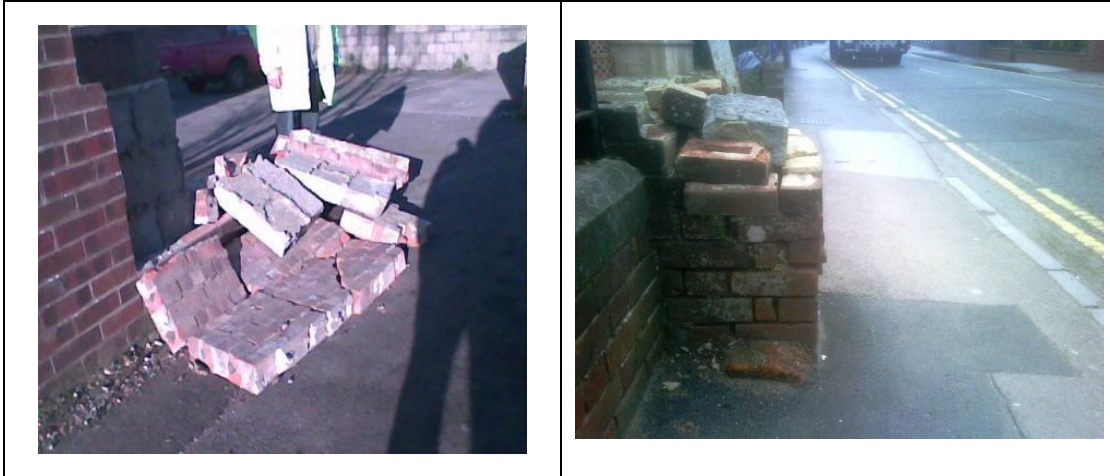
Sample Photographs:

Footways – Miscellaneous: Private Property in an Unsafe Condition - FWPP

Where private property adjoining the highway is in an unsafe condition and poses an immediate hazard to the highway user, e.g. a destabilised private boundary wall in danger of collapsing into the footway.

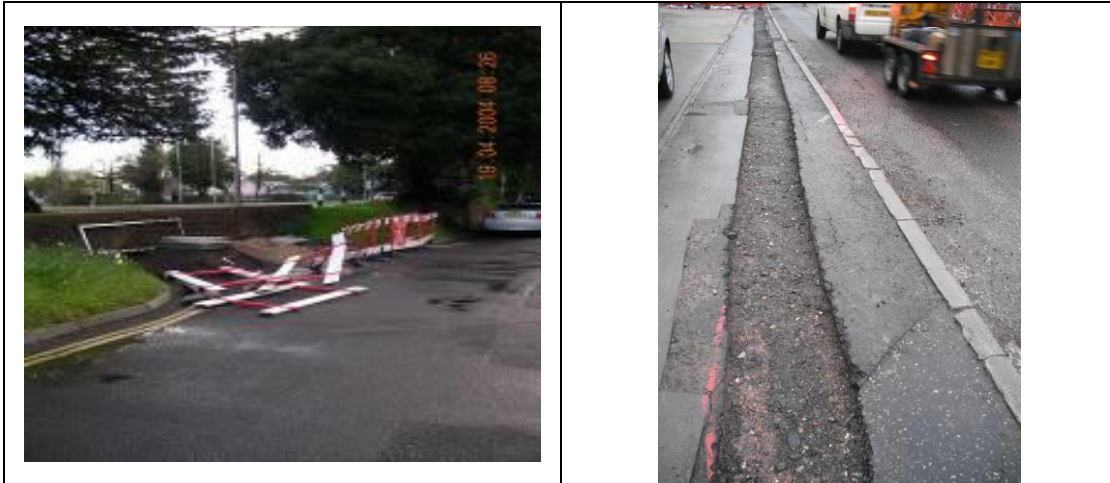
Sample Photographs:

An unattended excavation in the footway which is not sufficiently guarded and signed. For detailed guidance on appropriate signing & guarding see the Department for Transport's 'Safety at Street and Road Works' (2002).

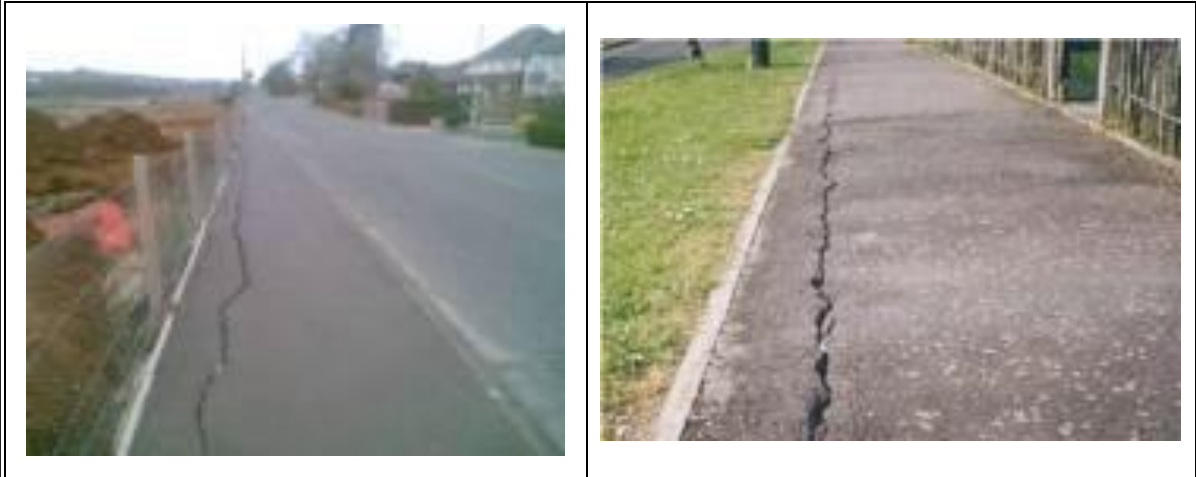
Sample Photographs:

Footways – Surfacing: Cracking and Open Surface Joints - FWCK

A crack or open joint in a bituminous footway surface.

Impact Rating	Criteria
High	Greater than 40mm Wide AND Greater than 20mm Deep

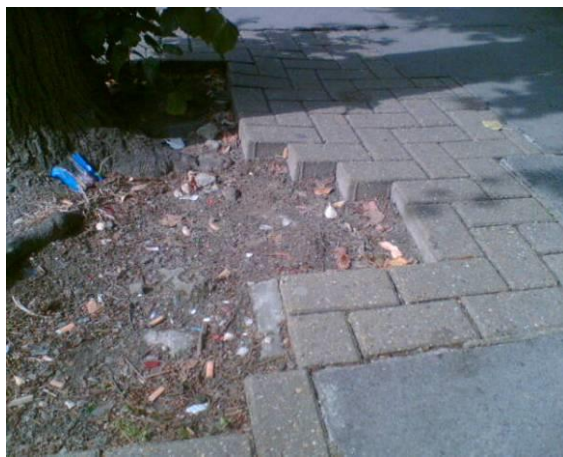
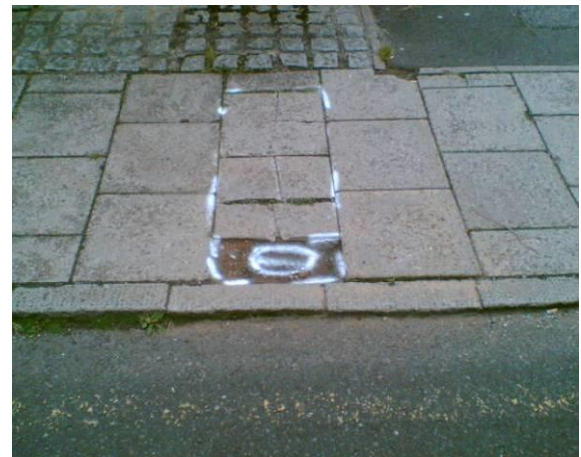
Sample Photographs:

Footways –Surfacing: Modular Paving Unit – Missing - FWMP

A missing modular paving unit, e.g. channel block, flag stone or paviour, anywhere within the footway.

Impact Rating	Criteria
High	Greater than 20mm Difference in Level

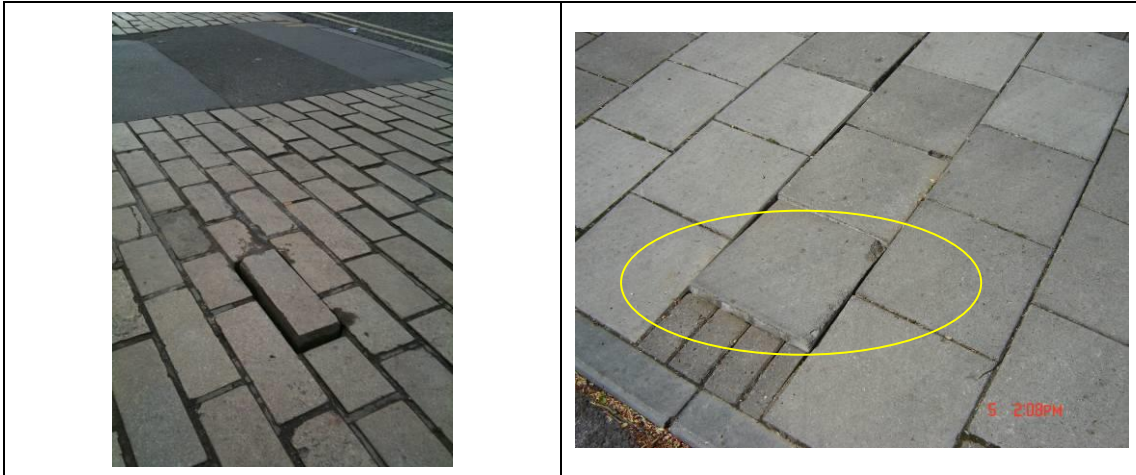
Sample Photographs:

Footways –Surfacing: Modular Paving Unit – Loose /Rocking - FWMP

Where a modular paving unit, e.g. channel block, flag stone or paviour, is moving or rocking and creating a vertical difference in level with the adjoining footway surface.

Impact Rating	Criteria
High	Greater than 20mm Difference in Level

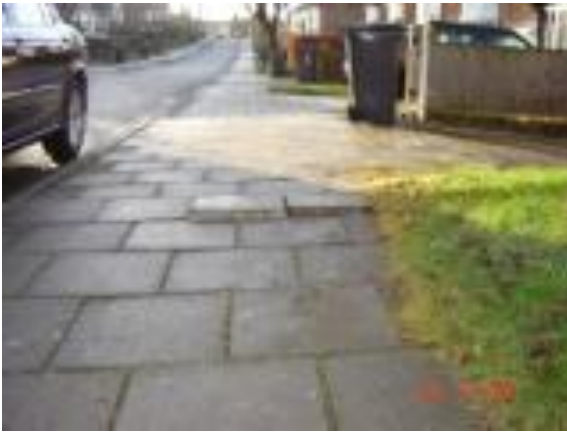
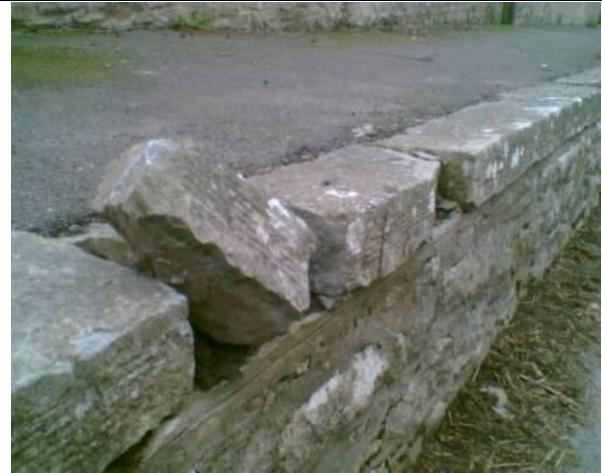
Sample Photographs:

Any modular paving unit, e.g. channel block, flag stone or paviour, creating a vertical difference in level with the adjoining footway surface.

Impact Rating	Criteria
High	Greater than 20mm Difference in Level

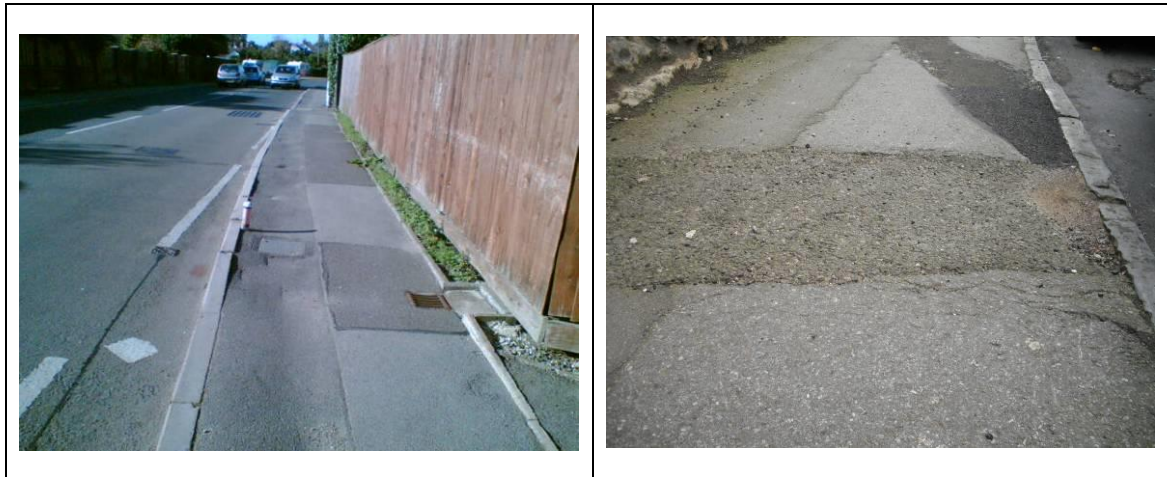
Sample Photographs:

Where the surface height of a patch or reinstatement creates a vertical difference in level with the adjoining footway surface. If it appears to be a utility patch within its guarantee period (typically 2 years) then please contact the traffic team for advice.

Impact Rating	Criteria
High	Greater than 20mm Difference in Level

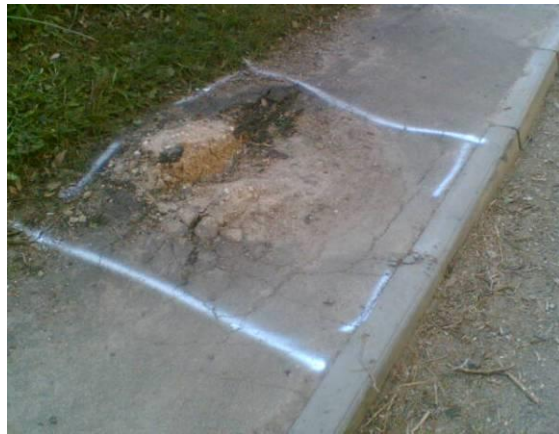
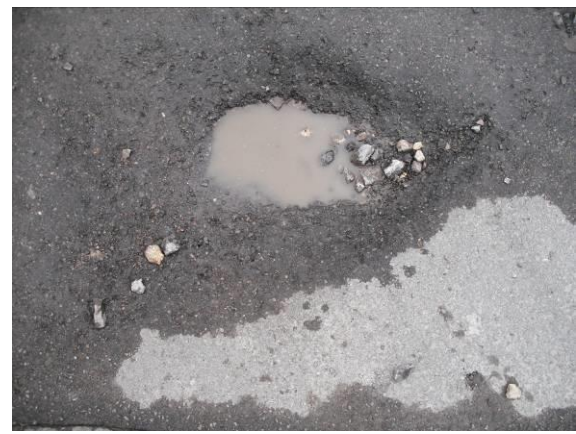
Loss of surfacing material from a patch or reinstatement creating a pothole like defect within the footway surface. If it appears to be a utility patch within its guarantee period (typically 2 years) then please contact the traffic team for advice.

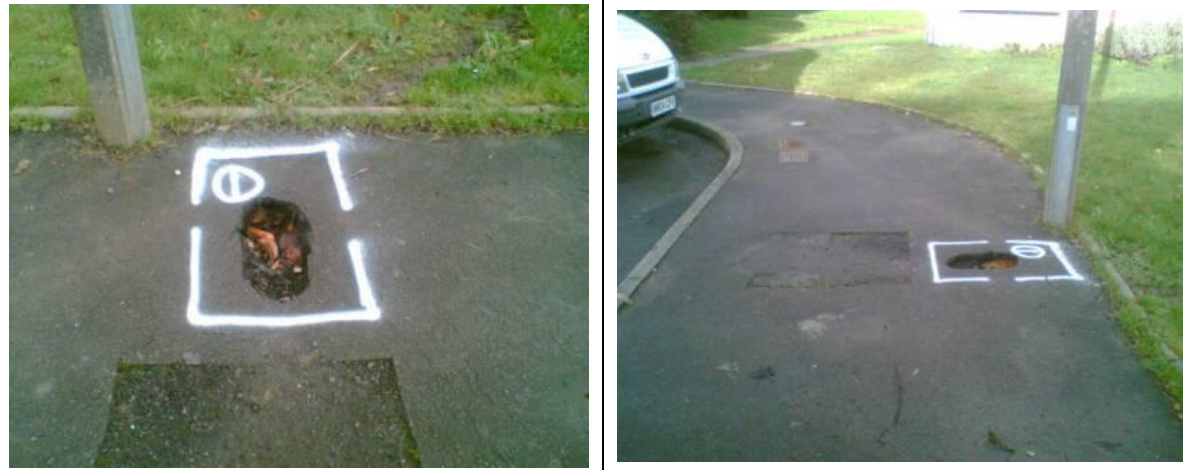
Loss of material from the footway surface creating a pothole, sharp edged depression or void.

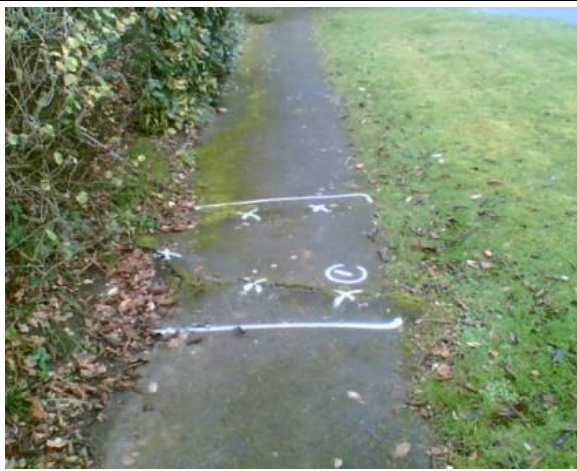
A rapid change in the surface profile of the footway creating a hump or depression with a difference in vertical level greater than 25mm over a length of less than 125mm.

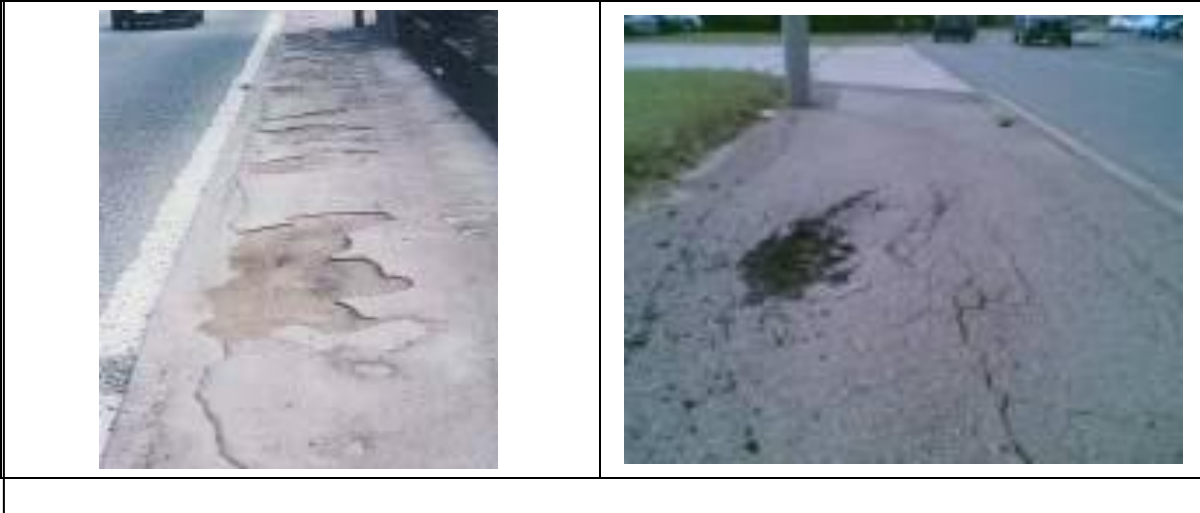
The loss of stone/chippings from a bituminous surface course to leave a sharp edge.

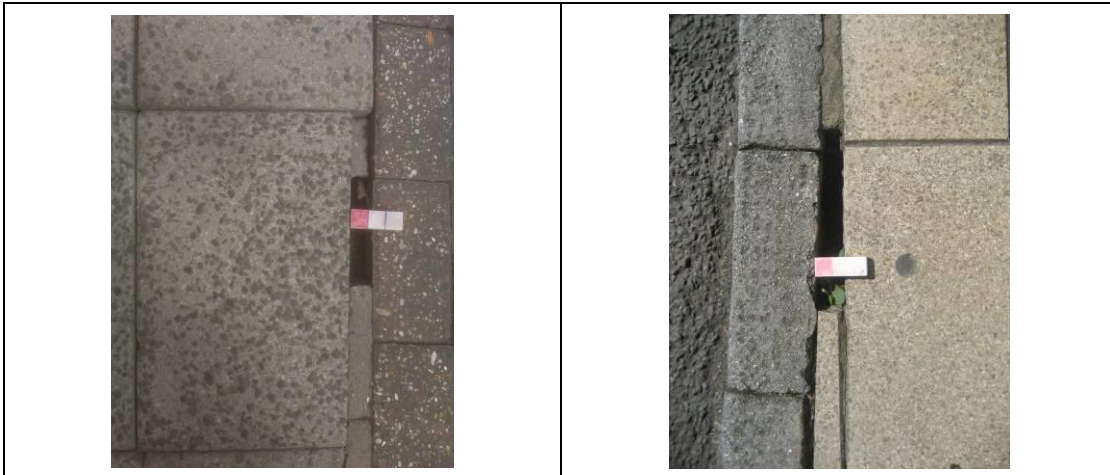
Unfilled gaps between flag stones and/or other modular paving units of sufficient width and depth as to pose a hazard to the footway user.

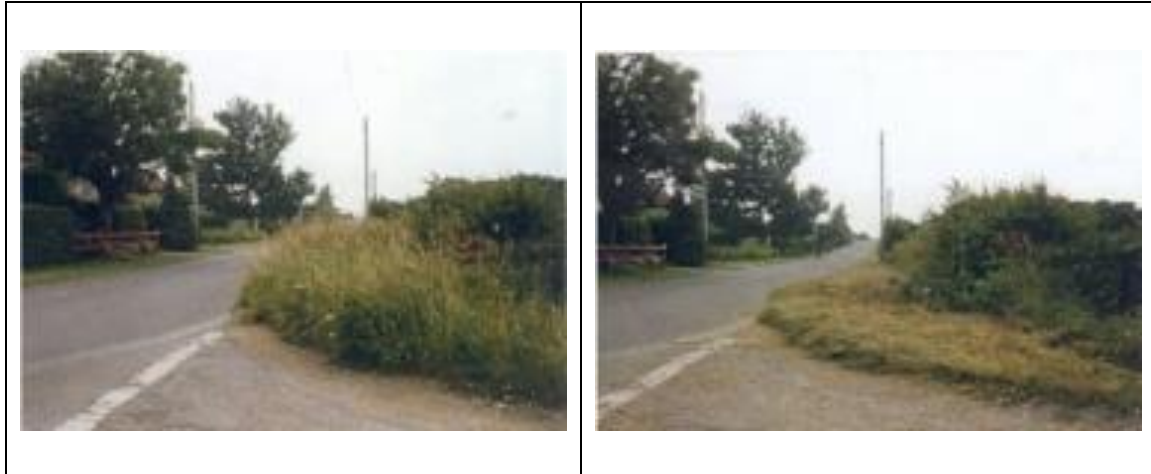
Verges & Landscaped Areas – Inadequate Visibility - VGVS

Where overgrown grass and vegetation obscures visibility to such an extent as to pose a possible hazard to highway users.

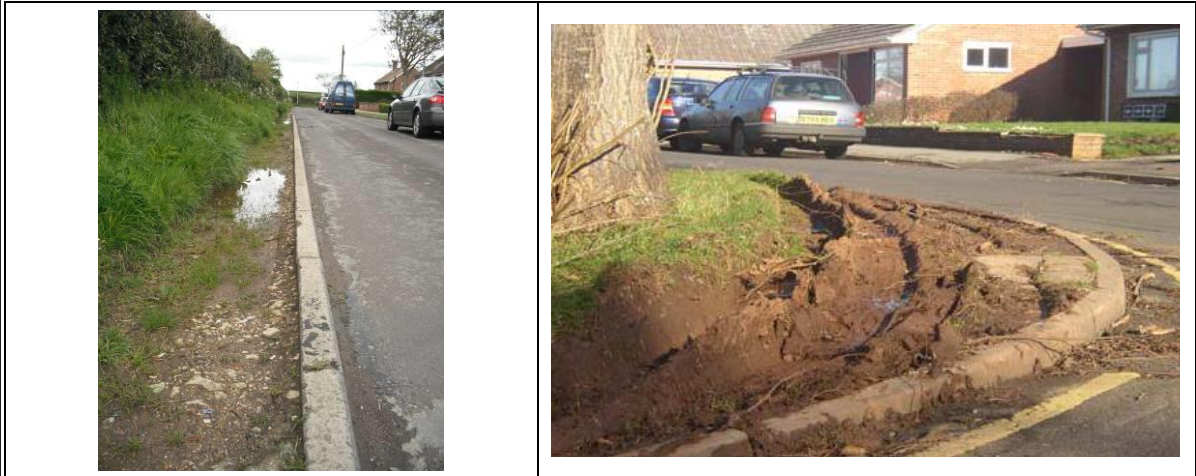
Where a verge adjoining a carriageway has been subject to over-running from vehicular traffic and is a condition which may pose a hazard to the highway user.

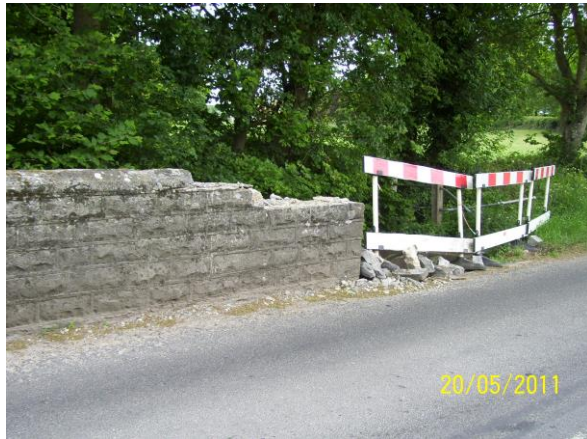
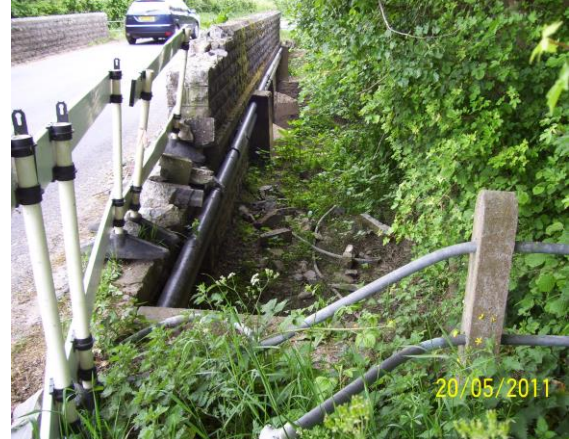
Structures – Damaged Structure - RWDG

Where a highway structure such as a bridge, retaining wall or culvert, has been damaged and poses an immediate hazard to the highway user.

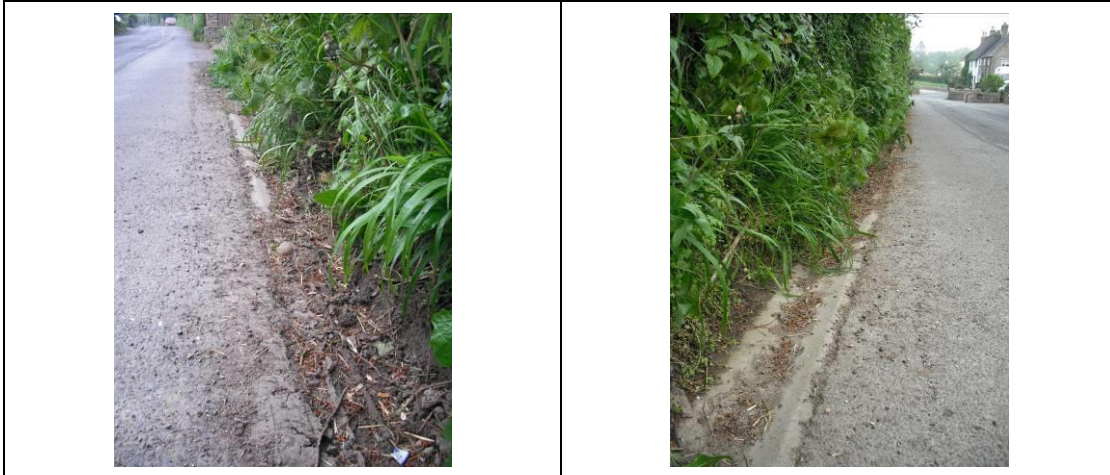
Where the free flow of water along a channel is significantly impeded, presenting a hazard to the highway user.

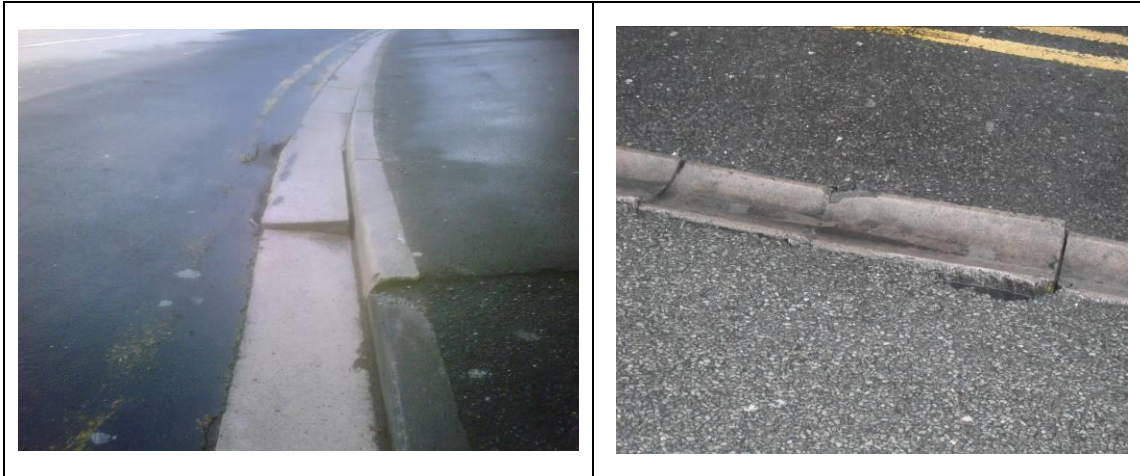
A channel unit which is creating a vertical difference in level with the adjoining surface.

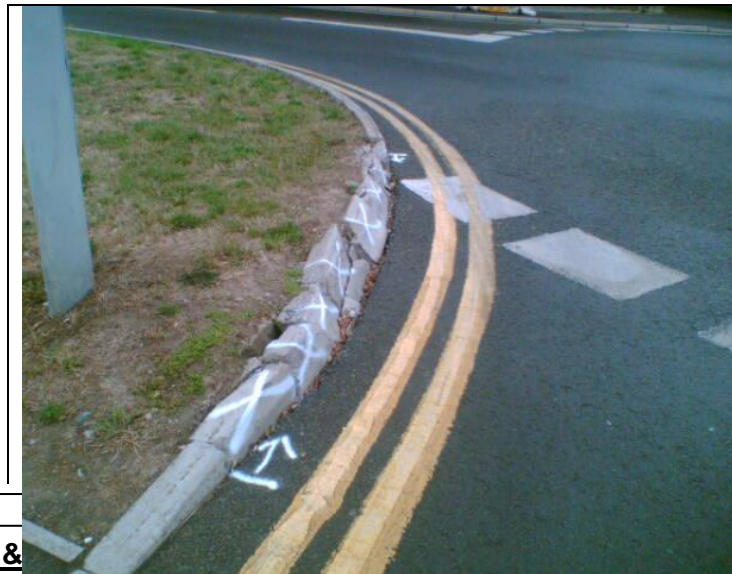
Kerbs & Channels – Kerb Unit: Adjoining a Verge & Damaged / Missing - KBVG

A significantly damaged or missing kerb unit adjoining a verge, grassed area or other unmetalled surface.

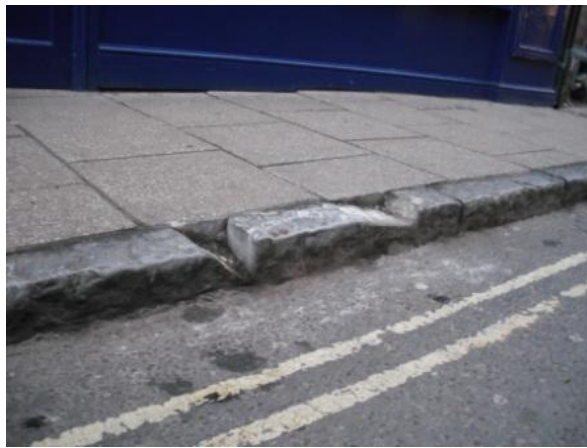
Kerbs & Channels – Kerb Unit: Damaged - KBVP

A significantly damaged kerb unit adjoining a metalled footway.

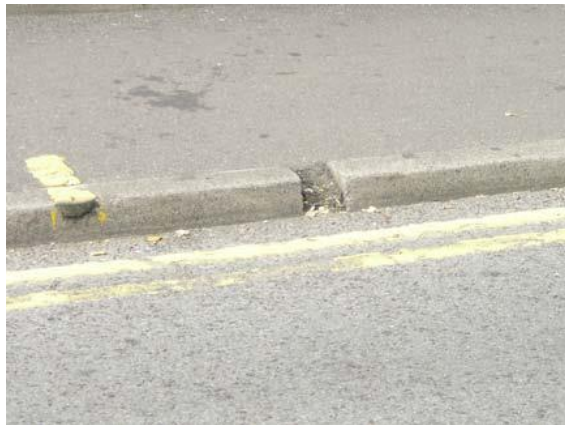
An excessive gap between two adjoining kerb units next to a metalled footway.

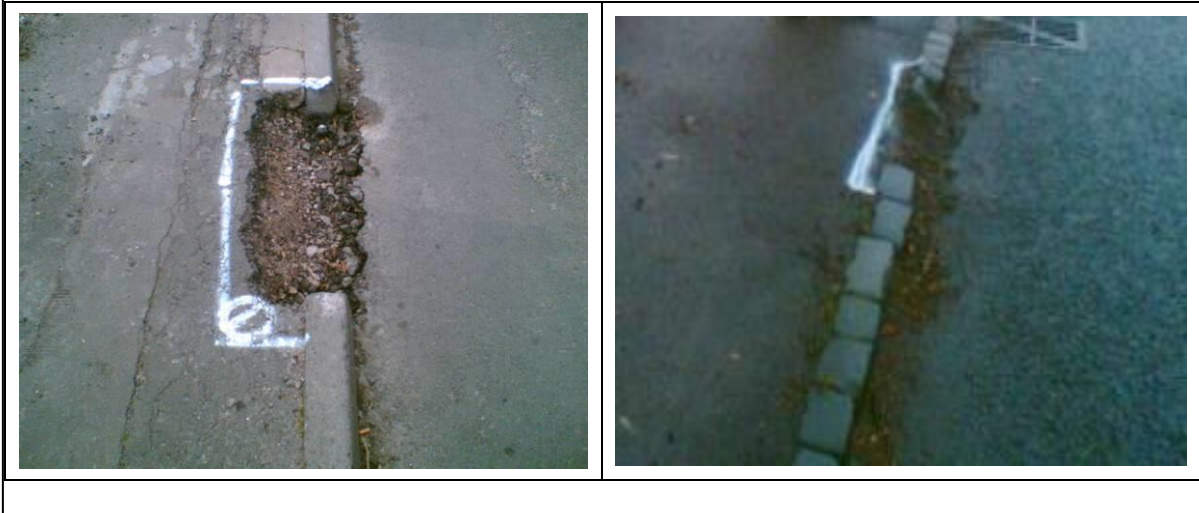
Kerbs & Channels – Kerb Unit: Missing - KBMS

A missing kerb unit adjoining a metalled footway.

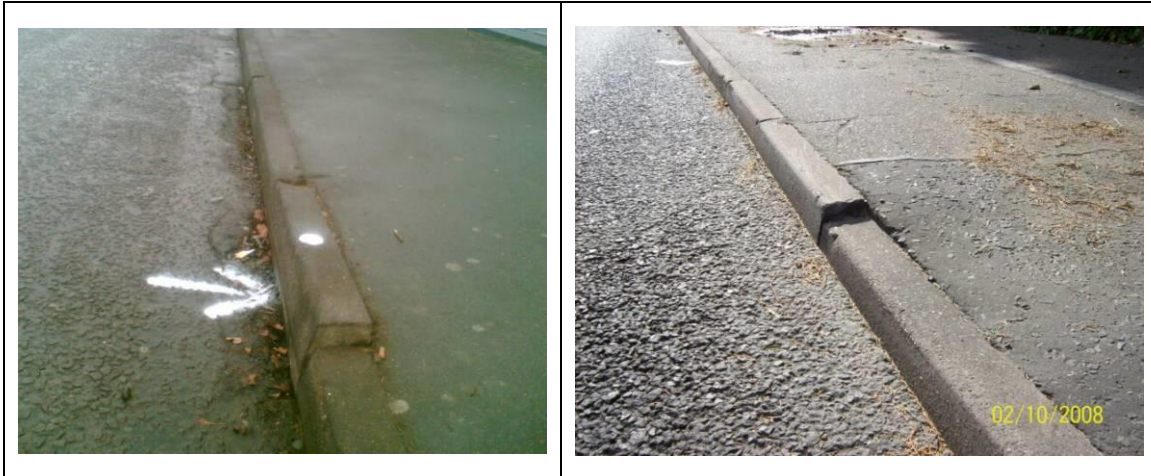
A kerb unit adjoining a metalled footway which is creating a vertical difference in level with the adjoining surface.

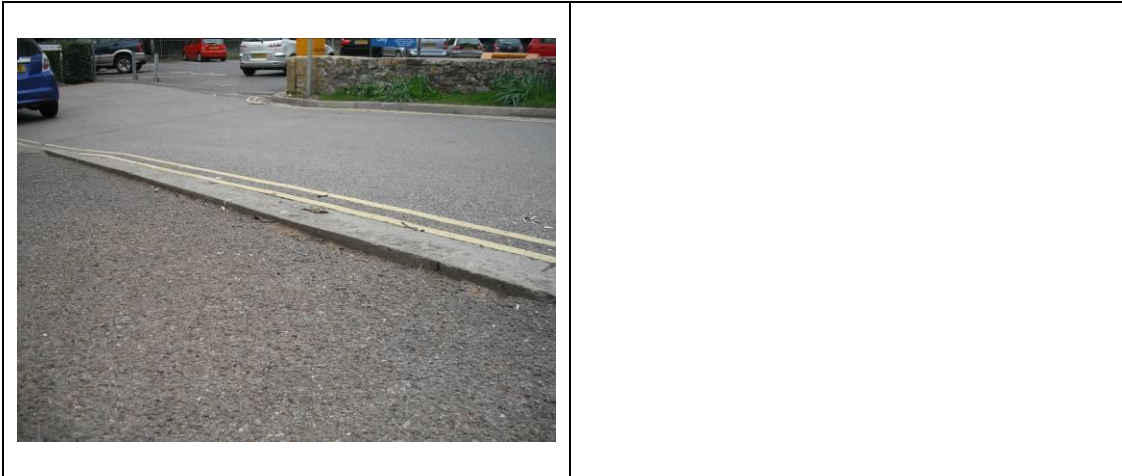
A kerb unit at a defined crossing point causing a vertical difference in level with the adjoining footway surface.

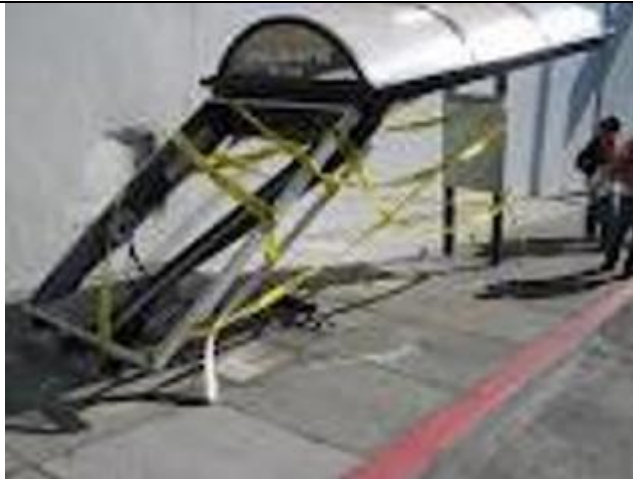
Street Furniture – Bus Shelter: Damaged - BSDG

Where a bus stop or shelter has been vandalised and poses an immediate hazard to highway users e.g. is unstable and may collapse into the carriageway.

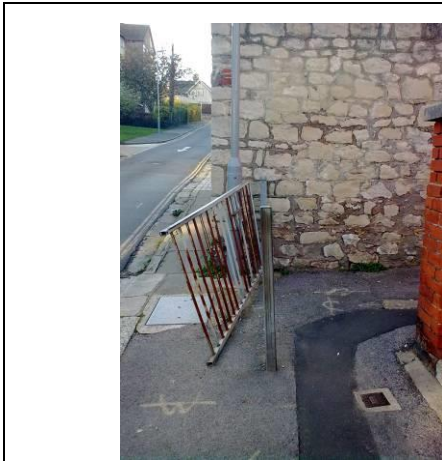
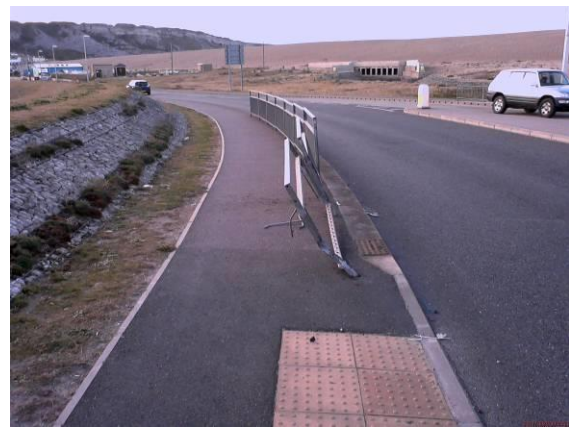
Street Furniture – Fence / Guardrail: Damaged - PGD

Where a pedestrian guardrail is damaged to such an extent that it poses a hazard to the highway user.

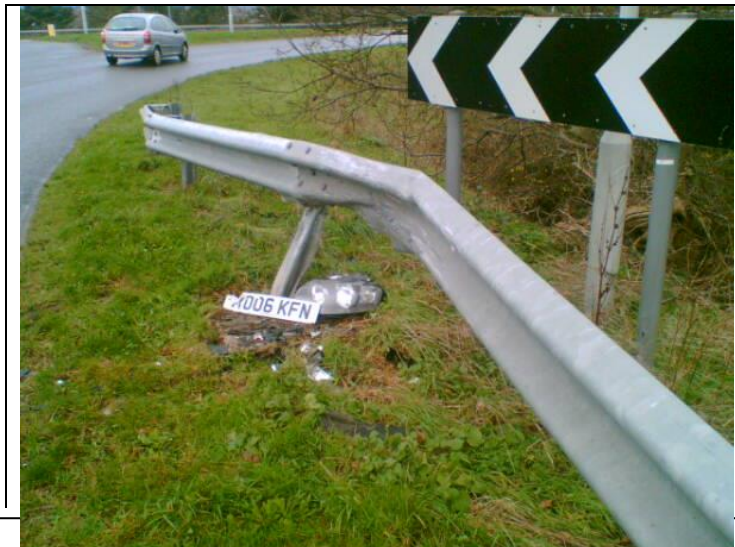
Street Furniture – Safety Barriers: Accident Damage - SFAC

Where a safety barrier has been subject to vehicular impact and is damaged and/or misaligned.

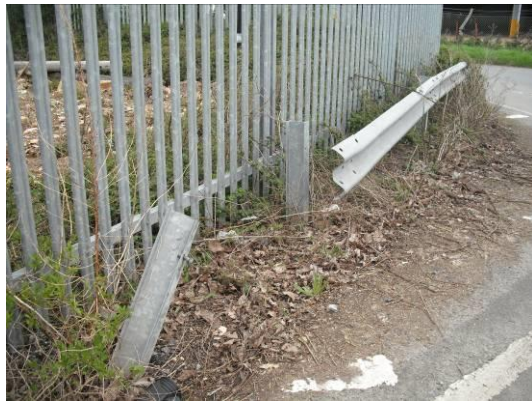
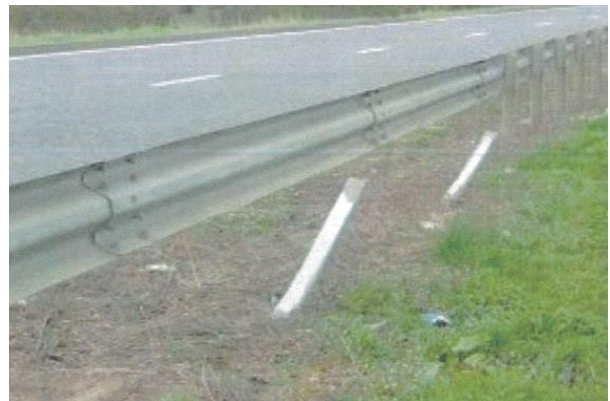
Street Furniture – Safety Barriers: Missing Component-SFMS

Where a safety barrier has been subject to vehicular impact / accident damage and has missing components such as vertical posts or tension bolts.

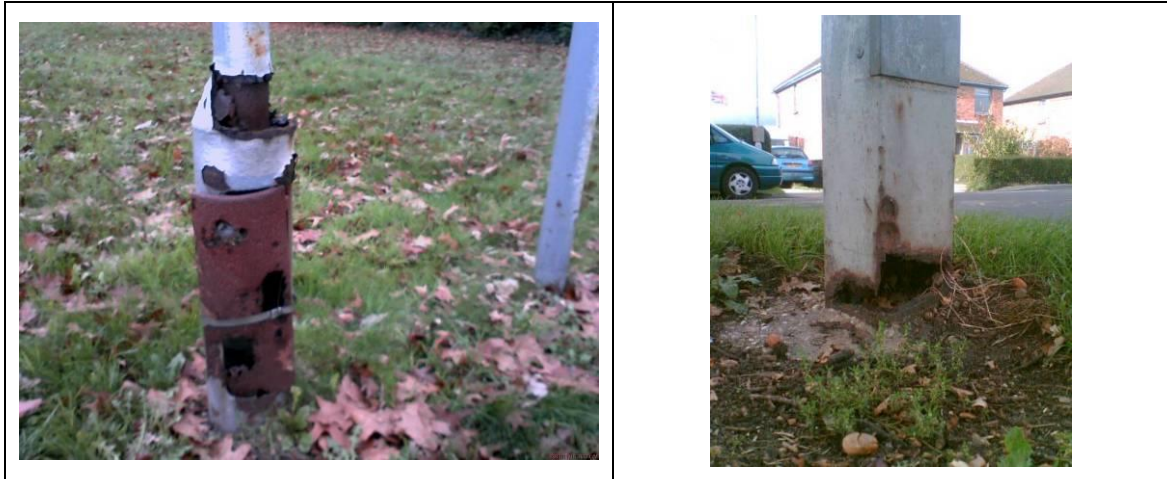
Street Lighting & Illuminated Traffic Signs – Condition of Post - LPCO

Where a street lighting column is significantly damaged or corroded and in danger of collapse.

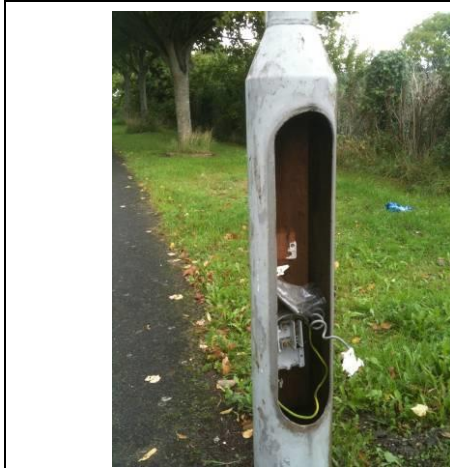
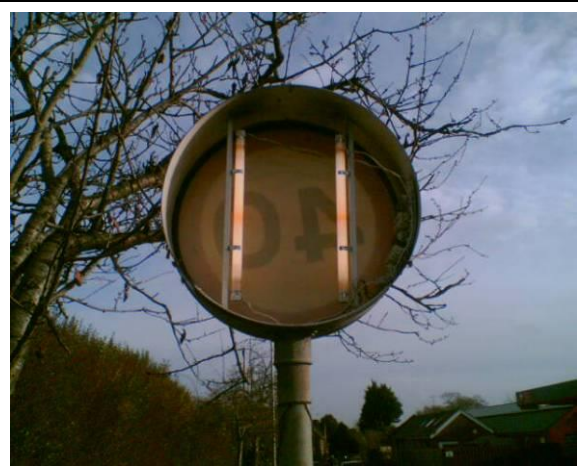
Street Lighting & Illuminated Traffic Signs – Missing Covers/ Exposed Wiring - LPXW

A street lighting column or illuminated traffic sign with a missing cover and/or exposed wiring.

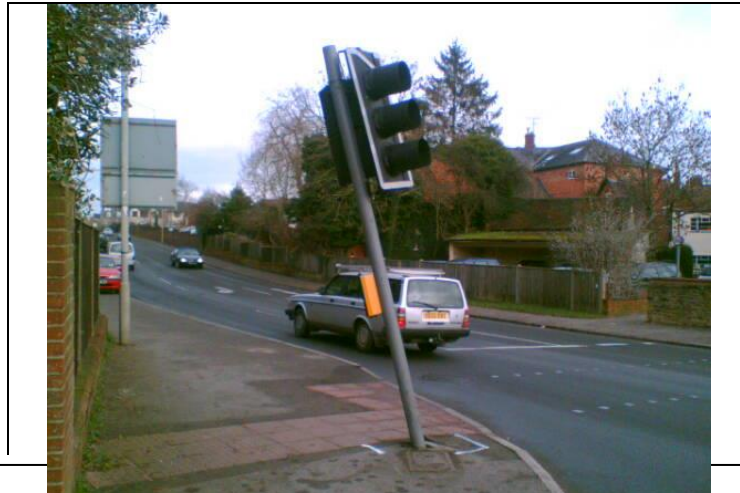
Traffic Control & Signal Installations – Damaged or Defective Traffic Signal - TSDG

A traffic signal which is damaged and/or defective to such an extent that it poses an immediate hazard to the highway user.

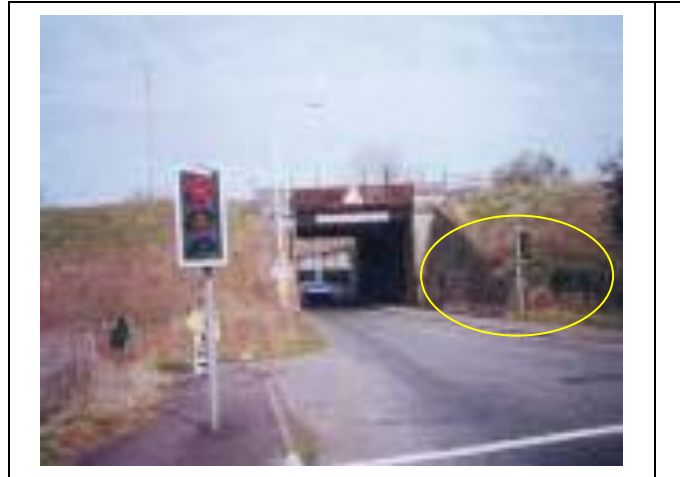
Any traffic signal where the lamps are obscured and/or misaligned, posing an immediate hazard to the highway user.

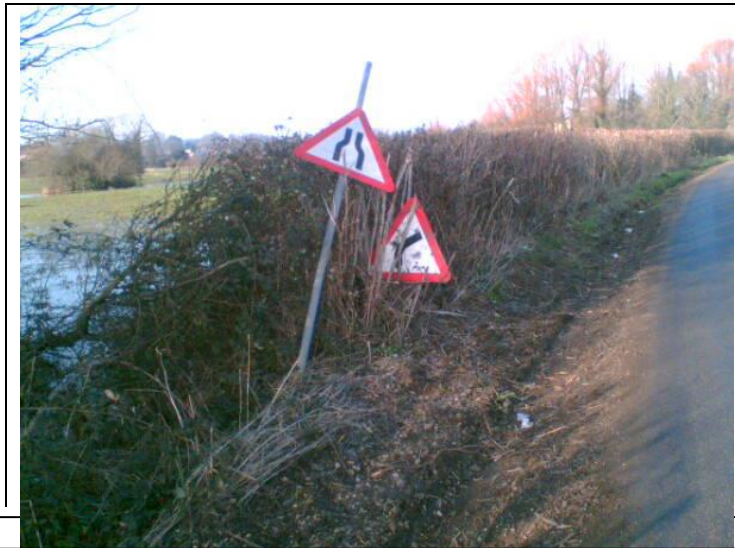
Road Signs – Damaged Road Sign - SND

A road sign which is damaged and poses a hazard to the highway user.

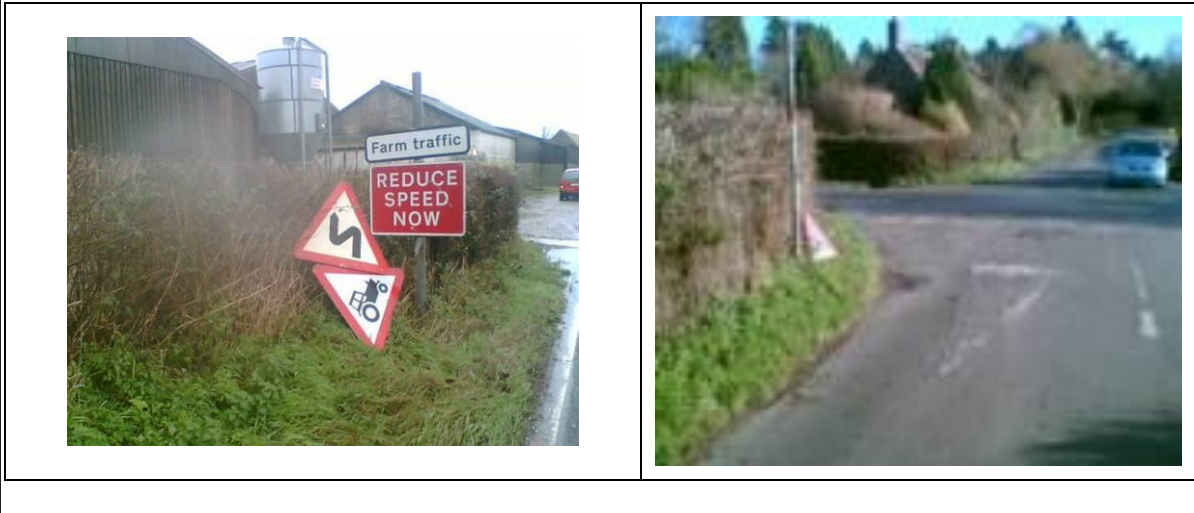
Sample Photographs:

Road Signs – Missing Road Sign - SNM

A completely missing road sign.

Impact Rating	Criteria
High	Regulatory Sign
Medium	Non – Regulatory Triangular ‘Warning’ Sign

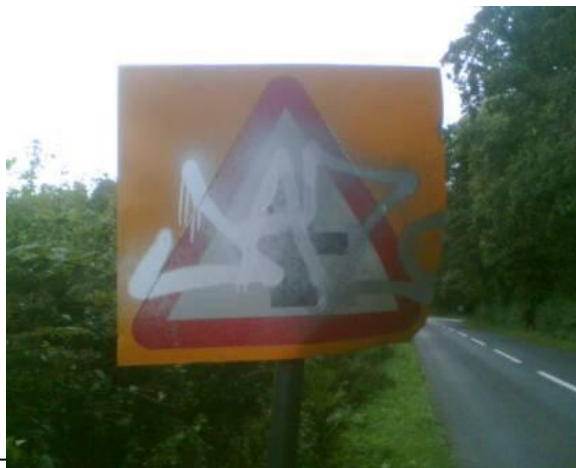
Sample Photograph:

Graffiti which could be considered as being offensive written, drawn or painted upon a road sign.

Impact Rating	Criteria
Medium	Offensive Graffiti

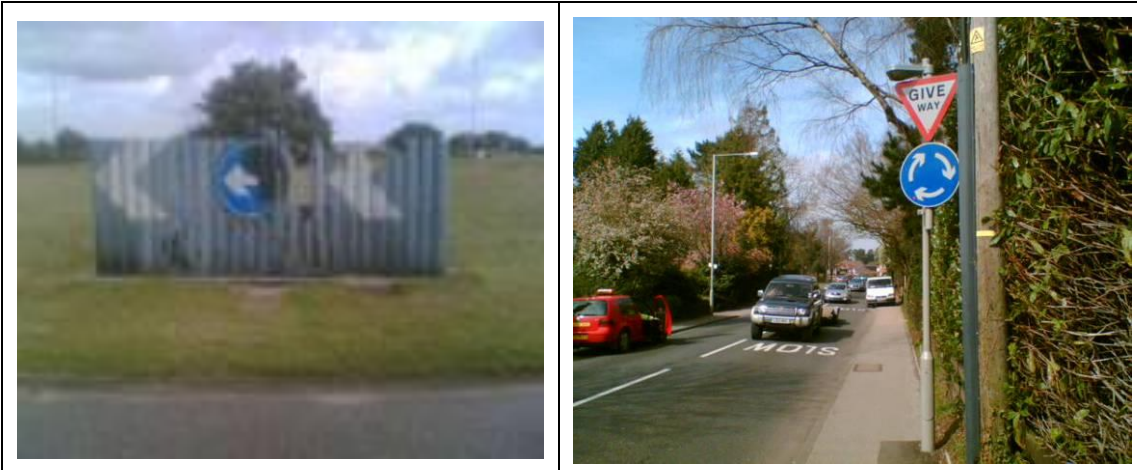
Sample Photographs:

Road Signs – Sign Face: Worn / Obscured / Dirty / Misaligned - SOB

Where a road sign is either worn, obscured, dirty or misaligned to the extent that it is illegible.

Impact Rating	Criteria
High	Regulatory Sign
Medium	Non – Regulatory Triangular ‘Warning’ Sign
