Dorset Highways:

Code of Practice for the Classification of Highway Safety Hazards & Defects

Version 3.0, Revision 0 July 2021

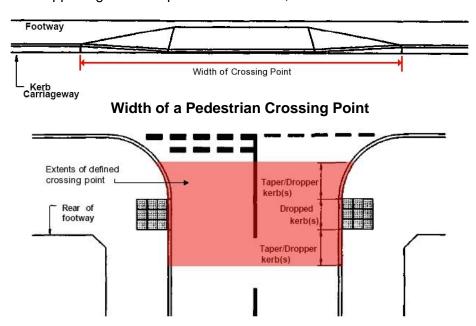
Plan View of a Typical Pedestrian Crossing Point

Carriageways shall be subject to the same investigatory levels as Footways at all defined pedestrian crossing points. Defined pedestrian crossing points can be identified by tapered and dropped kerb units, often accompanied by tactile paving. The width of carriageway subject to footway investigatory levels shall be that width between opposing sets of tapered kerb stones, as illustrated below.

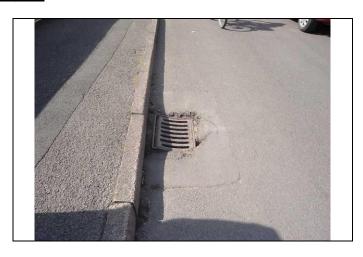
Sample Photographs:

Inspection chamber covers, gully gratings and other ironwork causing a step-in level to the surrounding carriageway surface. Where it is clear that the cover is the responsibility of a Statutory Undertaker (e.g. gas, water, or telecoms) and NOT the Councils the defect should be recorded using the defect option: Carriageways – Utility Cover: Difference in Level.

Impact Rating	Criteria
High	Greater than 300mm Wide AND Greater than 40mm Deep
Medium	Less than 300mm Wide AND Greater than 40m Deep
Low	Greater than 300mm Wide AND Greater than 20mm Deep

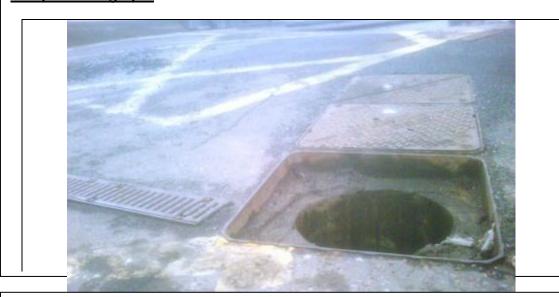
Sample Photograph:

A missing Inspection chamber cover, gully grating or other ironwork anywhere within the carriageway, which is clearly the responsibility of a Statutory Undertaker.

Impact Rating	Criteria
High	Cover Greater than 150mm Wide or Long
Low	Cover Less than 150mm Wide or Long

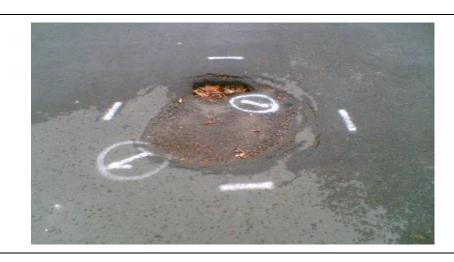
Sample Photographs:

An unguarded area of the carriageway which has become significantly depressed or where substrata has been washed away creating a visible void underneath the carriageway surface course, and which poses an immediate hazard to highway users.

Impact Rating	Criteria
High	Posing an Immediate Hazard

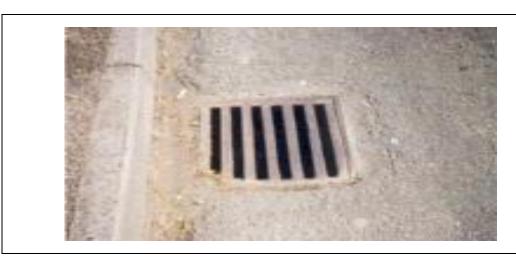
Sample Photographs:

Where a gully grating has been installed with the drainage slots running parallel to the direction of vehicular traffic.

Impact Rating	Criteria
Medium	Parallel Gully Grating

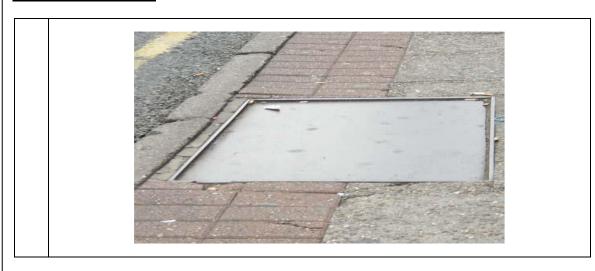
Sample Photograph:

Worn or smooth covers which pose a potential skidding / slipping hazard to highway users. Where it is clear that the cover is the responsibility of a Statutory Undertaker (e.g. gas, water, or telecoms) and NOT the Councils the defect should be recorded using the defect option: Footways – Utility Cover: Significantly Worn/Smooth Cover.

Impact Rating	Criteria
Medium	Greater than 75% Worn/Smooth

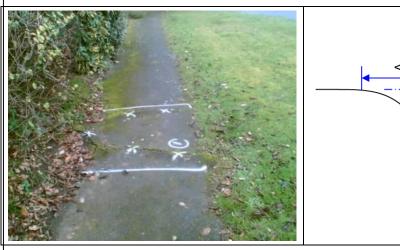
Sample Photographs:

A rapid change in the surface profile of the footway creating a hump or depression with a difference in vertical level greater than 25mm over a length of less than 125mm.

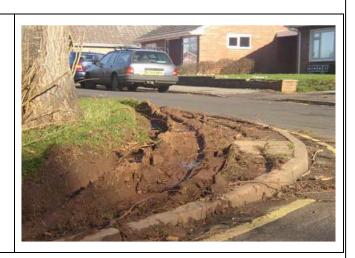
Sample Photographs:

Impact Rating	Criteria
Medium	Greater than 100mm Deep AND Greater than 300mm Wide AND
	Greater than 1.5m in Length

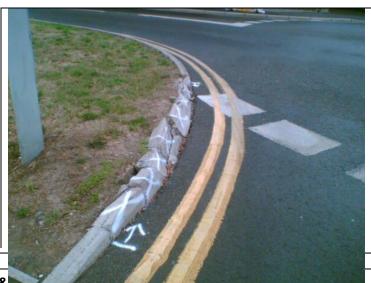
Sample Photograph:

A significantly damaged or missing kerb unit adjoining a verge, grassed area or other unmetalled surface.

Impact Rating	Criteria
Medium	Severely Damaged or Missing Components

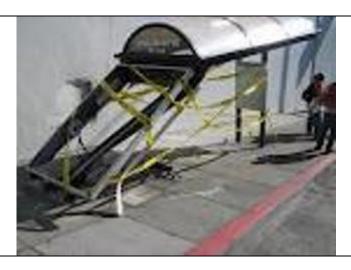
Sample Photograph:

Where a bus stop or shelter has been vandalised and poses an immediate hazard to highway users e.g. is unstable and may collapse into the carriageway.

Impact Rating	Criteria
High	Posing an Immediate Hazard

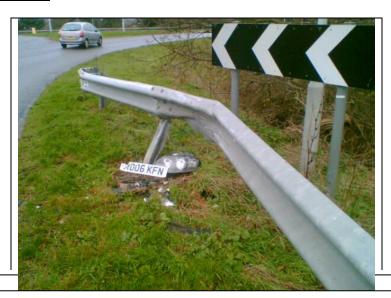
Sample Photograph:

Where a safety barrier has been subject to vehicular impact and is damaged and/or misaligned.

Impact Rating	Criteria						
High	Damaged/Misaligned

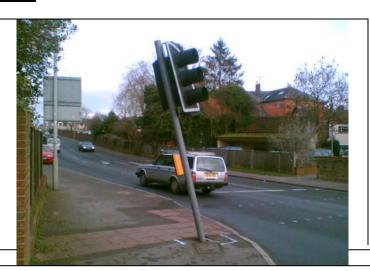
Sample Photograph:

A traffic signal which is damaged and/or defective to such an extent that it poses an immediate hazard to the highway user.

Impact Rating	Criteria
High	Posing an Immediate Hazard

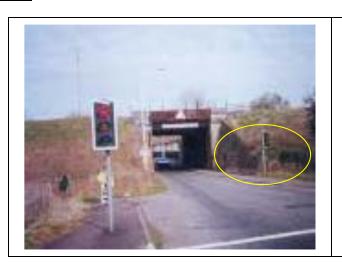
Sample Photograph:

Any traffic signal where the lamps are obscured and/or misaligned, posing an immediate hazard to the highway user.

Impact Rating	Criteria
High	Posing an Immediate Hazard

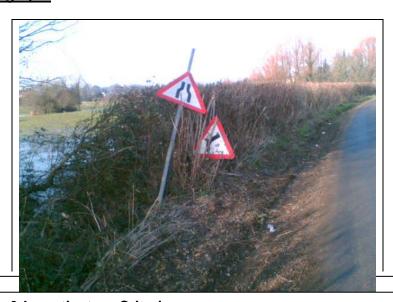
Sample Photograph:

A road sign which is damaged and poses a hazard to the highway user.

Impact Rating	Criteria
High	Sign on the footway
Medium	Sign adjacent to the carriageway no footway

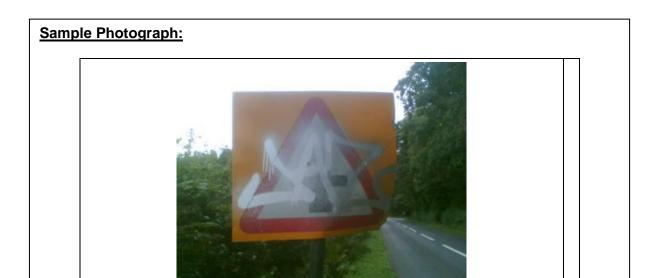
Graffiti which could be considered as being offensive written, drawn or painted upon a road sign.

Impact Rating	Criteria
Medium	Offensive Graffiti
