Area 6 - North Dorset

C13 - Dinah's Hollow - Melbury Abbas

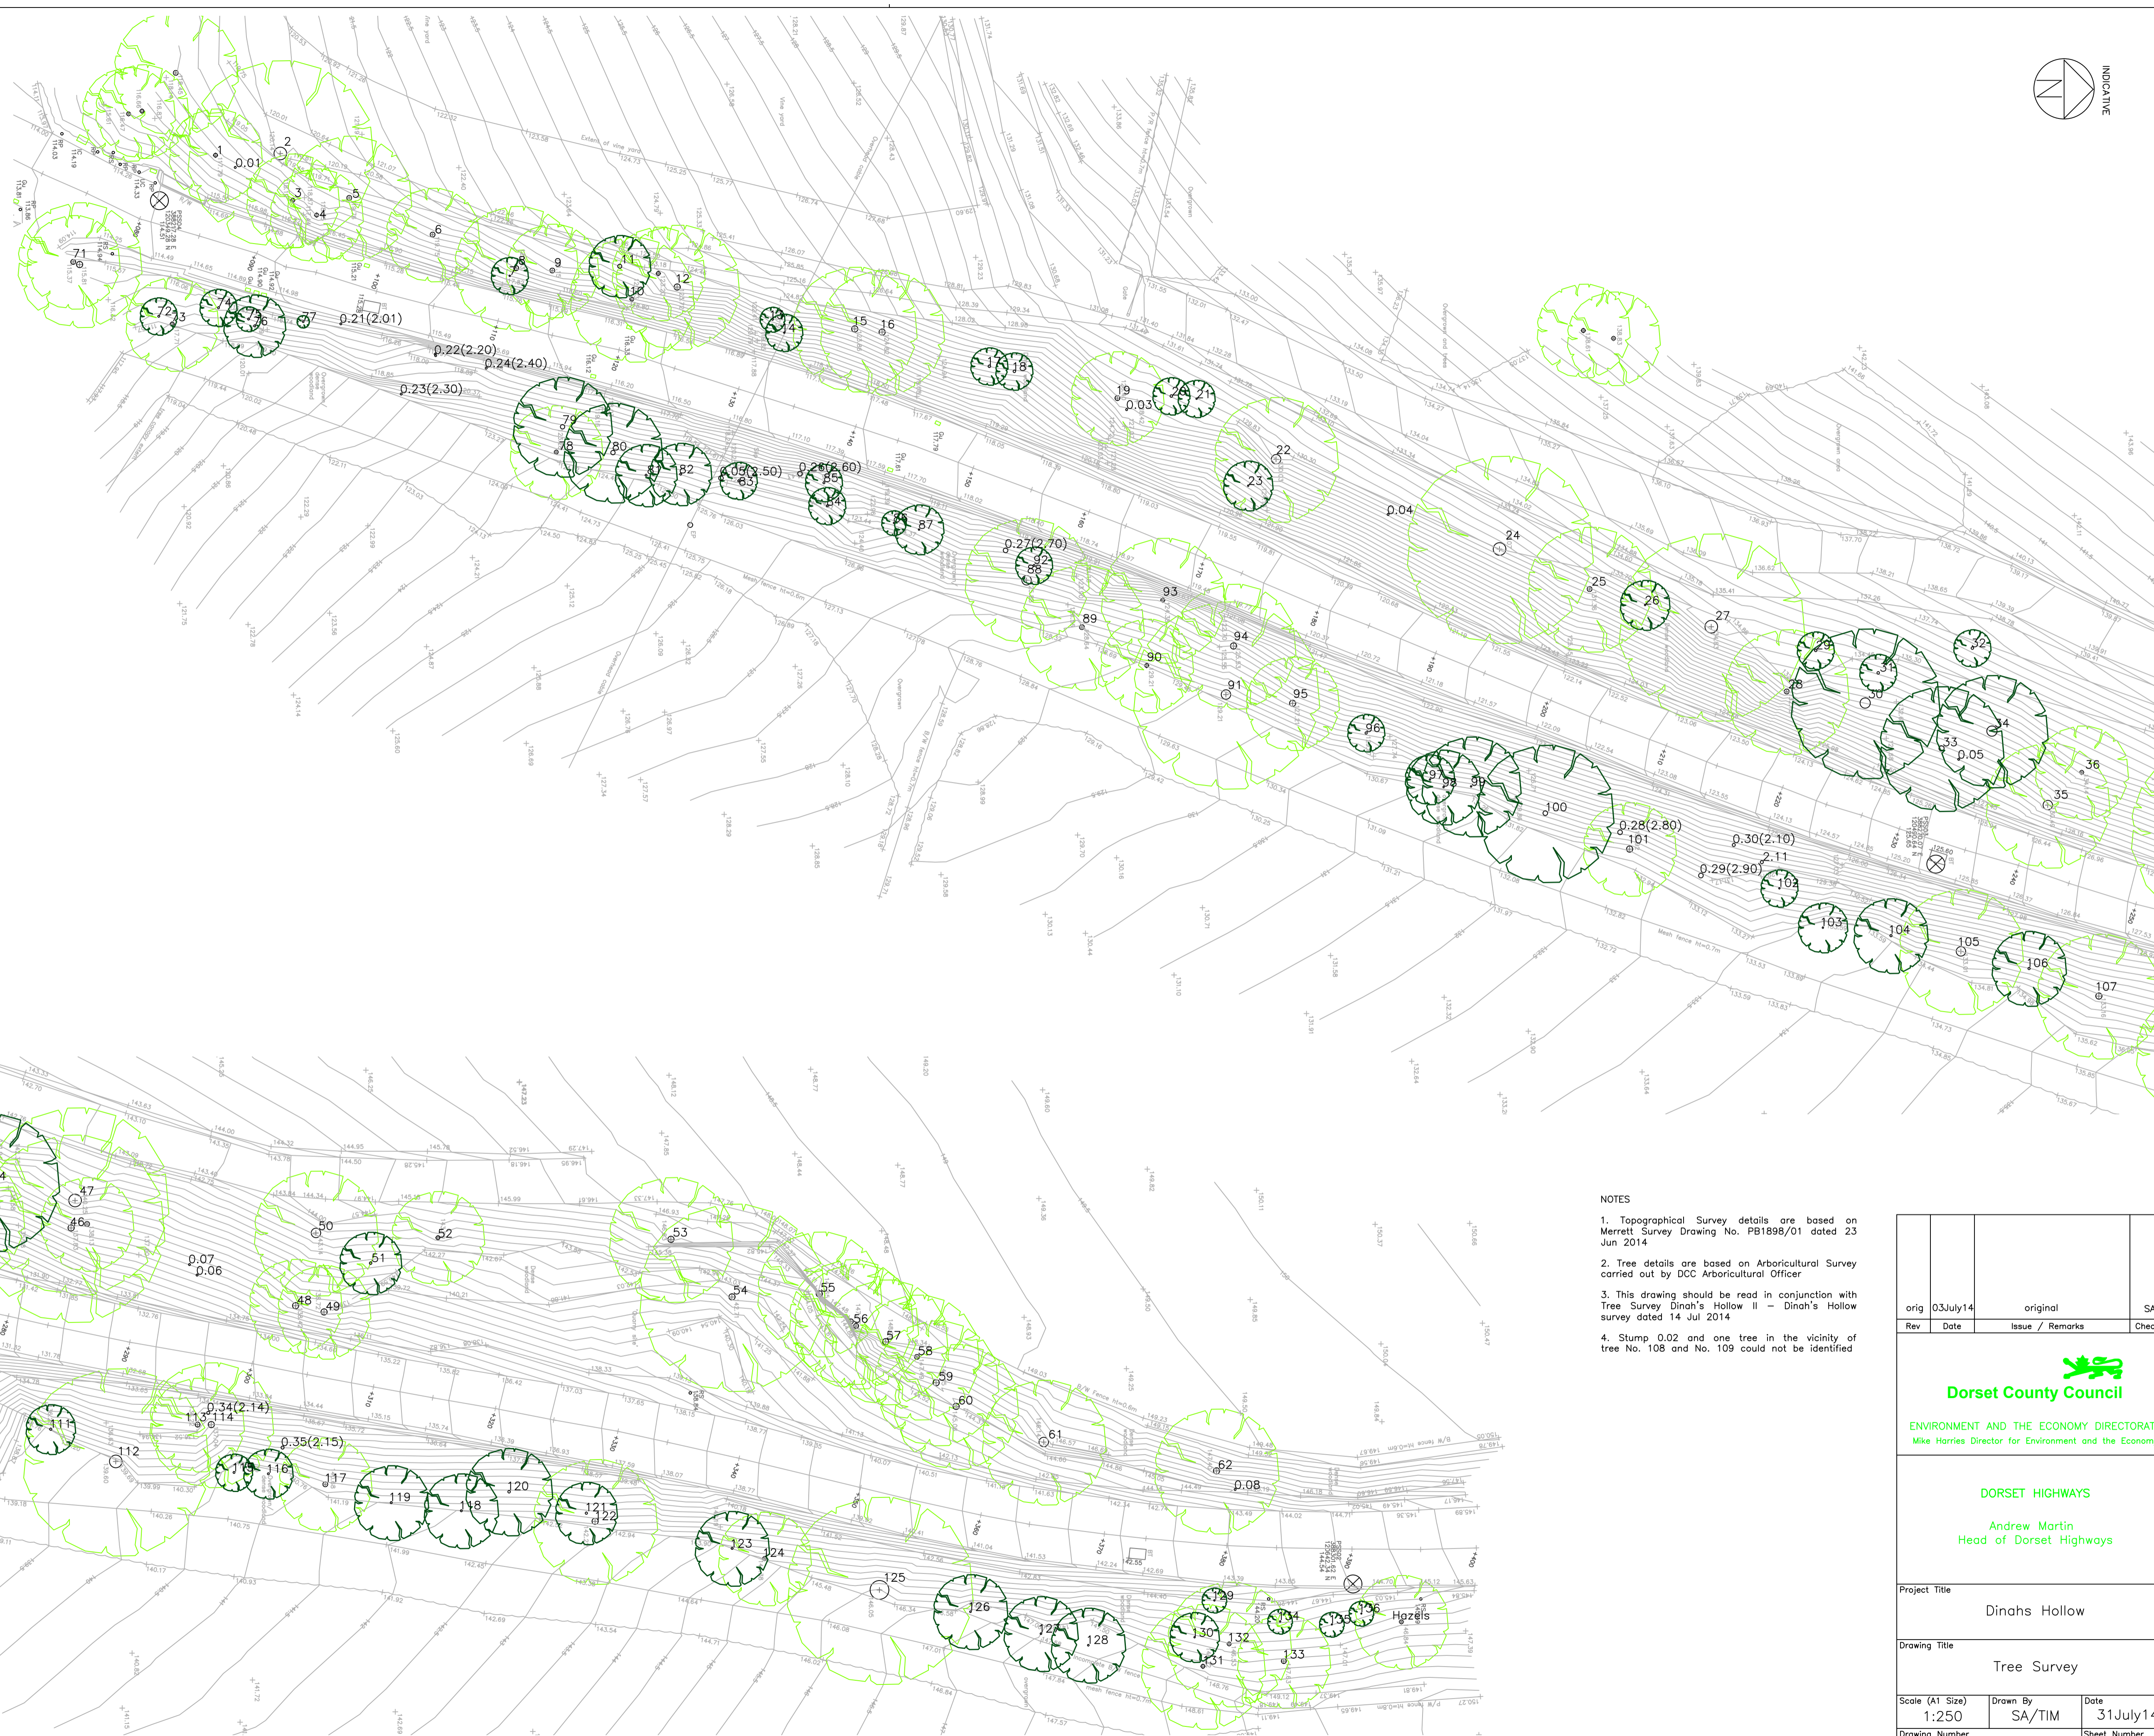
Trees – as surveyed

Trees – not surveyed, approximate location only shown

Stumps – not surveyed, approximate location only shown (numbers shown in brackets relate to numbers shown on Tree Survey plot where these differ from that shown on schedule)

1. Topographical Survey details are based on Merrett Survey Drawing No. PB1898/01 dated 23 Jun 2014
2. Tree details are based on Arboricultural Survey carried out by DCC Arboricultural Officer
3. This drawing should be read in conjunction with Tree Survey Dinah's Hollow II - Dinah's Hollow survey dated 14 Jul 2014
4. Stump 0.02 and one tree in the vicinity of tree No. 108 and No. 109 could not be identified
