**BACK ANALYSIS OF EXISTING SLOPES & ASSESSMENT OF CHARACTERISTIC VALUES FOR DINAHS HOLLOW**

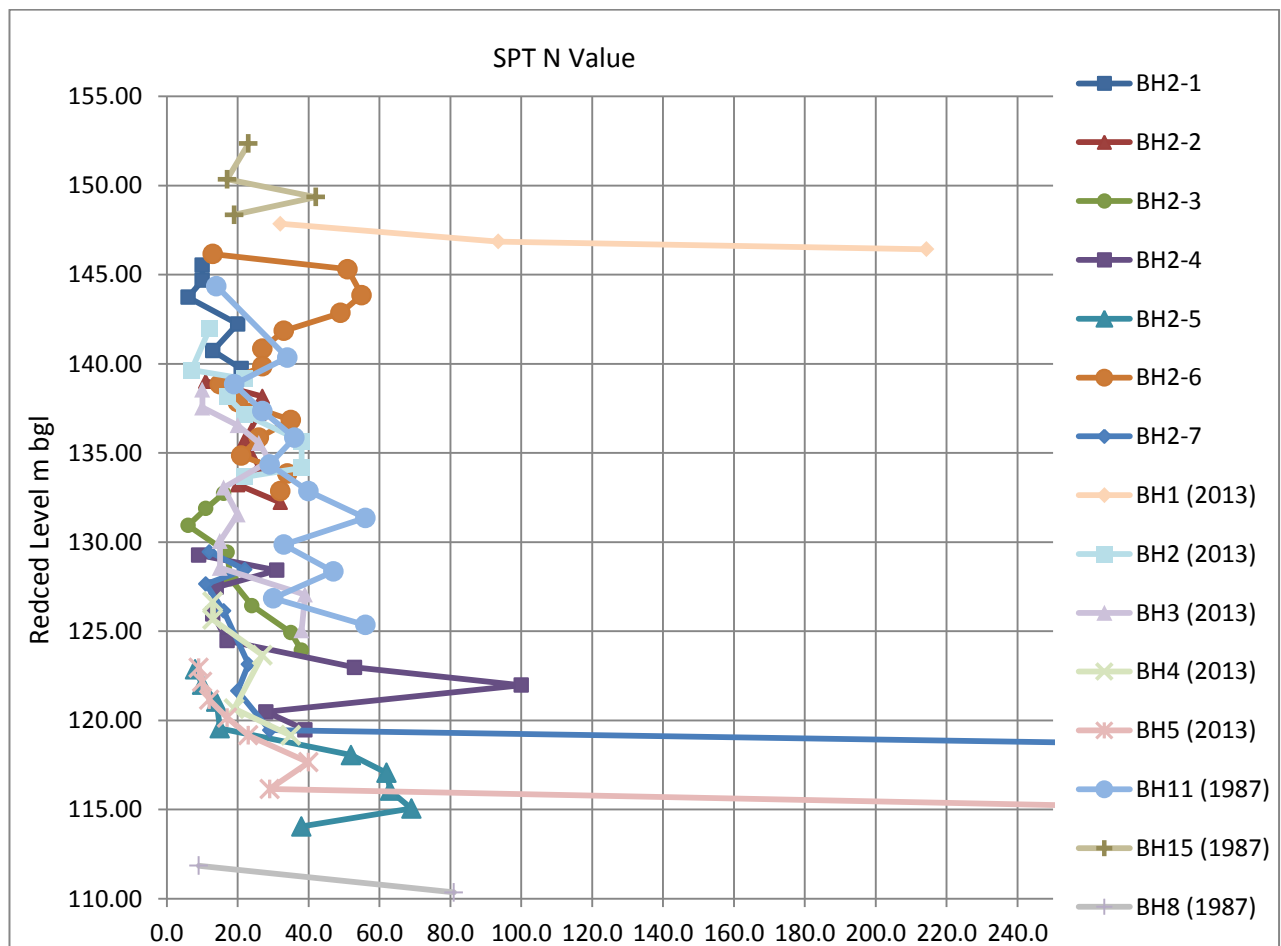
Figure 1 - SPT 'N' Value vs Reduced Level AoD

The results of the SPTs taken in the 2014 site investigation have been collated and assessed along with the results of the 2013 ground investigation by Brody Forbes, and relevant results from a 1981 investigation by Norwest Holst. These are as presented in Figure 1 below.

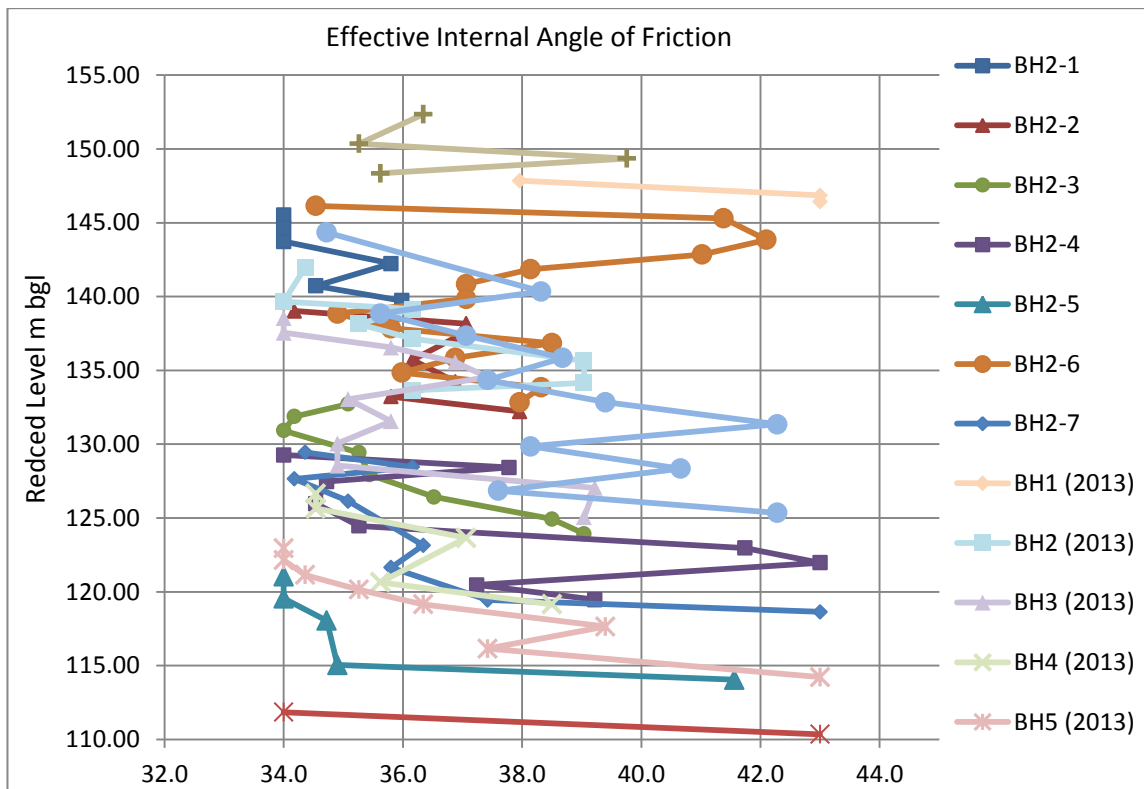
Figure 2 - Effective Internal Angle of Friction derived from SPT Results

The effective internal angle of friction has been derived from each SPT result in accordance with BS8002, Table 2. These have been collated and presented in Figure 2 below.

The results of the statistical analysis indicate that a characteristic value of 35° for the effective internal angle of friction is suitable, based upon the 2014 and historic SPT results, and the effective stress testing undertaken in the 2014 site investigation. This is corroborated by the results of the literature review.

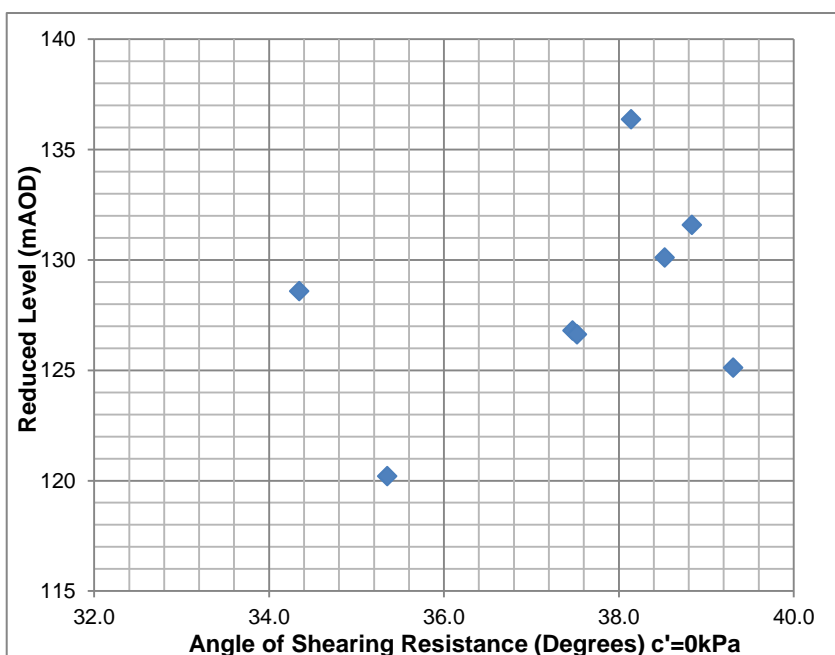
Figure 3 - Effective Internal Angle of Friction according to Triaxial Tests

Consolidated, drained Triaxial Tests have been undertaken as part of the 2014 site investigation, which provide an effective angle of shearing resistance. Assuming cohesion of 0kPa, the effective internal of friction has been derived from each Triaxial test. These results have been collated and presented in Figure 3 below.
